3803-2 / 3420

Magnetic Tape Subsystem  
Maintenance Manual

CAPSTAN AND TRACKING CHECKS/  
ADJUSTMENTS/REMOVALS/  
REPLACEMENTS

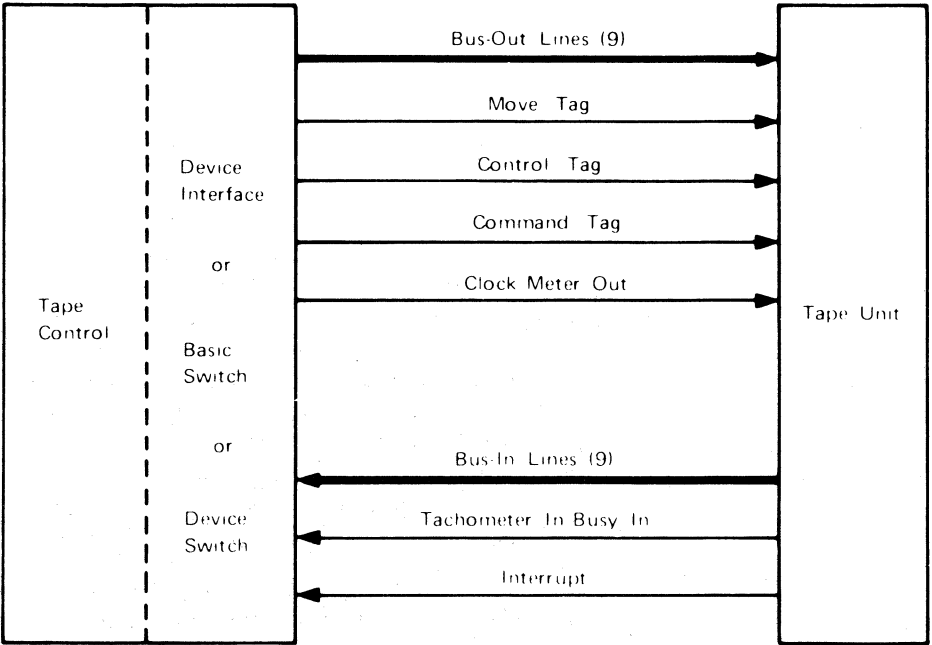
Device Interface Lines

BUS OUT Lines

BUS OUT Bit	COMMAND Tag Active	CONTROL Tag Active
0	Backward read	Rewind Unload
1	Forward read	Not used
2	Diagnostic (LWR)	(Model 4, 6, 8 only) Diagnostic (set high sense)
3	Pulse	NRZI or 6250 BPI mode
4	Write	(Model 4, 6, 8 only) Diagnostic (set low sense)
5	Set Extend Stop (Model 4, 6, 8 only)	Data security erase
6	Reset error latches	(Model 4, 6, 8 only) Erase Status
7	Not used	Rewind

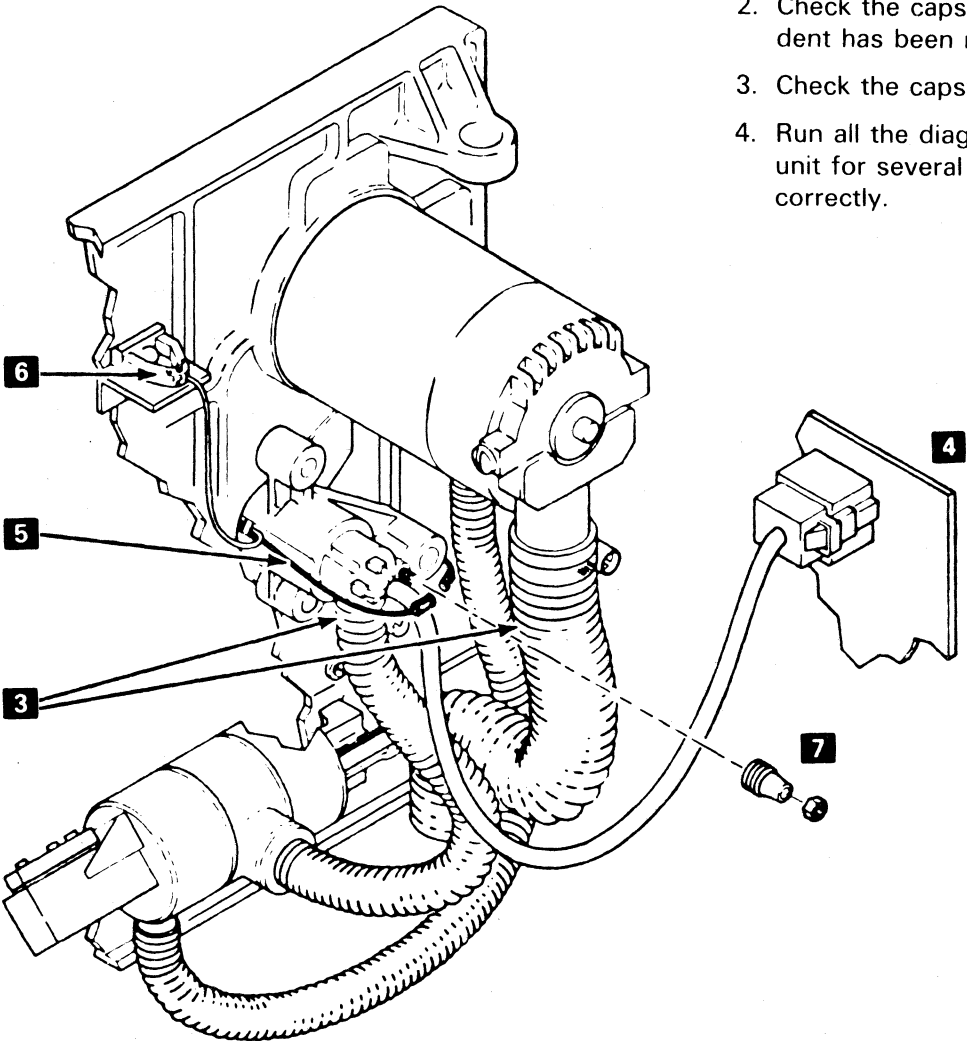
1. Unload the tape unit and turn off tape unit power.
2. Loosen the two upper stubby bar mounting screws and slide the bar down and to the right to increase capstan clearance. Tighten the screws temporarily.
- 3 Disconnect the air hose(s) from the capstan motor and the left reel motor.

- 4 Unplug the power cable from the capstan motor control board.
- 5 Disconnect the tachometer cable.
- 6 Remove the wedge holding the capstan fiber optic bundle in the light manifold and pull out the bundle.
- 7 Remove the spring cluster load nut and spring cluster.
8. Remove the capstan assembly from the rear, being careful not to snag any wires or damage the capstan or reference plate.

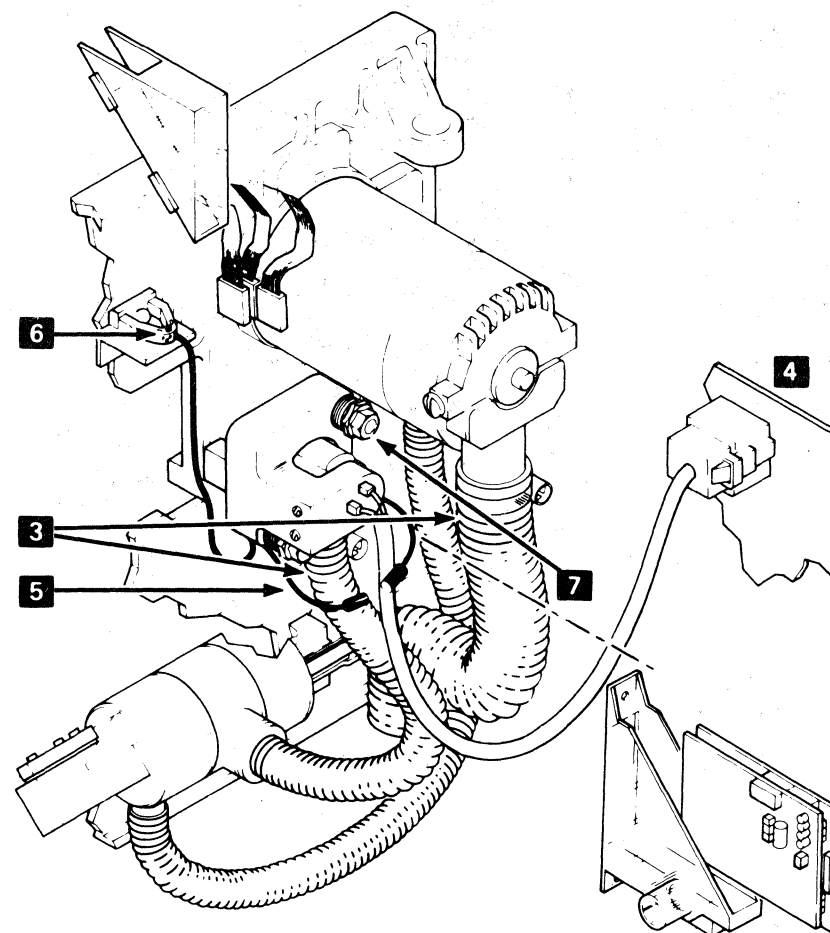
1. Unload the tape unit and turn off tape unit power.
2. Loosen the two upper stubby bar mounting screws and slide the bar down and to the right to increase capstan clearance. Tighten the screws temporarily.
3. Disconnect the air hose(s) from the capstan motor and the left reel motor.

**Note:** If the tape unit has a square capstan support, remove the read/write head cards and cooling shroud to make removal of the capstan easier. See 08-260, "Read/Write Head Card Removal/Replacement."

8. Remove the capstan assembly from the rear, being careful not to snag any wires or damage the capstan or reference plate.

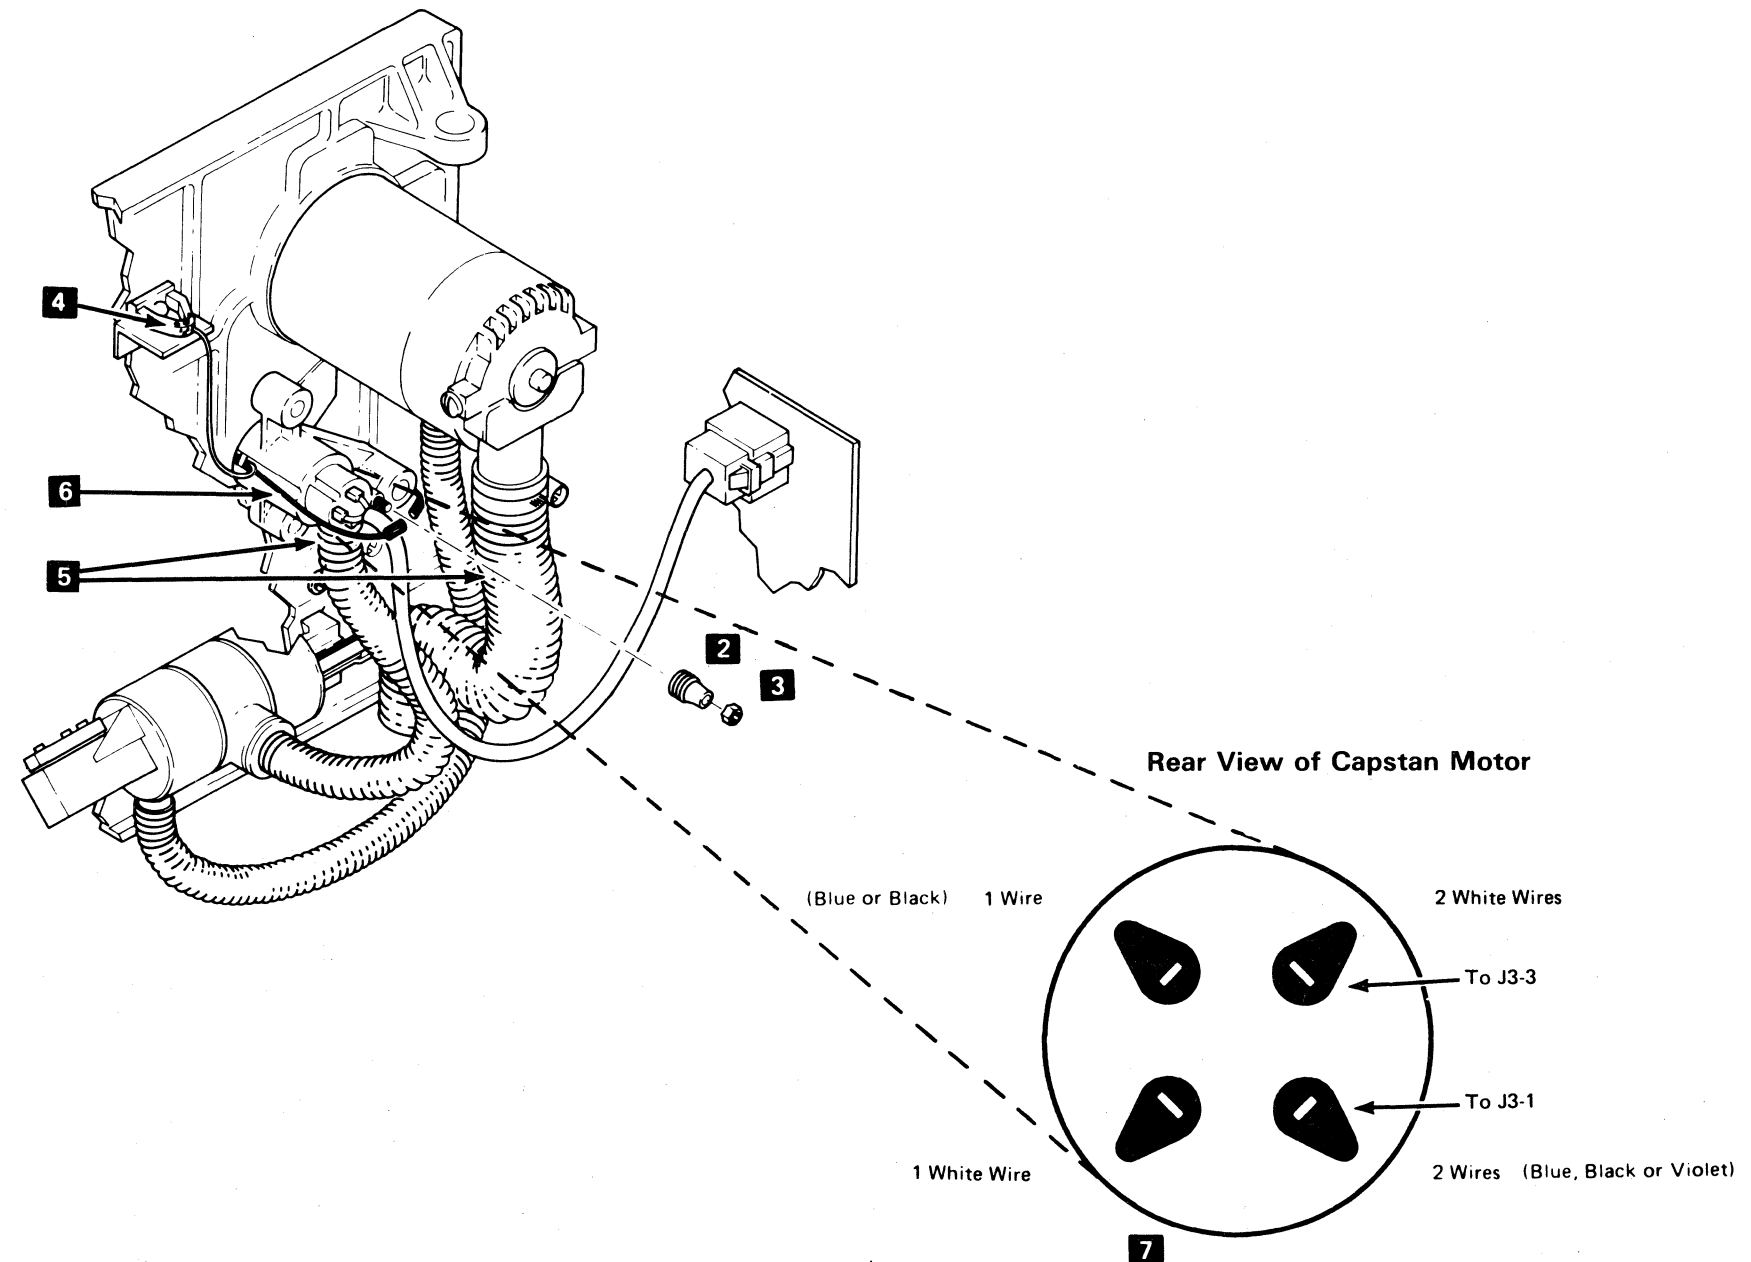
### CAPSTAN ASSEMBLY REPLACEMENT (NON-90,000 SERIES TAPE UNITS)

**Note:** Before installing the capstan assembly, inspect the capstan for damage.

**Note:** See the capstan motor wiring chart if the wires are disconnected from the motor.

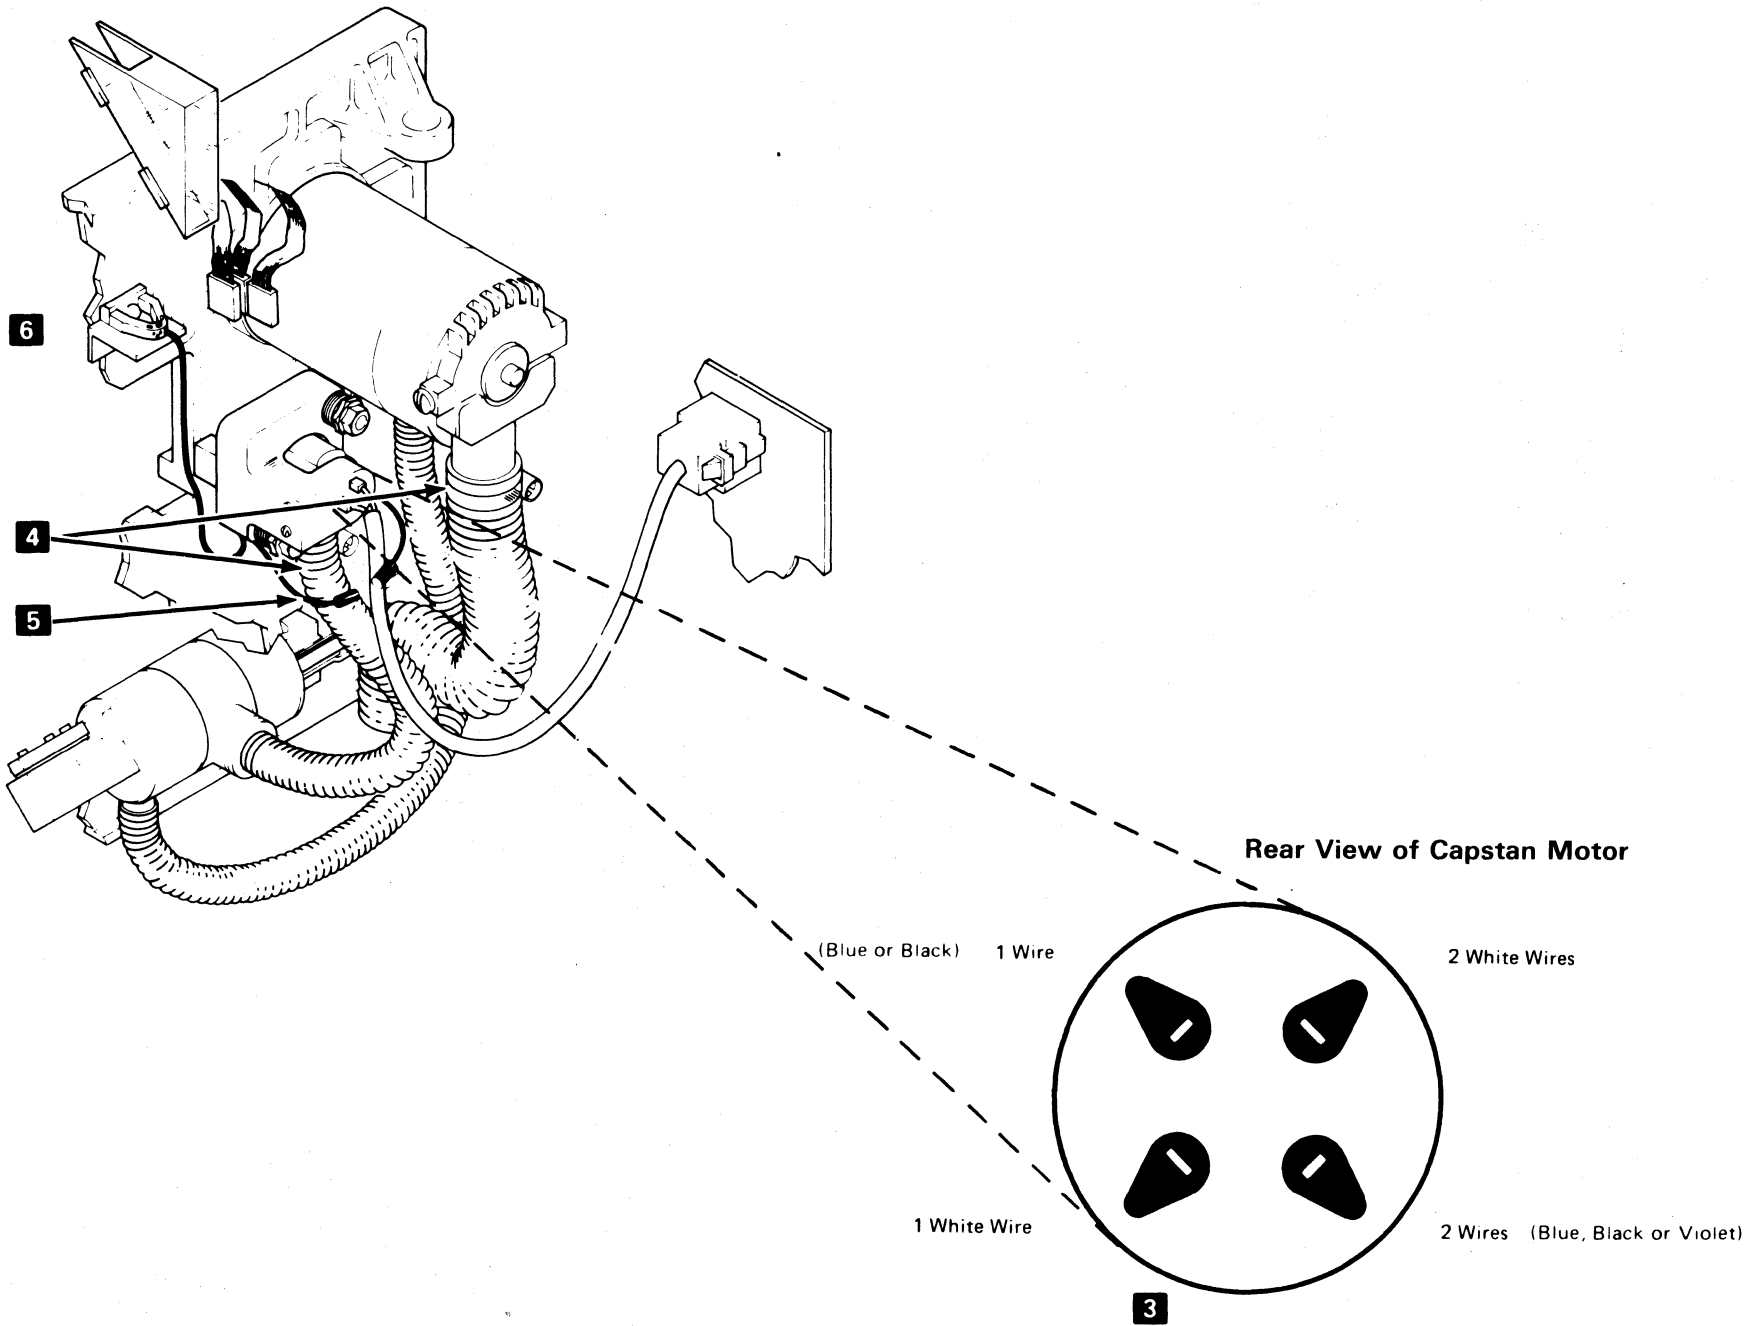
CAPSTAN ASSEMBLY REPLACEMENT  
(90,000 SERIES TAPE UNITS)

**Note:** If the read/write head cooling shroud was removed, replace it. See 08-260, "Read/Write Head Card Removal/Replacement."

- 7. Perform the following procedures in the order listed:
  - a. Capstan Tachometer Check/Adjustment, 08-120 or 08-130
  - b. Capstan Dynamic Alignment, 08-160
  - c. Capstan-To-Stubby Bar Clearance Adjustment, 08-080
  - d. Mechanical Skew Check/Adjustment, 08-170 or 08-180

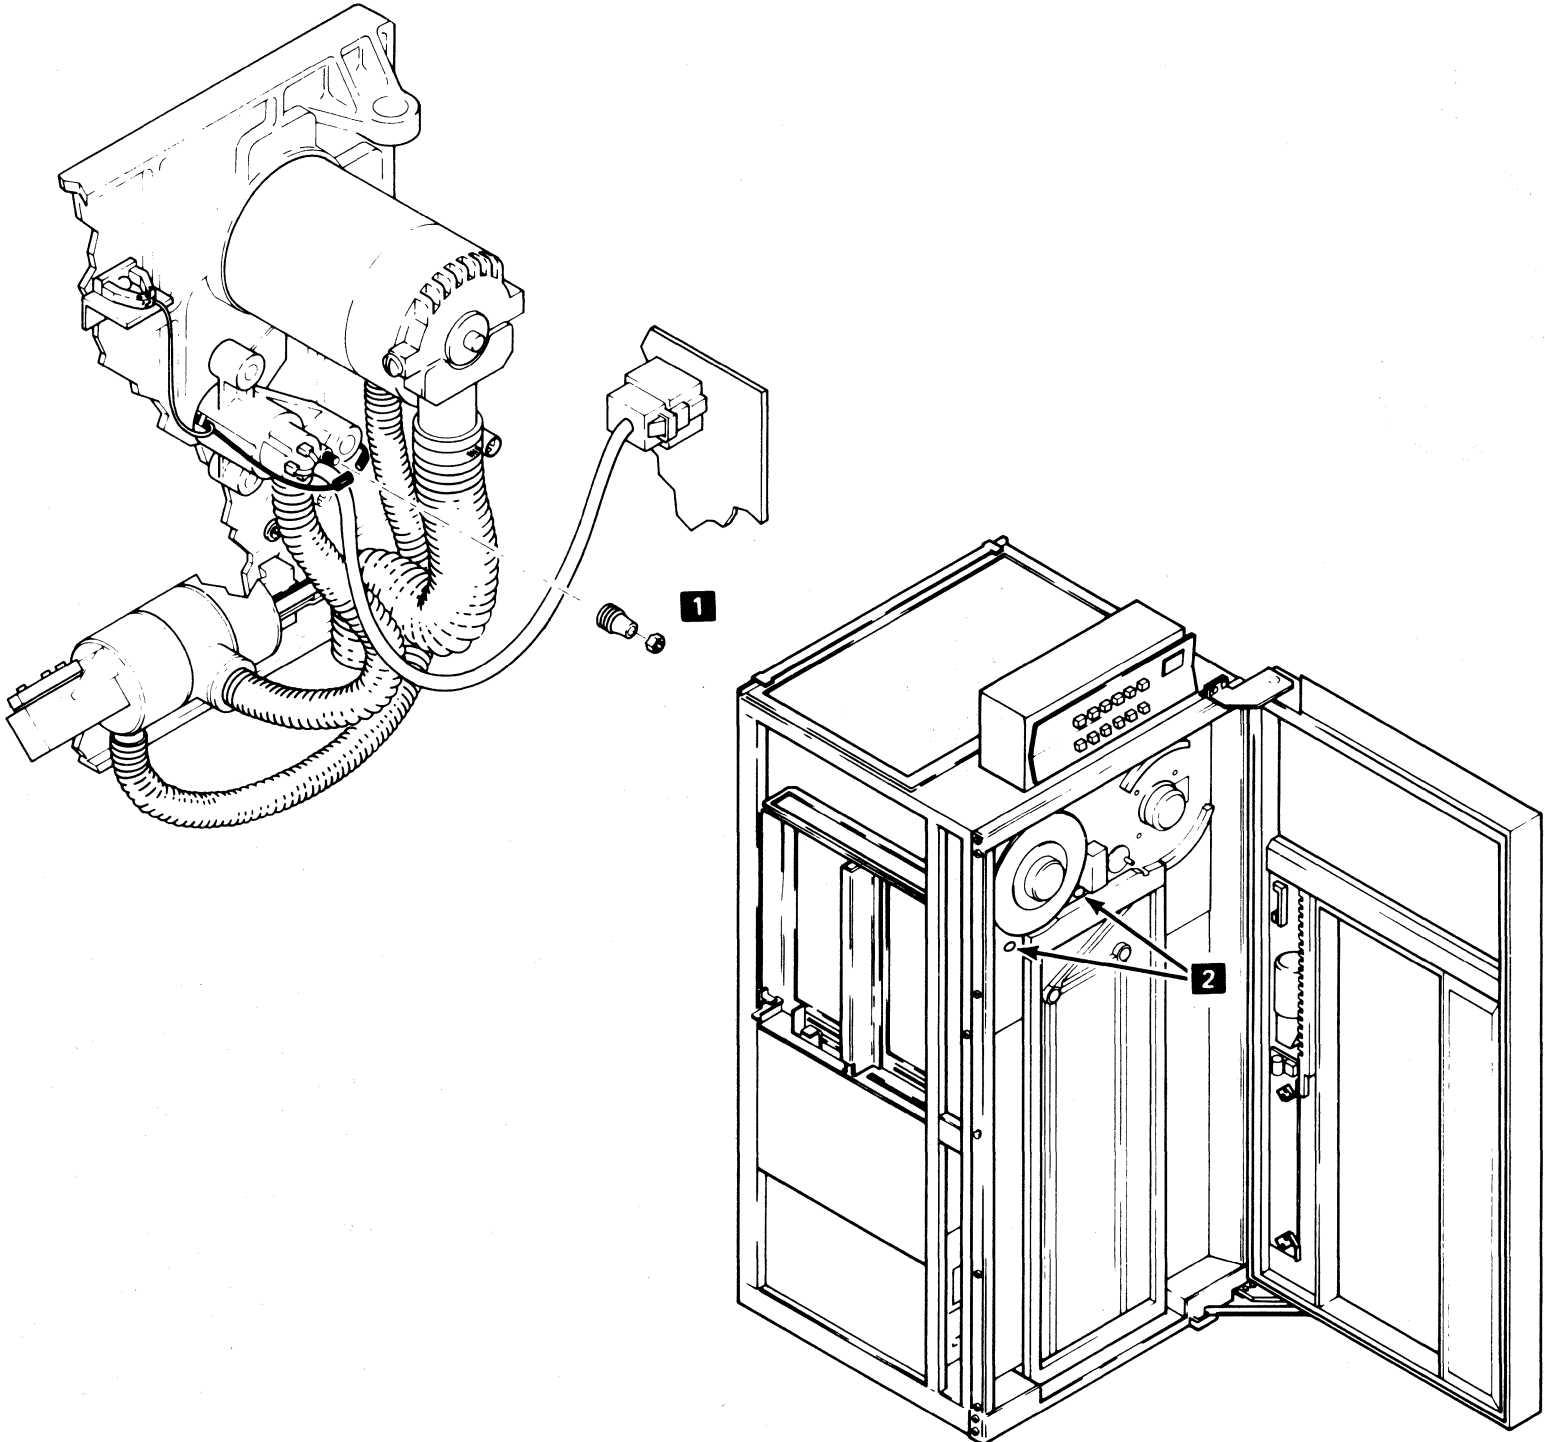
Non-90,000 Series Tape Units

- 1 Loosen the spring cluster load nut three turns.
- 2 From the front, turn both adjusters counterclockwise until they touch the bottom in the threaded sleeve. Access is made through holes in the faceplate.
- 3 Turn each adjuster two full turns clockwise.
- 4 Tighten the spring cluster load nut until slack is removed; then tighten 4 to 4-1/4 turns more. If no slack is present, loosen the cluster load nut 1 until the slack is just noticeable, then retighten 4 to 4-1/4 turns.
- 5 Perform the Capstan-To-Stubby Bar Clearance Adjustment procedure on 08-080.
- 6 Check for 17/32 ±1/64 inch (13.5 ±0.4 mm) from the reference plate to the front edge of the capstan wheel.

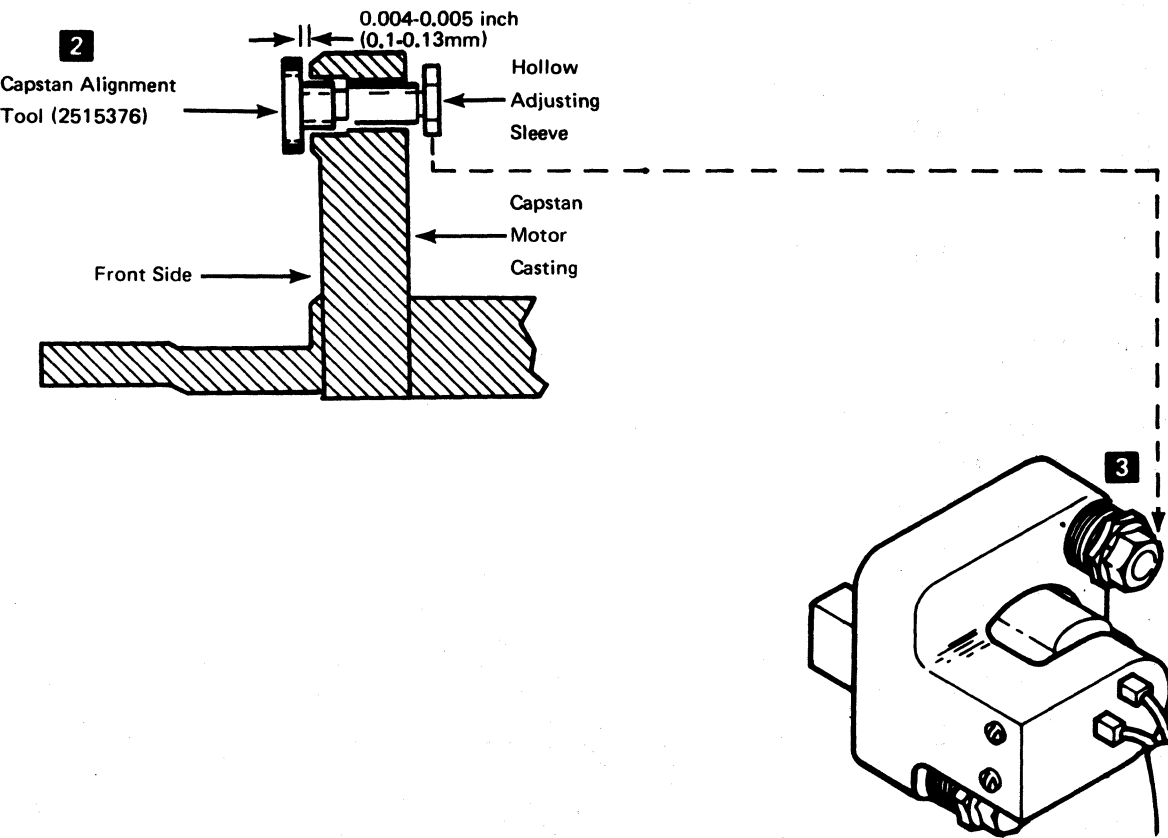
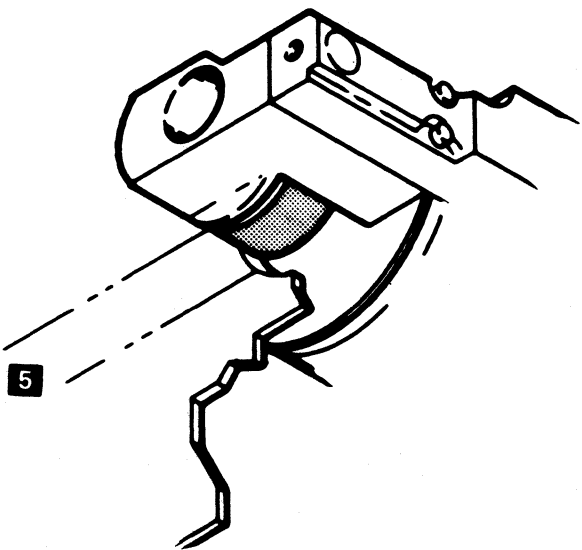
1. Remove the capstan assembly. See 08-030, "Capstan Assembly Removal."
  2. Insert the capstan alignment tool, P/N 2515376, through the front of the motor casting.\*
  3. If necessary, rotate each hollow adjusting sleeve until the shoulder of the alignment tool is 0.004 to 0.005 inch (0.102 to 0.127 mm) from the casting surface for each sleeve.
  4. Replace the capstan drive assembly. See 08-050, "Capstan Assembly Replacement."
- Caution:** Be very careful not to damage the capstan wheel, reference plate, fiber optic bundle, or tachometer cable when installing the capstan assembly.
- The front edge of the capstan should be  $17/32 \pm 1/64$  inch ( $13.5 \pm 0.4$  mm) from the reference plate. If not, rotate the adjusting sleeves until this condition is met.

\*If tool is not available, perform the procedure on 08-064, step 2.

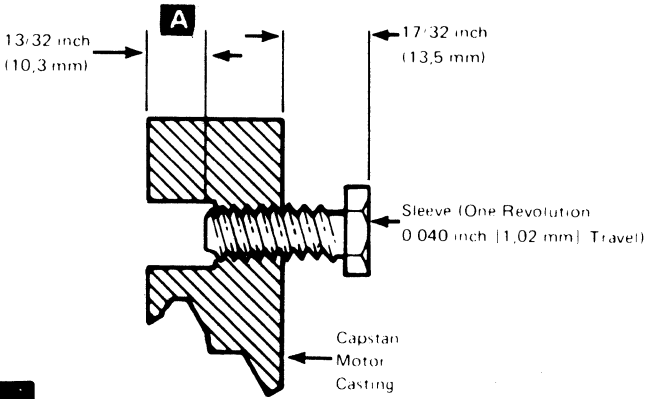
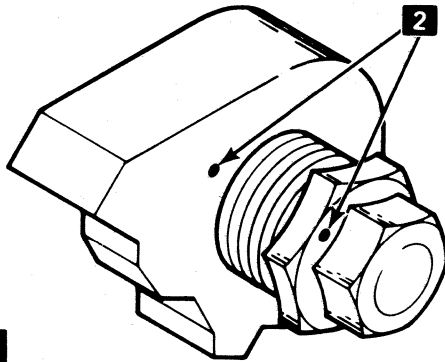
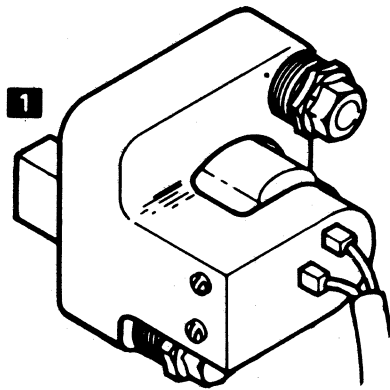
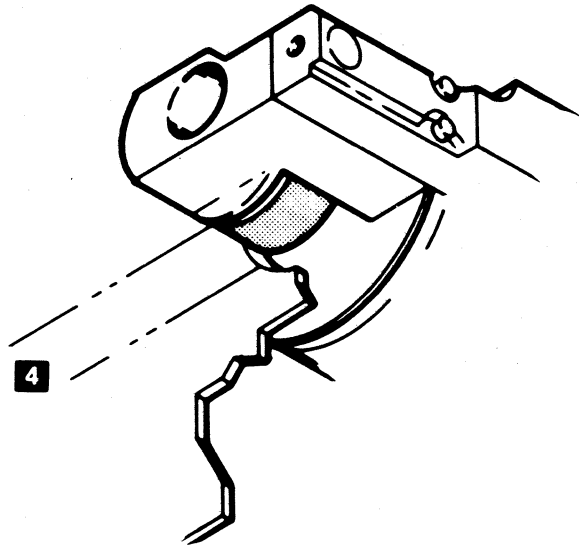
If the capstan alignment tool, P/N 2515376, is available, use the procedure on 08-062. If the tool is not available, proceed as follows:

- 1 Remove the capstan assembly. See 08-030, "Capstan Assembly Removal."
  - 2 If necessary, rotate each sleeve until the zero marks align, and the sleeve tips are  $13/32$  inch (10.3 mm) **A** from the end of the capstan motor casting. Use a steel scale, P/N 450158 or equivalent, to make this measurement.
  - 3 Replace the capstan assembly. See 08-050, "Capstan Assembly Replacement."
- Caution:** Be very careful not to damage the capstan wheel, reference plate, fiber optic bundle, or tachometer cable when installing the capstan assembly.
- 4 The front edge of the capstan should be  $17/32 \pm 1/64$  inch ( $13.5 \pm 0.4$  mm) from the reference plate. If not, rotate all sleeves until this condition is met.

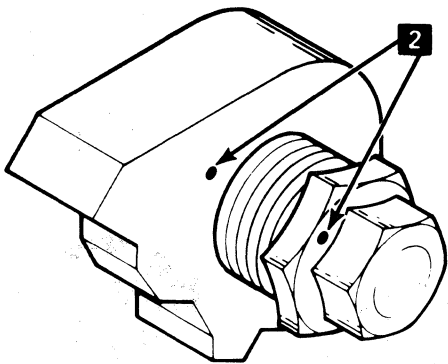
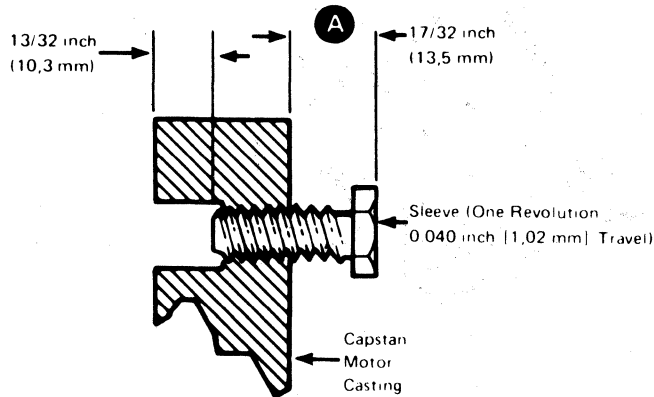
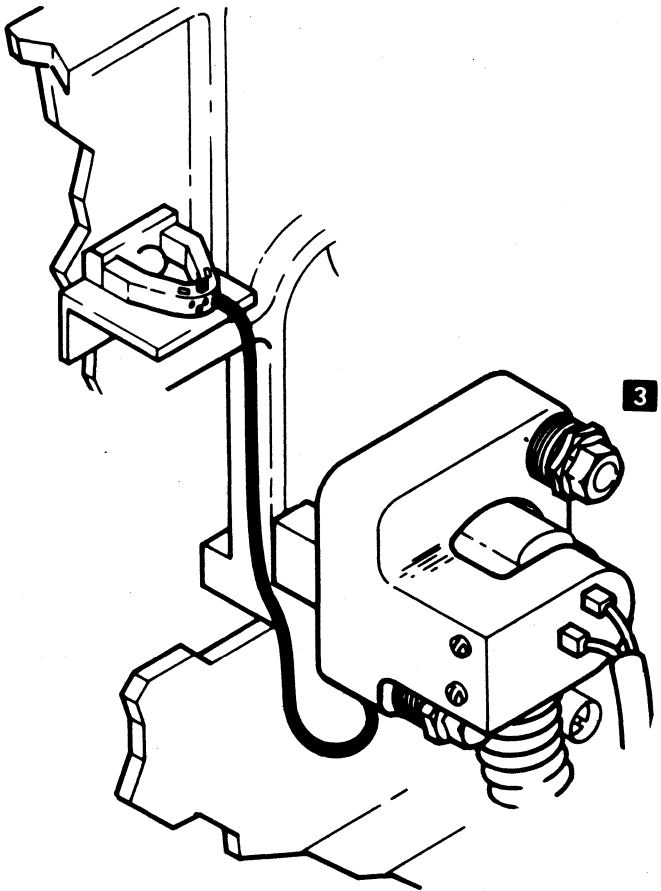
1. Check the zero mark on each sleeve for alignment with its corresponding casting mark.
2. If the zero marks are not aligned, turn the adjustable sleeves in the direction that requires the least rotation to align the sleeve and casting marks.

**Note:** If any sleeve requires more than 135 degrees of rotation, remove the capstan assembly and follow the procedure on 08-062 or 08-064.
3. When all the sleeves are aligned with their casting marks, measure from outside edge of each sleeve to the edge of the capstan casting. Each should measure  $17/32 \pm 1/32$  inch ( $13.5 \pm 0.8$  mm) **A**; all should be within  $1/32$  inch (0.8 mm) of each other. Use a steel scale, P/N 450158 or equivalent to make this measurement.
4. If the previous check is not within specifications, rotate each sleeve, where necessary, to meet this condition.

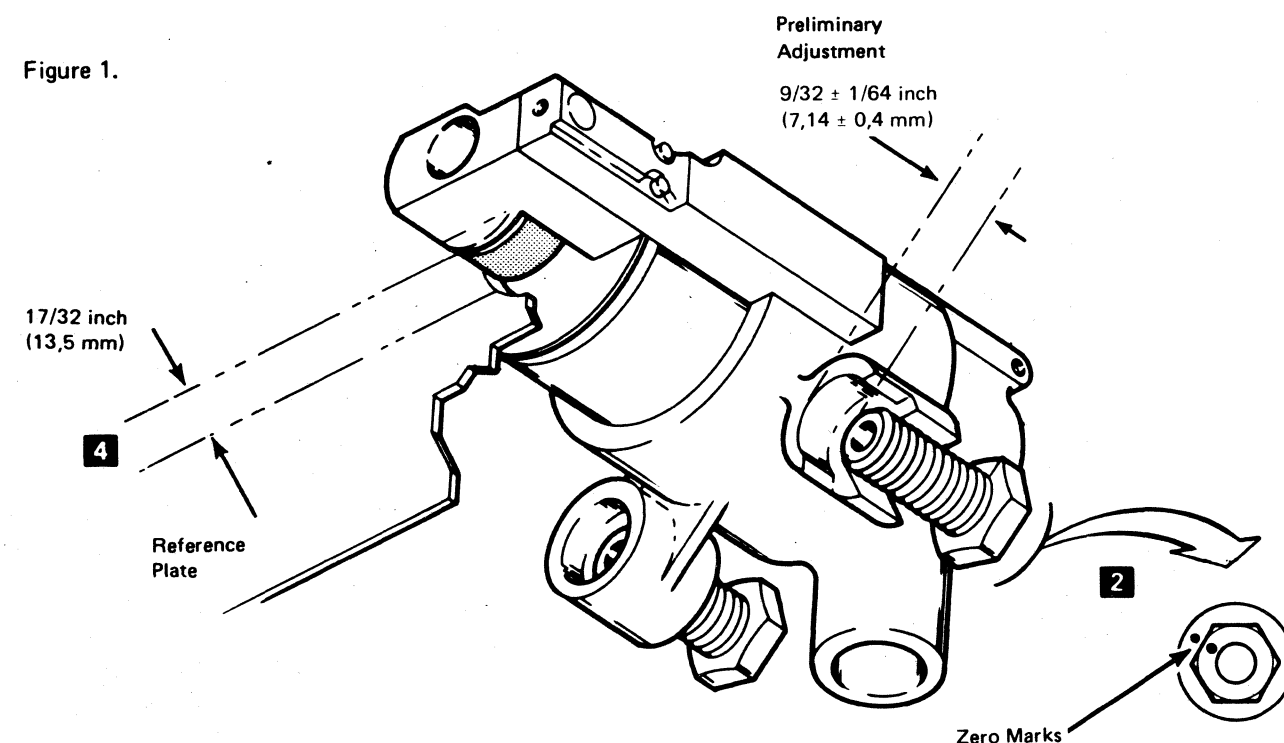
Figure 1.

1. Remove the capstan assembly. See 08-020 or 08-030, "Capstan Assembly Removal."
2. Turn each sleeve until the zero marks align with the corresponding casting marks. When all the sleeves are aligned with their casting marks, measure from the sleeve tip to the end of the capstan motor casting. Each should measure  $9/32 \pm 1/64$  inch ( $7.1 \pm 0.4$  mm). Use a steel scale, P/N 450158 or equivalent, to make this measurement.
3. Replace the capstan assembly. See 08-040 or 08-050, "Capstan Assembly Replacement."
4. The front edge of the capstan should be  $17/32 \pm 1/64$  inch ( $13.5 \pm 0.4$  mm) from the reference plate. If not, rotate all the sleeves until this condition is met.

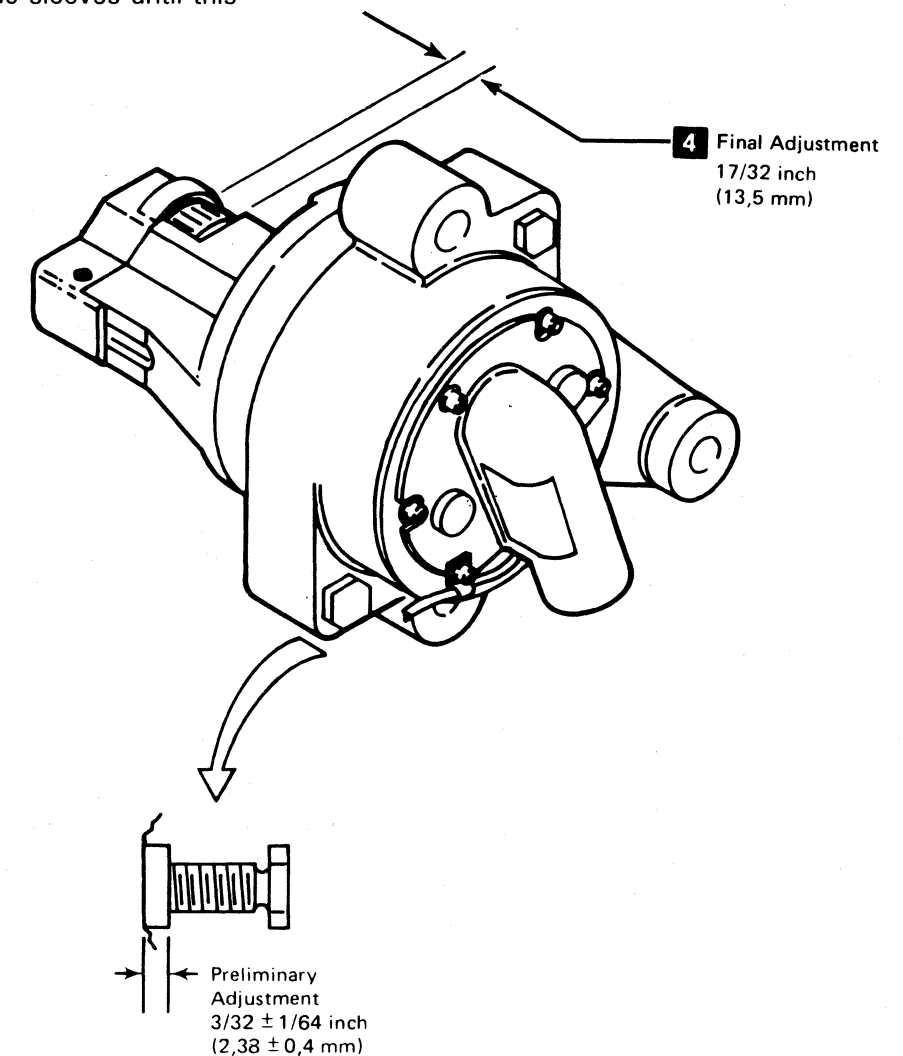
Figure 2.

## Model 8 (with Zero Marks, See Figure 2)

1. Remove the capstan assembly. See 08-020 or 08-030, "Capstan Assembly Removal."
2. Turn each sleeve until the zero marks align with the corresponding casting marks. When all the sleeves are aligned with their casting marks, measure from the sleeve tip to the end of the capstan motor casting. Each should measure  $3/32 \pm 1/64$  inch ( $2.38 \pm 0.4$  mm). Use a steel scale, P/N 450158 or equivalent, to make this measurement.
3. Replace the capstan assembly. See 08-040 or 08-050, "Capstan Assembly Replacement."
4. The front edge of the capstan should be  $17/32 \pm 1/64$  inch ( $13.5 \pm 0.4$  mm) from the reference plate. If not, rotate all the sleeves until this condition is met.

## Model 8 (without Zero Marks, See Note on Figure 2)

1. Remove the capstan assembly. See 08-020 or 08-030, "Capstan Assembly Removal."
2. Turn each sleeve until all sleeves measure  $3/32 \pm 1/64$  inch ( $2.38 \pm 0.4$  mm) from the sleeve tip to the end of the capstan motor casting. Use a steel scale, P/N 450158 or equivalent, to make this measurement.
3. Replace the capstan assembly. See 08-040 or 08-050, "Capstan Assembly Replacement."
4. The front edge of the capstan should be  $17/32 \pm 1/64$  inch ( $13.5 \pm 0.4$  mm) from the reference plate. If not, rotate all the sleeves until this condition is met.

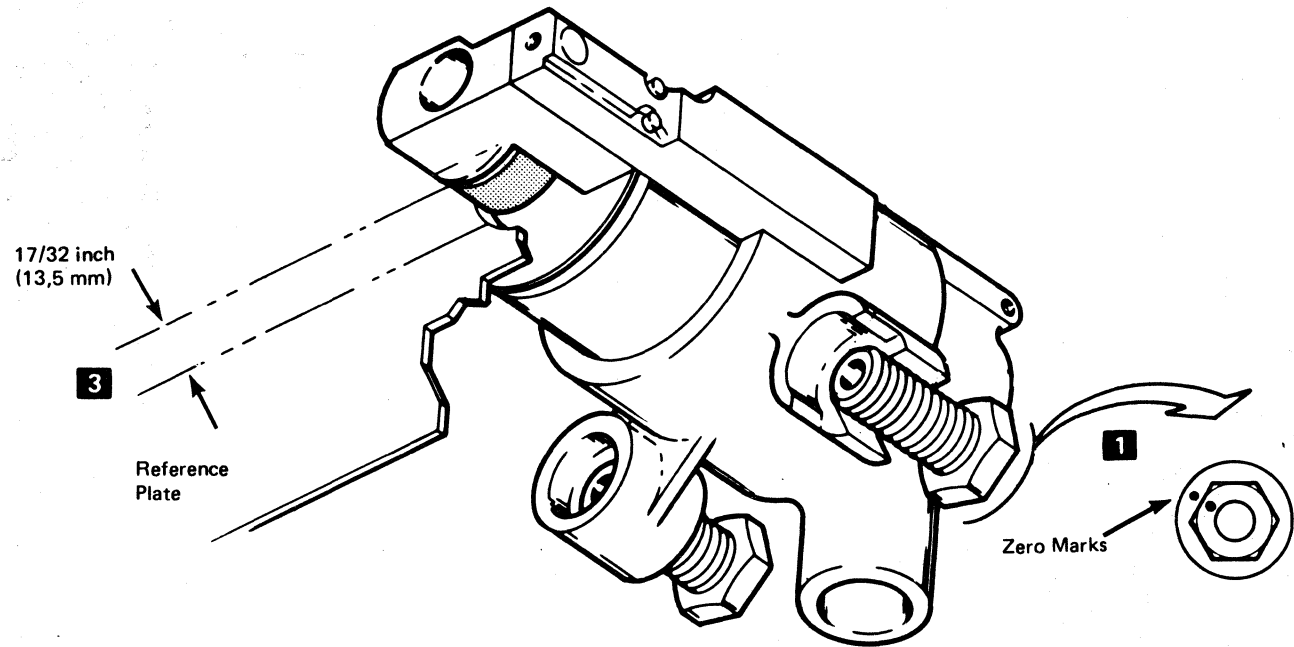
**Note:** This procedure does not apply to tape unit Model 8 without the zero marks. For tape unit Model 8 without zero marks, use the procedure on 08-068.

- 1 Check the zero mark on each sleeve for alignment with its corresponding casting mark (loosen and partially unscrew the sleeve locking nut if a sleeve mark is obscured).
- 2. If the zero marks are not aligned, loosen the locking nut and turn the sleeve in the direction that requires the least rotation to align the sleeve and casting marks. **Note:** If any sleeve requires more than 135 degrees of rotation, remove the capstan assembly and follow the procedure on 08-068.
- 3 Check for  $17/32 \pm 1/64$  inch ( $13.5 \pm 0.4$  mm) from the front surface of the reference plate to the front edge of the capstan. If this dimension is not met or you cannot see seven exposed threads on each sleeve, remove the capstan assembly and follow the procedure on 08-068.

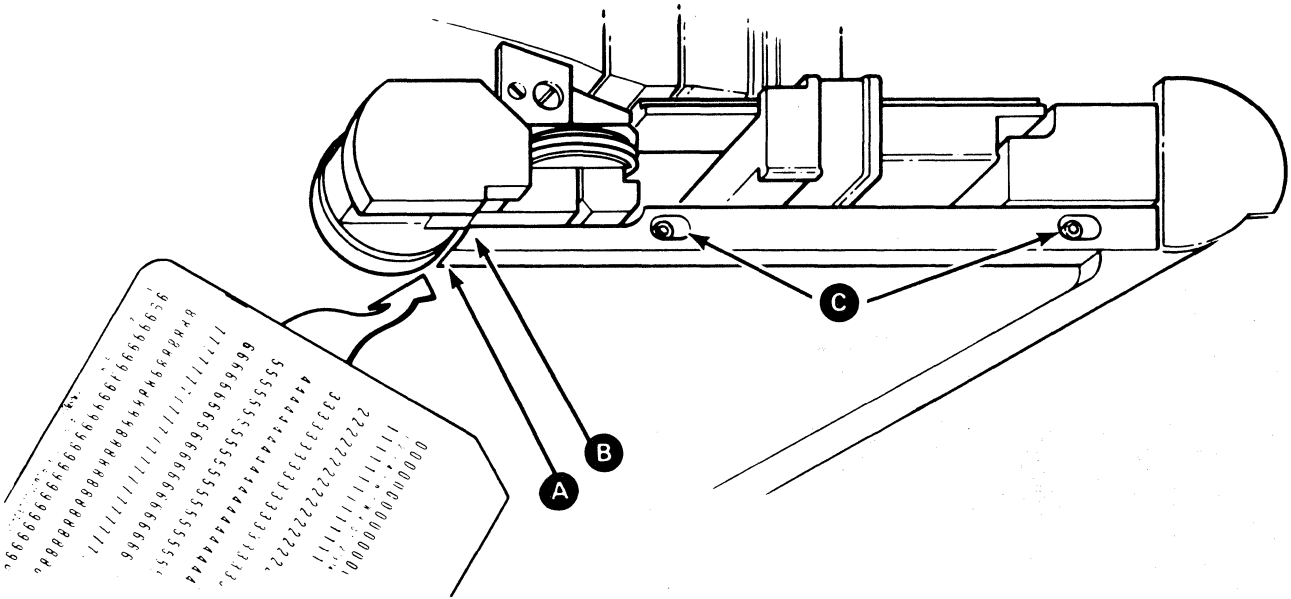
The capstan-to-upper stubby bar clearance must be 0.006 to 0.010 inch (0.15 to 0.25 mm) at both reference points **A** and **B** on the stubby bar, as shown. To adjust, loosen the two screws **C** in the upper stubby bar, position the bar to correct clearance and horizontal, then tighten the screws.

**Note:** Moving the stubby bar can affect the autocleaner adjustments. See 08-382.

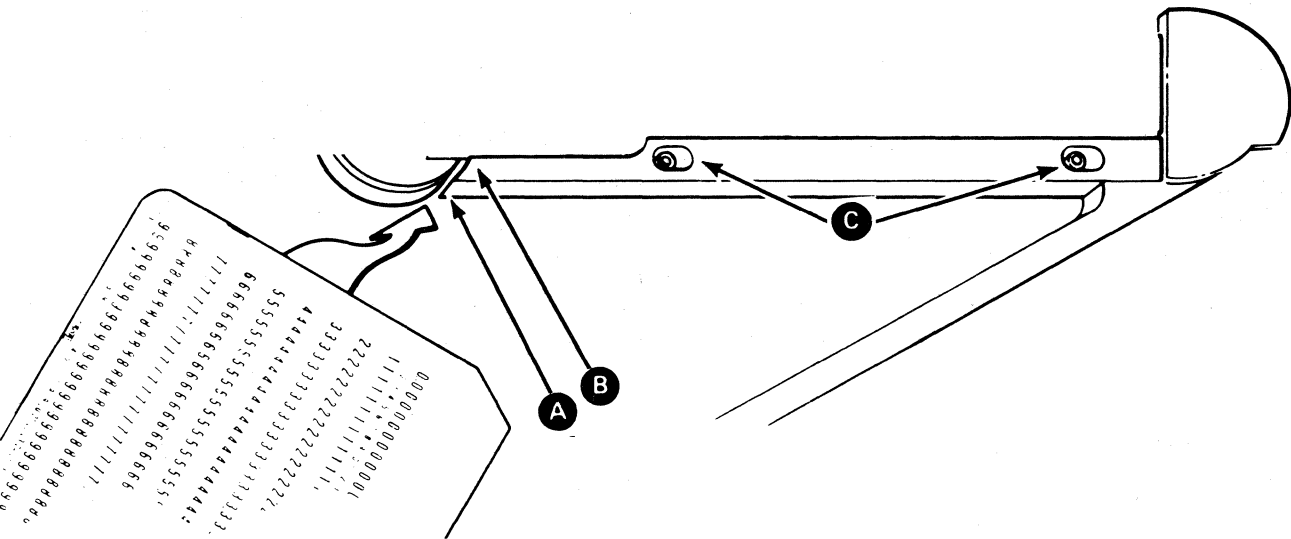
CAPSTAN-TO-STUBBY BAR CLEARANCE  
ADJUSTMENT (TAPE UNIT MODELS  
3, 5, 7)

**Caution:** To avoid damaging the smooth surface of the tape path, do not use a metal feeler gauge or any other hard object to measure the clearance. One data-processing card, approximately 0.0065 inch (0.165 mm) thick, can be used.

Check that the outside capstan diameter clears the radius of the upper stubby bar by 0.006 to 0.010 inch (0.15 to 0.25 mm) at **A** and **B**. The flip-down mirror must be centered between the capstan and the EOT/BOT block. Loosen the screws **C** on the stubby bar to adjust it.

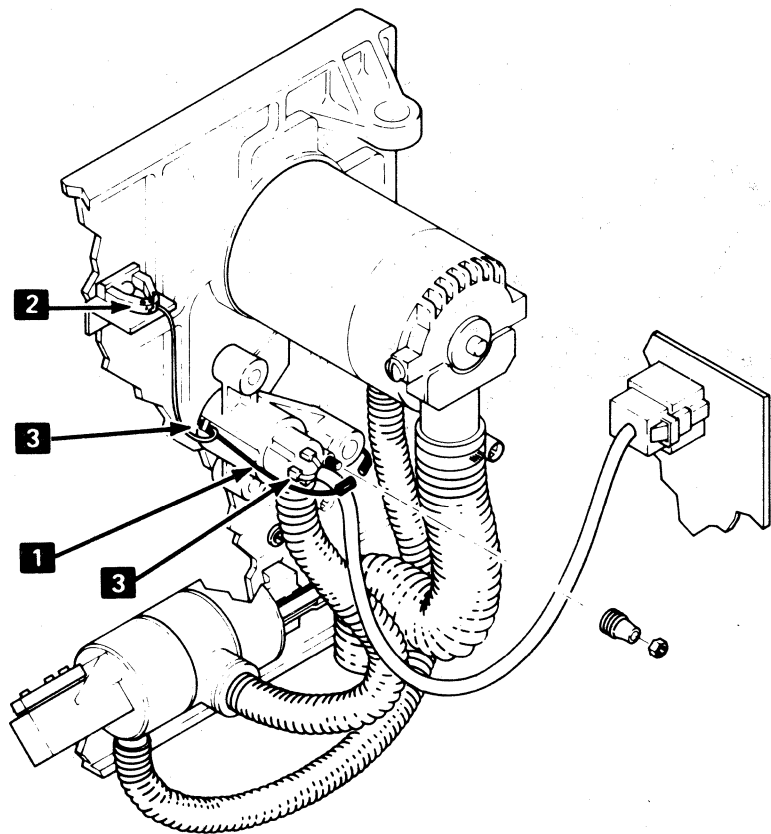
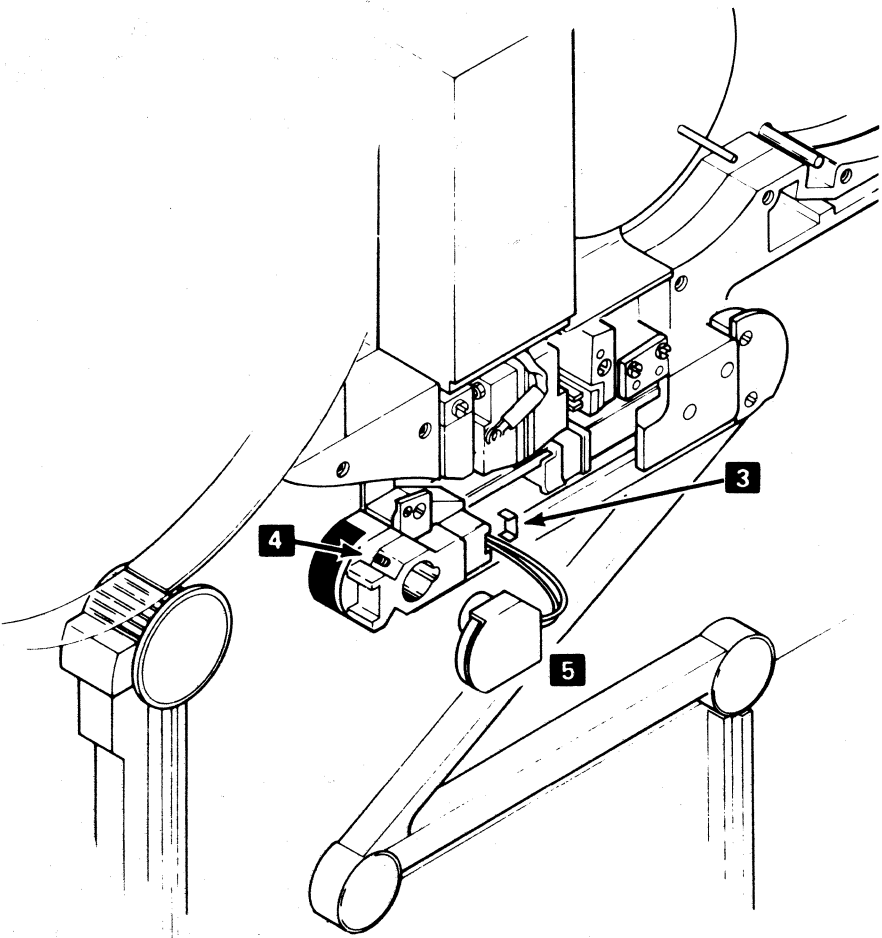
CAPSTAN TACHOMETER  
REMOVAL/REPLACEMENT  
(TAPE UNIT MODELS 4 AND 6)

- 1 Unplug the tachometer cable.
- 2 Remove the wedge and disconnect the fiber optic bundle from the light manifold.
- 3 Loosen the cable clamps at the front and rear of the capstan.
- 4 Loosen the protruding setscrew on top of the front motor support.
- 5 Carefully pull the tachometer and fiber optic bundle out of the supporting block.
- 6 Reverse the procedure to install the tachometer.
- 7 After installing the tachometer, perform the Capstan Tachometer Check/Adjustment procedure on 08-120.

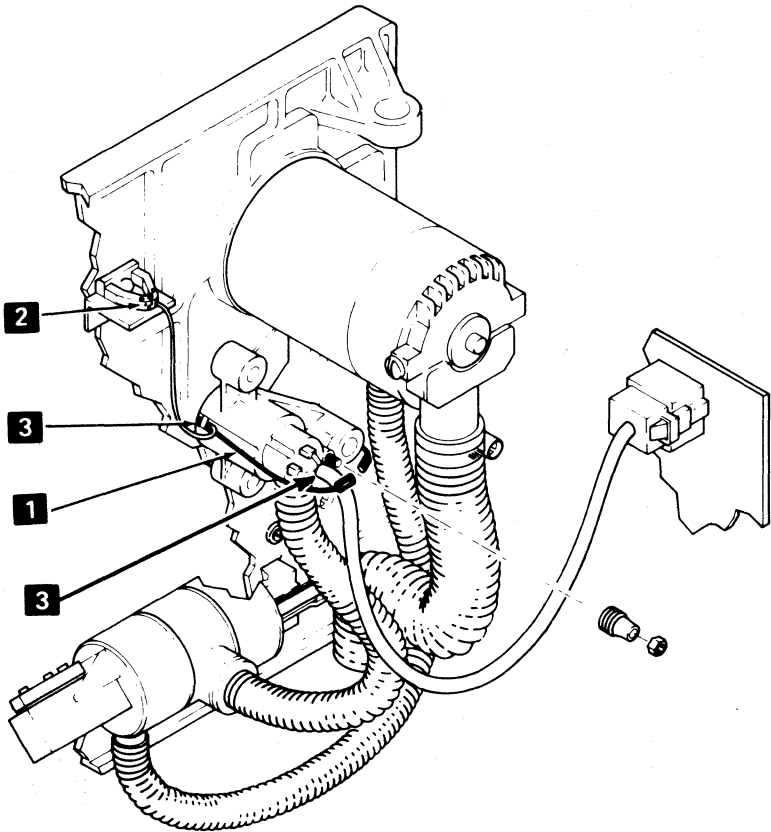
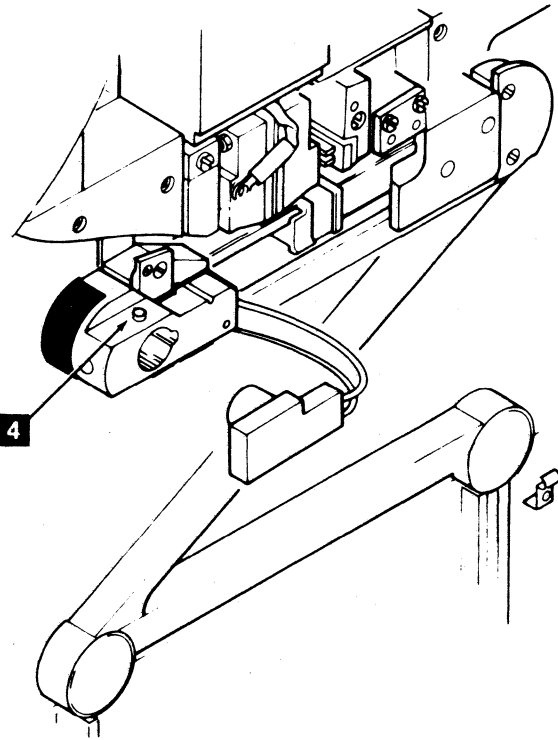
CAPSTAN TACHOMETER  
REMOVAL/REPLACEMENT  
(TAPE UNIT MODELS 3, 5, 7)

- 1 Unplug the tachometer cable.
- 2 Remove the wedge securing the tachometer fiber optic bundle to the light manifold; then remove the fiber optic bundle.
- 3 Loosen the cable clamps at the front and rear of the capstan. Remove the cable strap on the side of the motor.
- 4 Loosen the protruding set screw above the front motor support.
- 5 Carefully pull the tachometer and fiber optic bundle out of the supporting block.
- 6 Reverse the procedure to install the tachometer.
- 7 After installing the tachometer, perform the Capstan Tachometer Check/Adjustment procedure on 08-130.

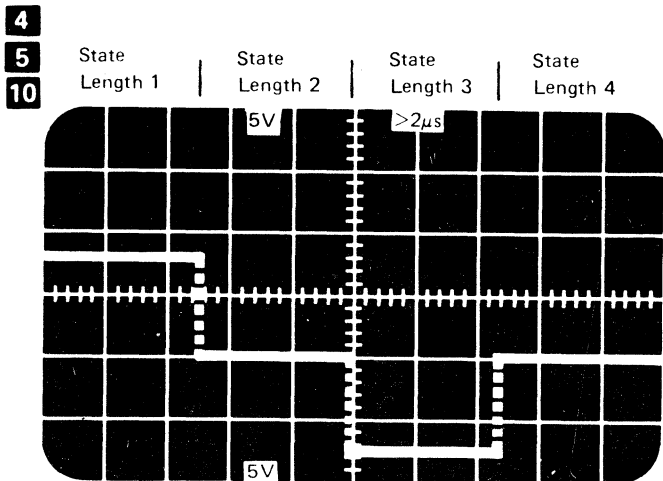
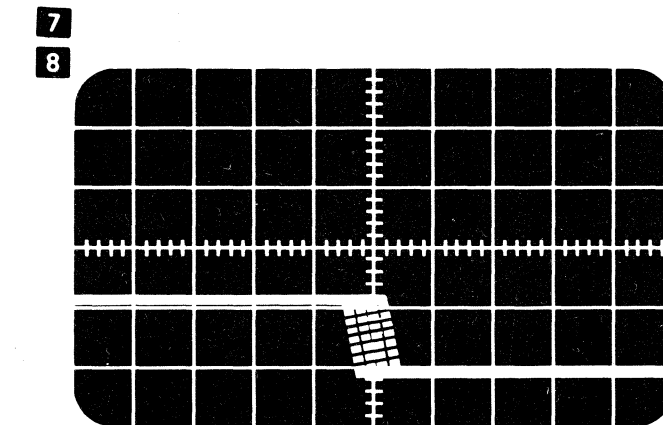
Repeat steps 7 and 8 for phase B using the phase B test point (T-A1H2P04) or pin B on the tachometer assembly.
9. Display both phases on the oscilloscope. Sync plus on phase B. Invert phase A and put the scope in the ADD position.
10. Total state length equals state length plus period variation. With symmetry set, as in steps 4 and 5, each total state length should exceed 1.2 cm for each of the four states.

If this limit cannot be obtained, clean or replace the tachometer. See 08-140, "Capstan Tachometer Cleaning;" 08-090 or 08-100, "Capstan Tachometer Removal/Replacement;" or 08-620, "Fiber Optics Lamp Removal/Replacement."
11. Direction sensing: Sync oscilloscope auto and check that -Backward Caps Motion (T-A1H2M12) is plus. This verifies the correct direction sensing.
12. Turn off tape unit power.
13. Return the capstan power plug to its normal operating position on the capstan motor control board.
