3803-2 / 3420

Magnetic Tape Subsystem  
Maintenance Manual

CAPSTAN AND TRACKING CHECKS/  
ADJUSTMENTS/REMOVALS/  
REPLACEMENTS

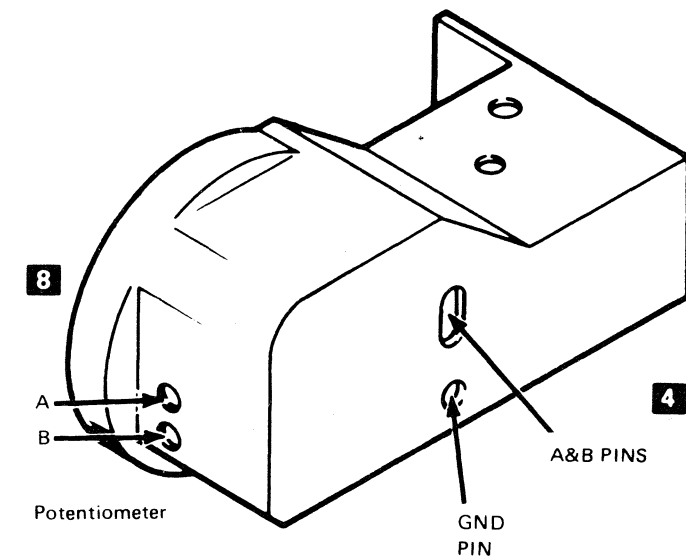
**Model 8 Capstan**

**Note:** If the waterfall is greater than 10%, remove the capstan tach and clean as instructed on 08-140.

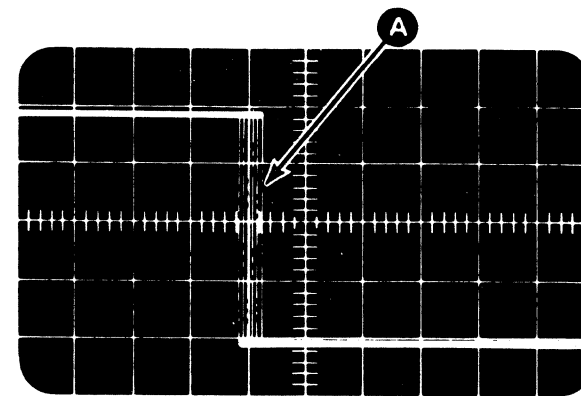
Figure 1.

If readjustment is necessary, do it at the normal tape unit operating temperature.

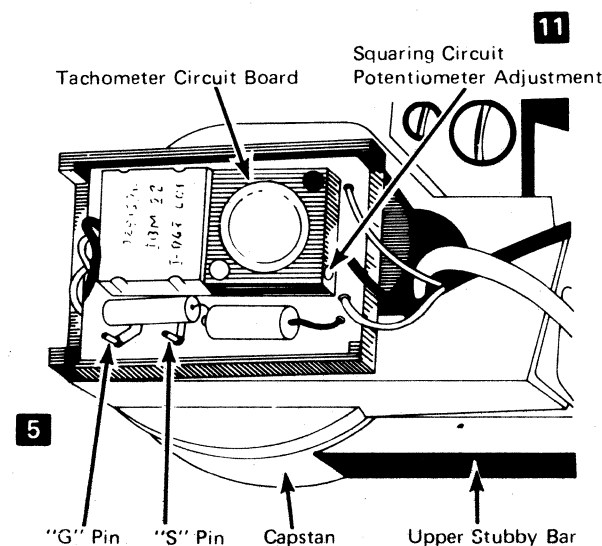
**Note:** If waterfall **A** is excessive, 10% of a full cycle or greater, remove the capstan tachometer and clean the tachometer disk and interrupter mask, following the procedure on 08-140.

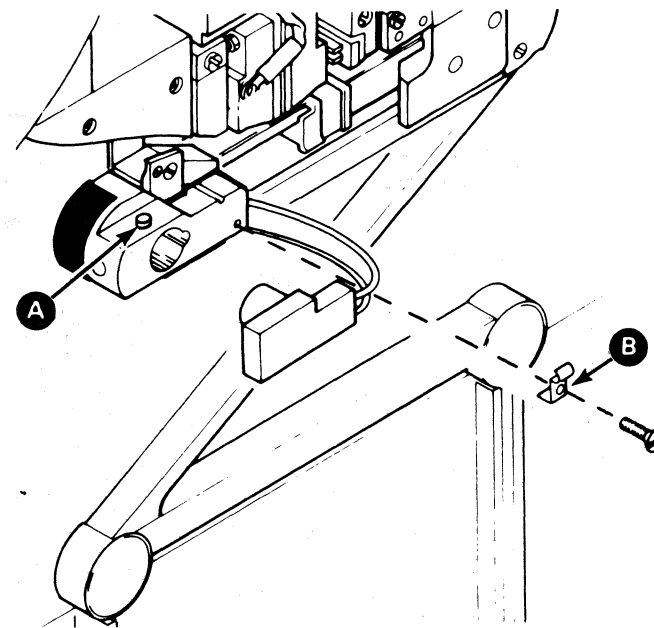
Model 3,5,7

4. Replace the tachometer by reversing the procedure in step 1.
5. Repeat the Capstan Tachometer Check/Adjustment procedure on 08-120 or 08-130.

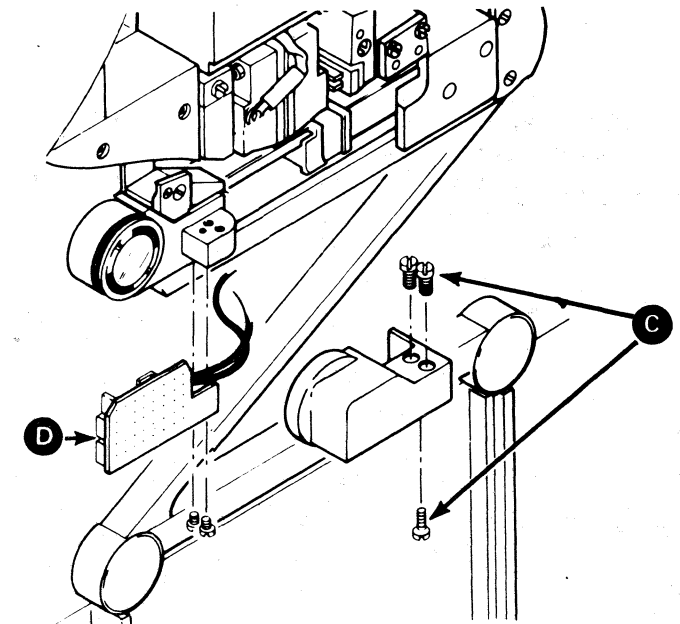
Model 8

**Note:** Tach block shown removed **D** for illustration only.

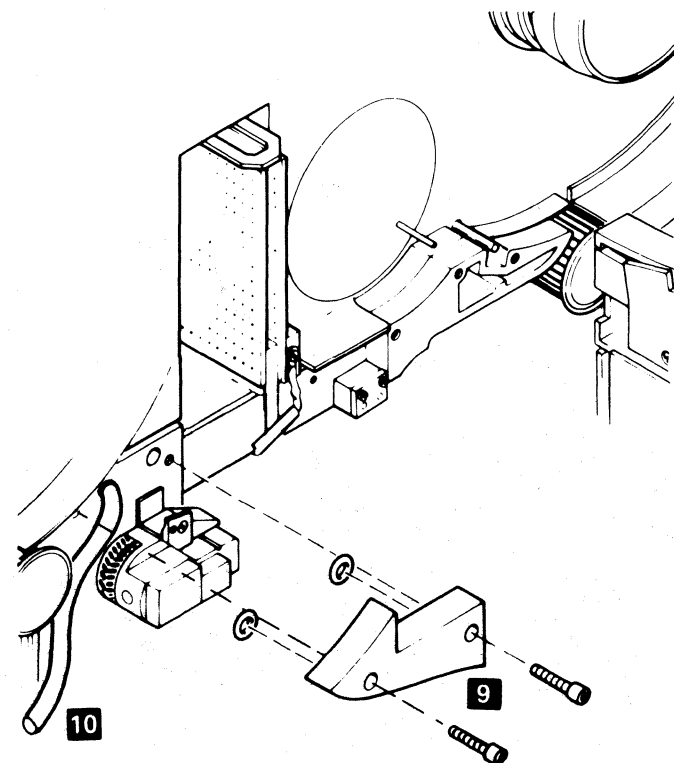
**Caution:** Do not lose the two O-rings located behind the threading channel.

10. On NRZI-featured tape units, remove the small hose attached to the threading channel. Allow 3 to 5 inches (76 to 127 mm) of hose to extend beyond the reference plate. If the hose falls out of the reference plate, it may be necessary to remove the capstan motor to reinstall it.

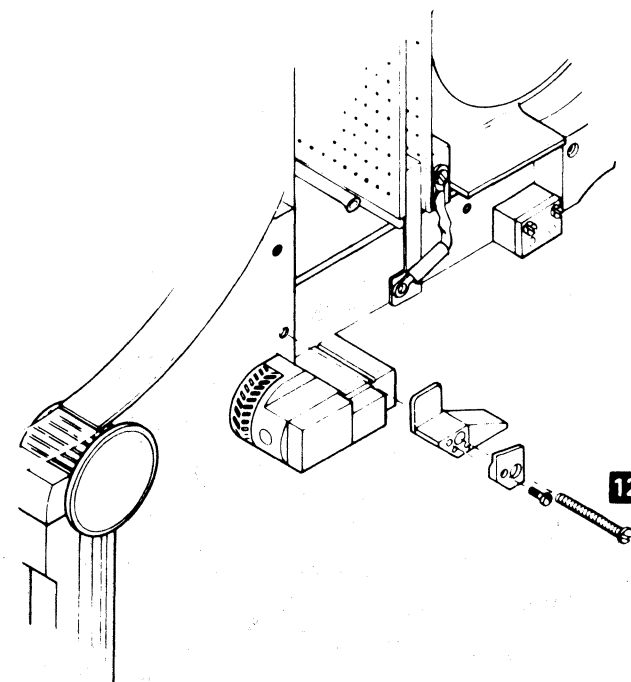
11. Remove the left threading plate on the vacuum column door so that you can observe the tape while making adjustments. Remove the rubber door spacer behind the threading plate, if necessary.

12. Remove the screws holding the front guide to the ramp and the large screw that holds the ramp to the reference plate. Remove the front guide.

**Caution:** Do not lose the spring behind the rear guide. (in NRZI-featured tape units only.)

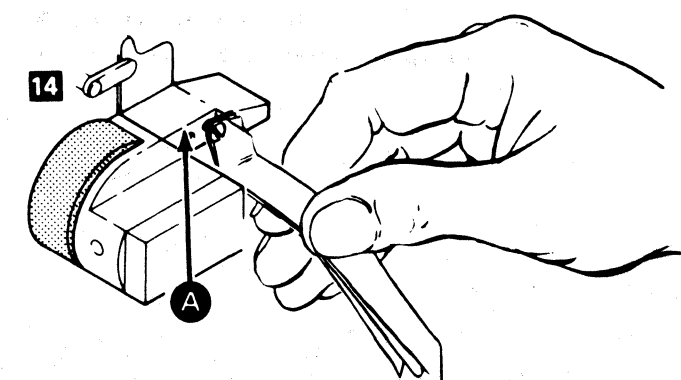
13. Use the long screw to fasten the ramp to the reference plate. Press down on the right side of the ramp for correct positioning.

14. On NRZI-featured tape units, retract the rear movable guide, using the retracting clip on the tape unit, P/N 2522983.

**Note:** The guide must retract completely behind the reference plate. Shape the retracting clip if necessary.

**Caution:** Do not allow the screw head to touch the tape. If necessary, fold a tab card several times and place it next to the screw head as shown (A) to prevent screw-head-to-ramp contact and damage to the reference plate.

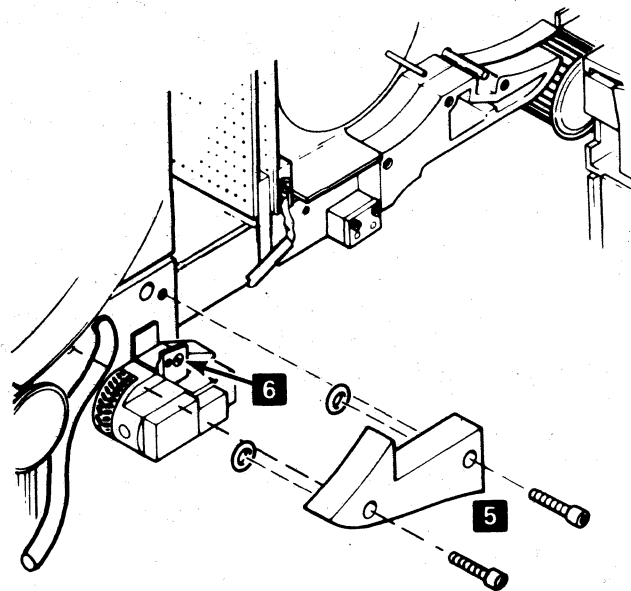
1. Switch tape unit offline.
2. Attach the 3420 field tester.
3. Load an undamaged CE work tape, set the field tester to read forward, and move the tape forward until the load-point sticker is past the BOT/EOT block.
4. Turn tape unit power off.
5. Remove the left threading channel and left threading plate on the vacuum column door so that you can observe the tape while making adjustments. Remove the rubber door spacer behind the threading plate, if necessary.

**Caution:** Do not lose the two O-rings located behind the threading channel.

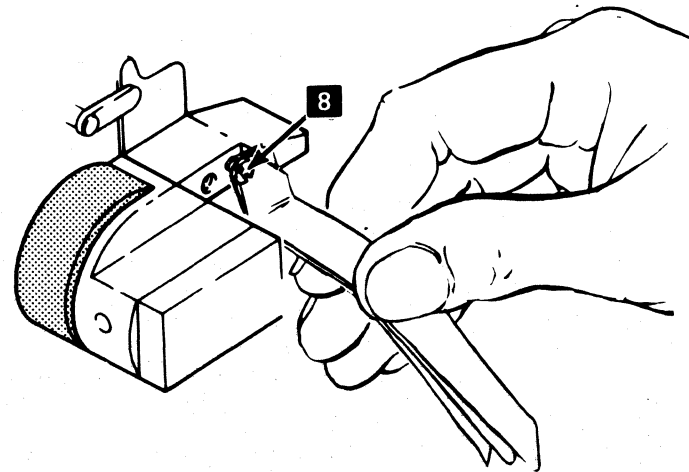
6. Remove one short and one long screw from the front of the carbide guide.
7. Remove the front carbide guide and threading ramp.
8. Use the long screw to fasten the threading ramp to the reference plate. Press down on the right side of the ramp for correct positioning. If a binder head screw is used, replace it with a flat-head screw to eliminate interference while setting the tracking, or place a folded tab card between the existing binder head screw and the ramp. A size 6 nut can also be used.

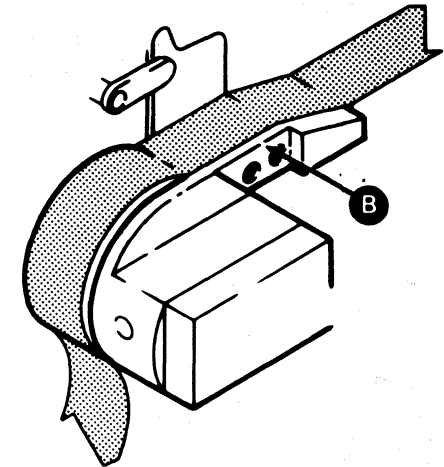
22. If distortion occurs in one direction only, adjust sleeve 1. See step 17.
23. If distortion occurs in both directions, adjust sleeve 3 slightly clockwise.

**Note:** A slight clearance at the reference plate and front of ramp B and no front-to-back movement indicates correct tracking.

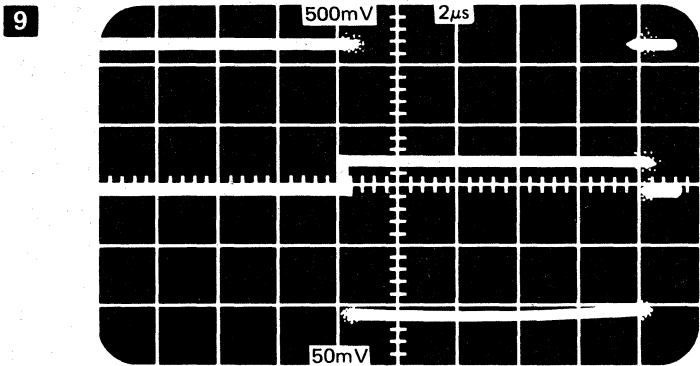
16. If the mechanical skew check procedure indicates that the skew is outside the given limits, go to the Mechanical Skew Adjustment procedure on this page.

17. If the mechanical skew check indicates that the skew is within the given limits, remove the jumper (step 4).

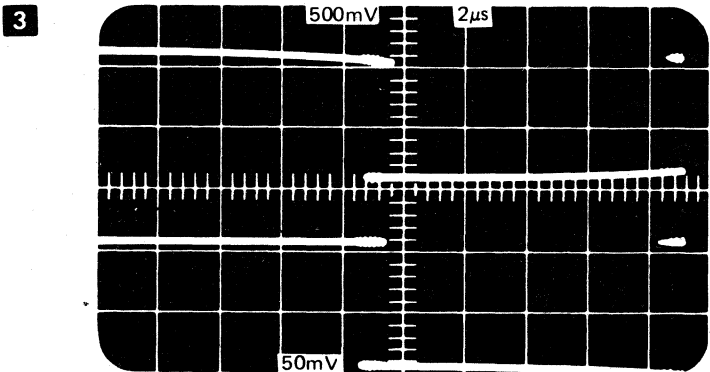
1. See the Mechanical Skew Check procedure on this page up to step 7, to set up the tester.
2. With tape reading forward, set the scope for 2 usec/cm, 500 mV amplitude, and sync positive on the track 2 read signal. Use the left test point on the read card.
3. Using both probes, scope the digital outputs of tracks 4 and 5. Use the horizontal control to align the center of the waterfall for the leading track with the vertical centerline on the scope face.

**Caution:** Do not attempt to loosen the lock nut on the adjusting screw.

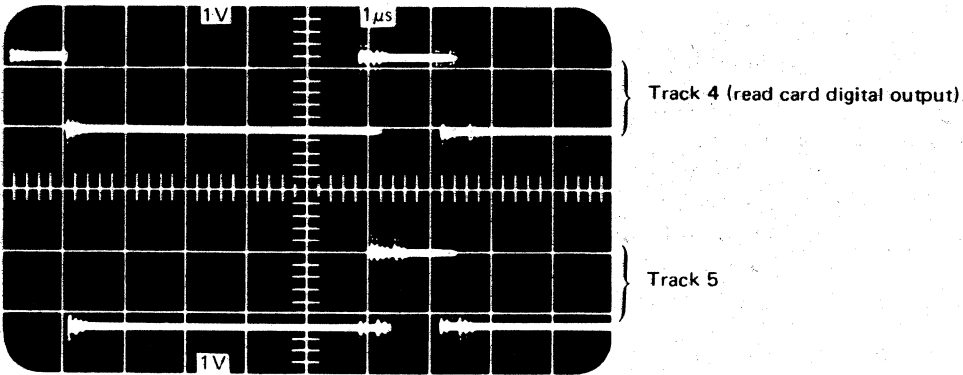
Typical Scope Presentation of Skew

- 11. If the skew exceeds the limits, repeat the Capstan Dynamic Alignment procedure on 08-150.
- 12. If the skew is within the limits, adjust the head skew plate until the outside track signal either leads or lags the inside track signal by the same amount when going forward or backward. Track 4 is inside, track 5 is outside, on 9-track tape units. Track P is inside, track 7 is outside, on 7-track tape units.
- 13. At the completion of the mechanical skew adjustment in NRZI mode, ensure that the analog sine waves for all tracks coincide at the read-card test points (left side).
- 14. Check the capstan-to-stubby bar clearance. See 08-080, "Capstan To Stubby Bar Clearance Adjustment."
- 15. Check the read and write electrical skew. See 08-190, "Read Electrical Skew Adjustment" and 08-200, "Write Electrical Skew Adjustment."

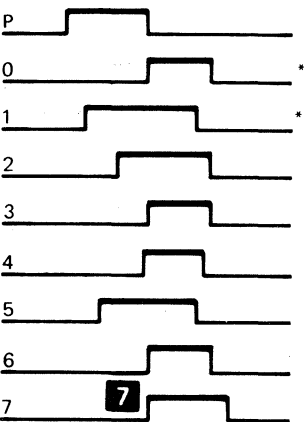
BEFORE

9. Adjust each remaining track's pulse width until the negative transition (trailing edge) lines up with the trailing edge of the pulse adjusted in step 8.
10. Set the tester to read backward continously.
11. Change the scope sync to negative.
12. Repeat steps 5 though 9 adjusting the backward potentiometer.
13. Check the write electrical skew. See 08-200, "Write Electrical Skew Adjustment."

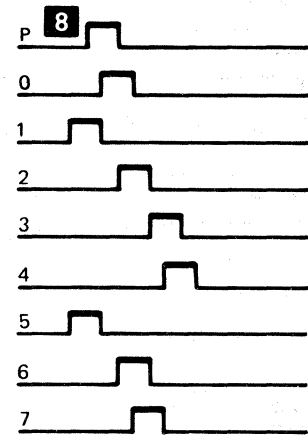
BEFORE

9. Adjust each track's write deskew potentiometer until the negative transition (trailing edge) lines up with the negative transition of the most lagging track (step 8.)

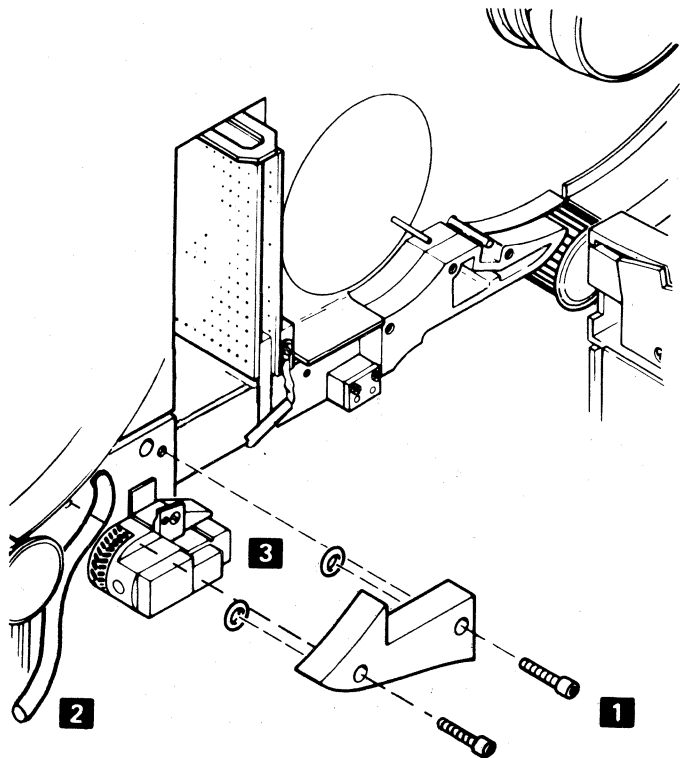
LEFT MOVABLE GUIDE AND RETRACTOR  
REMOVAL/REPLACEMENT  
(NRZI-FEATURED TAPE UNITS)

- 3 Remove the large screw that holds the carbide tape guide assembly.
- 4 Remove the solid guide, movable rear guide, and spring.
- 5 Reverse the procedure to reassemble.

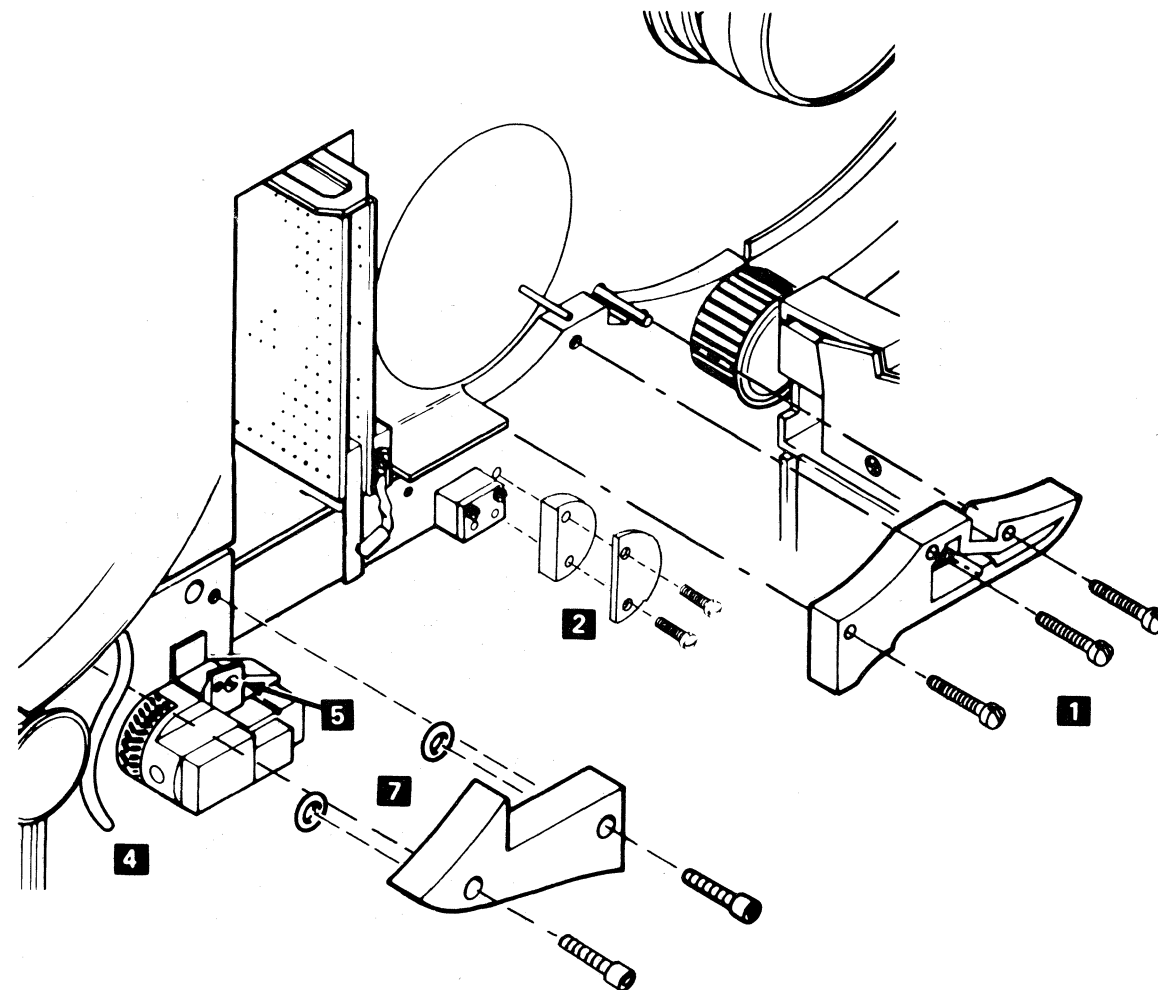
- 1** Remove the three screws that hold the right threading channel to the reference plate.
- 2** Clean the oxide deposits from the D-bearing, front flange, rear movable guide, and recessed area around the rear guide.
3. Inspect the flange and guide for wear and replace if the grooves are visible on their surfaces.
- 4** **Caution: Do not lose the two O-rings located behind the threading channel.**

- 5** Clean the oxide deposits from the left front guide, left rear movable guide, and the recessed area around the rear guide.
6. Check that the right and left rear guides move freely.
- 7** Reinstall the threading channels. Ensure that the two O-rings are in position behind the left threading channel.

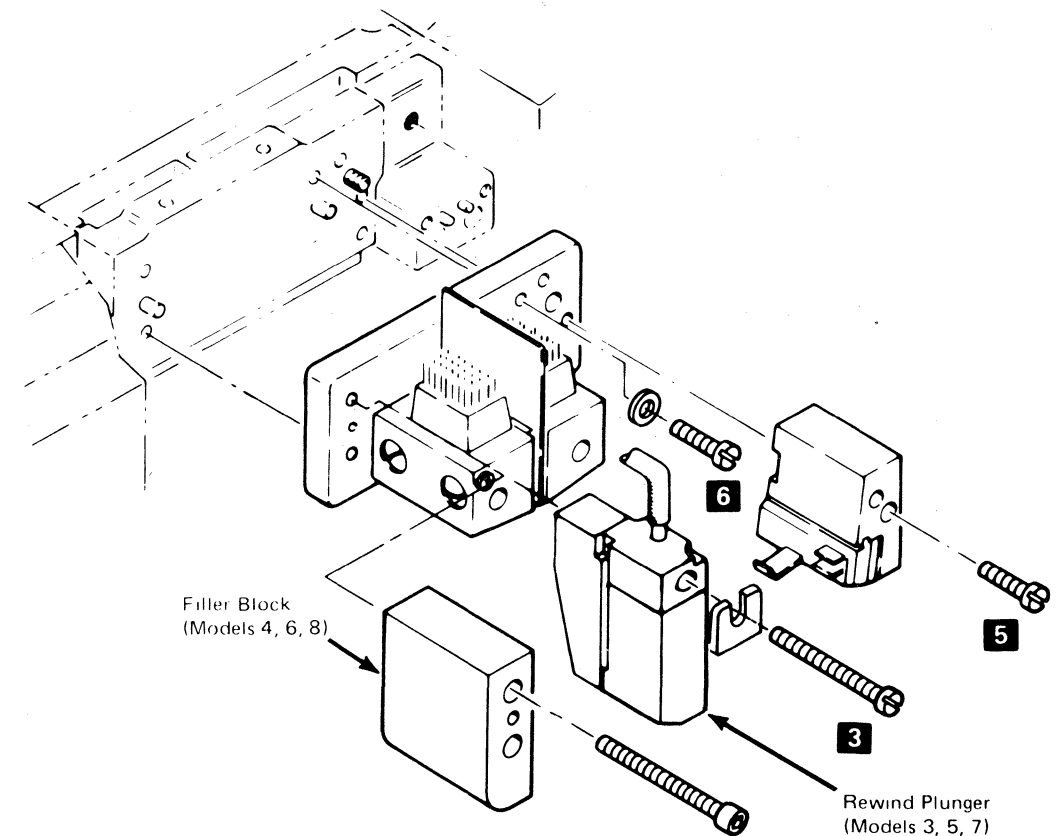
**To replace the read/write head:**

1. Turn off tape unit power.
2. Remove the front read/write card cover by pulling it straight out.
3. Remove the two mounting screws, disconnect the hose, and remove the filler block (Models 4, 6, and 8), or the rewind plunger (Models 3, 5, and 7).
4. Unplug the read/write cards from the head. See 08-260, "Read/Write Head Card Removal/Replacement."
5. Remove the nylon screw that holds the erase head to the mounting plate. Carefully pull out the erase head without damaging the wires. Care must be taken not to damage the cable while unsoldering the leads.
6. Remove the four screws from the mounting plate.
7. Carefully pull the head and mounting-plate assembly straight out. (If the locating pins bind, rock the assembly to loosen.)
8. Reverse the procedure to install a new head.

**Caution:** Do not loosen or remove the eight skew-plate screws, as this causes the factory-set read/write head wrap angle to be changed.

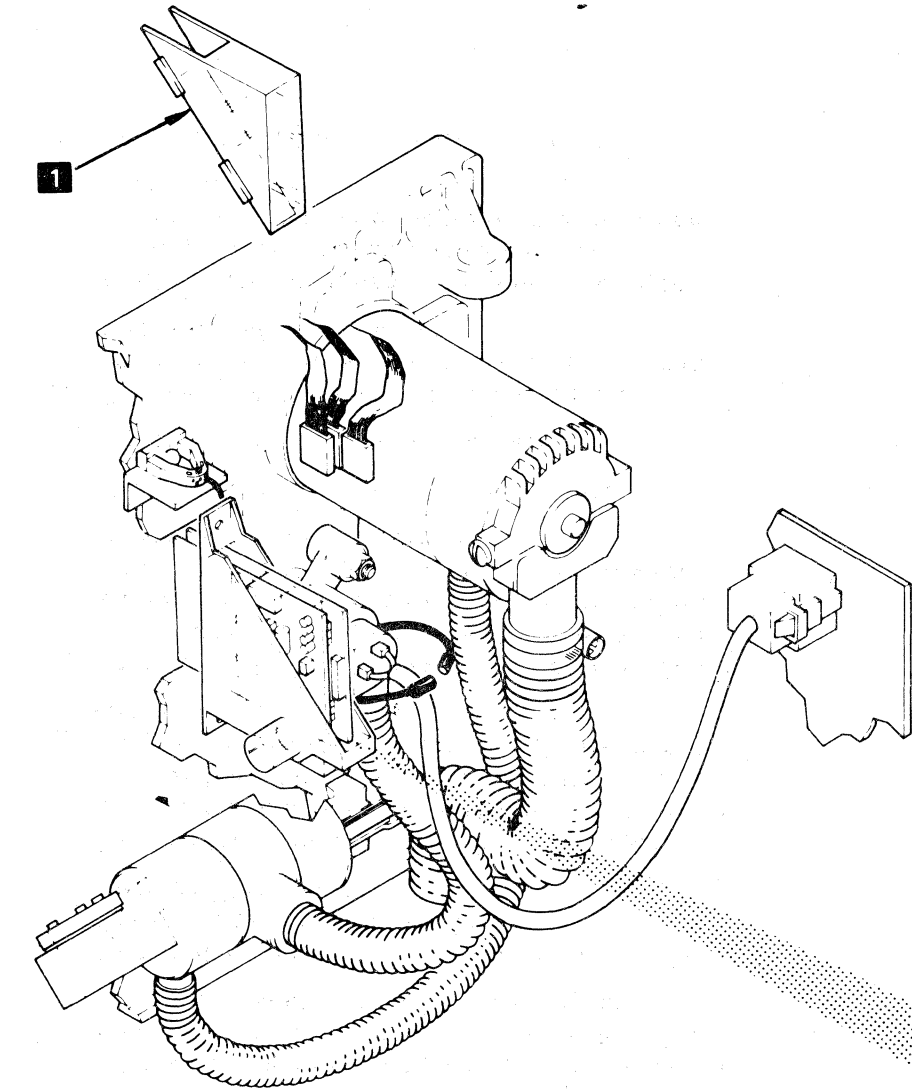
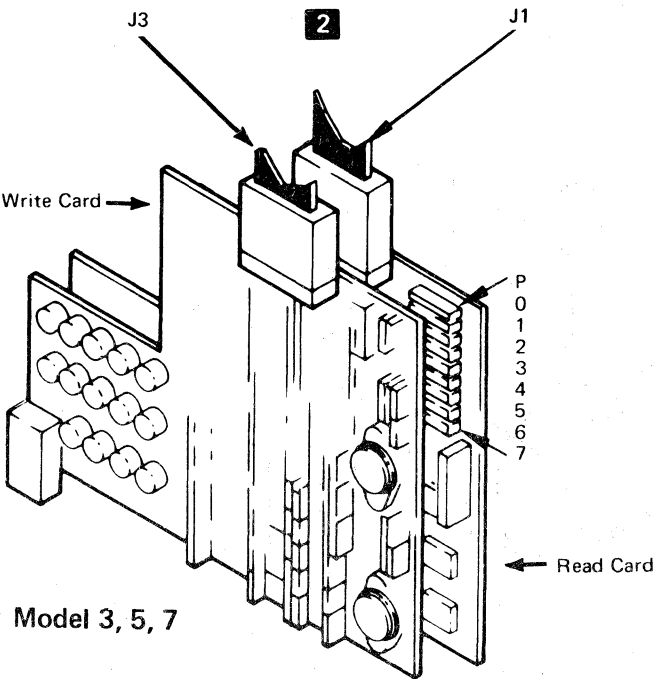
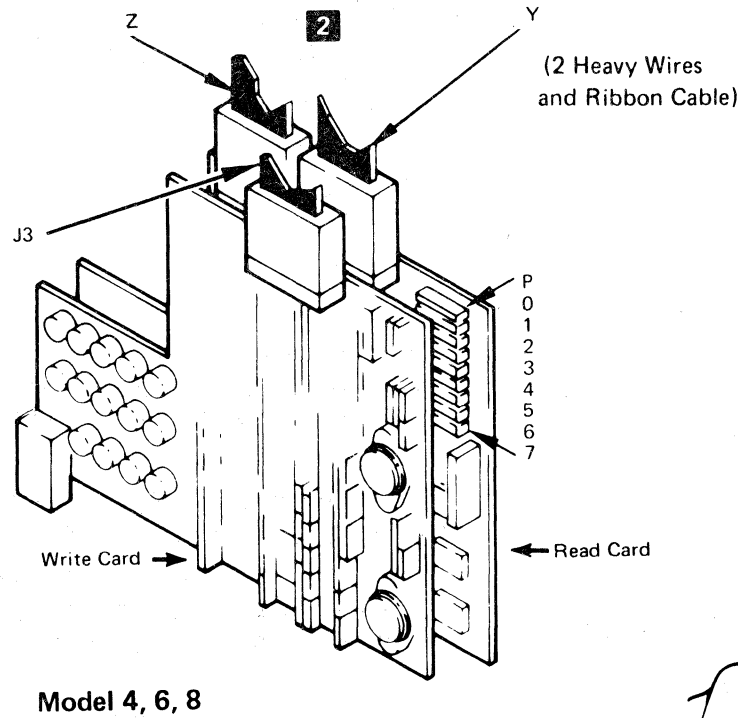
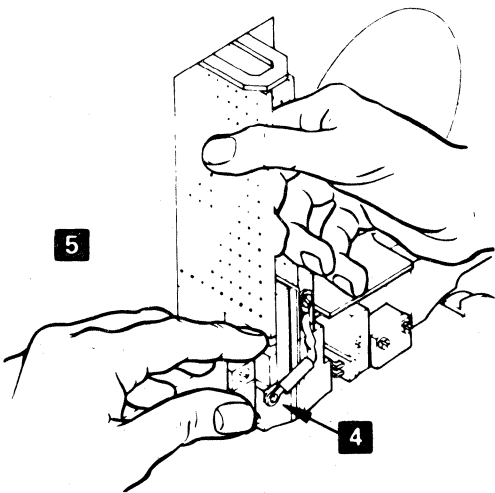
READ/WRITE HEAD CARD  
REMOVAL/REPLACEMENT

- 1 From the rear of the unit, unsnap the upper half of the read/write card cooling shroud.
- 2 From the rear of the unit, unplug the cable(s) from the top of the card being replaced. (Models 4, 6, and 8 have two cable plugs on the read card, Y and Z, and one on the write card J-3.) (Models 3, 5, and 7 have J3 and J1 cables only.)
- 3 From the front of the unit, remove the decorative head cover.
- 4 Disconnect the write card ground strap from the front of the read/write head.
- 5 Unplug the card while holding the socket with one hand, pull the front edge of the card straight up with your other hand, rocking gently to loosen.

- 12 After replacing the write card, shape the ground strap in such a manner that the resultant forces are in a downward direction 4.
- 13 The cooling shroud reduces overheating of the read and write head cards. Ensure that the cooling shroud is reinstalled after working in this area.

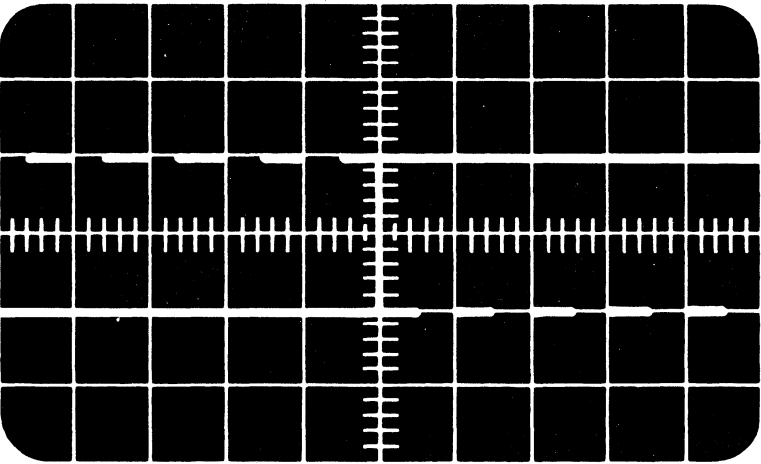
Figure A

5. Using an uncalibrated (variable) horizontal sweep, adjust the scope so that one complete cycle is displayed, as shown in Figure B.
6. Locate the correct potentiometer on the read card for the track you are adjusting. See the label on the card cover.
7. Turn the potentiometer counterclockwise while observing the negative pulse until a dim trace exists, as shown in Figure A.
8. Then, turn the potentiometer slightly clockwise until you have a solid digital data pulse, as shown in Figure B.
9. Repeat steps 4 through 8 for each track.
10. Remove the attenuator card, field tester, and the jumpers if used.

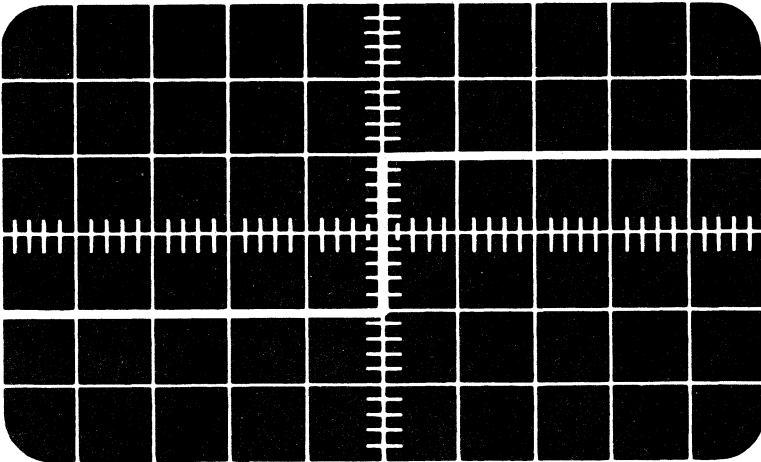
Figure B

**Note:** If digital data does not exist, turn the read card potentiometer until a good solid signal is obtained, as shown in Figure B.

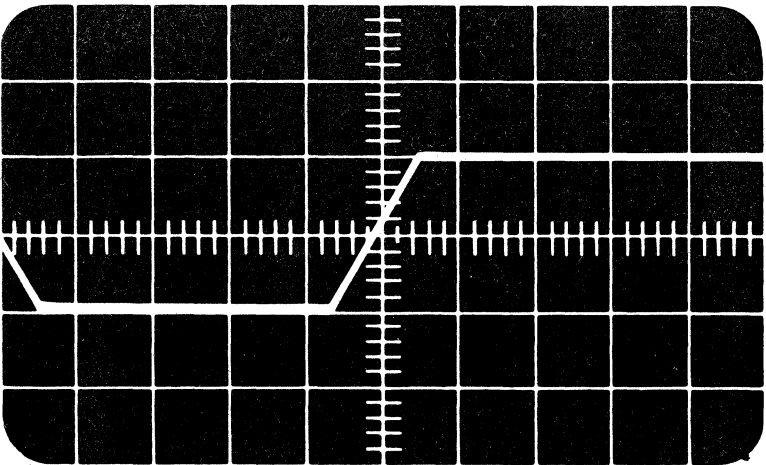
Figure A

8. Repeat steps 4 through 7 for each track.
9. Remove the attenuator card, field tester, and the jumpers if used.

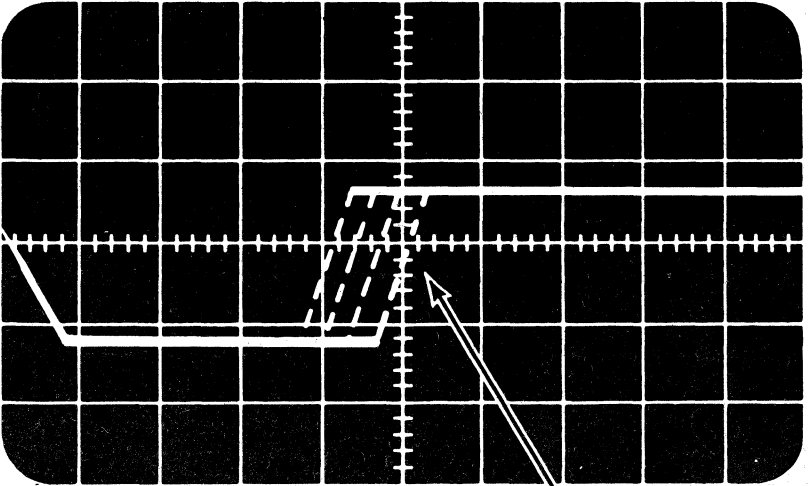
Figure C

**Note:** May not be visible.

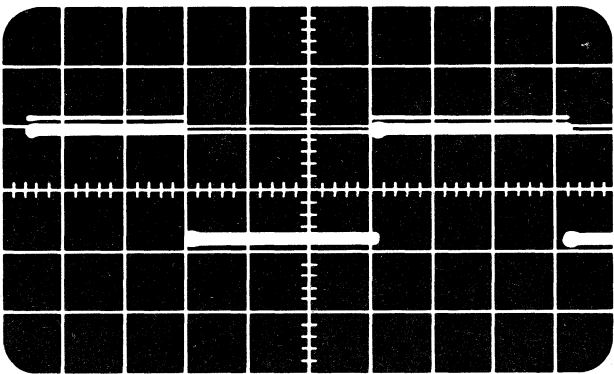
Figure 1. Read Amplitude Signal

- 1. Only the track 1 potentiometer (test point T-A1N3B07) is present on a 6250 bpi card.
- 2. Digital read signals for 1600 and 6250 bpi are:

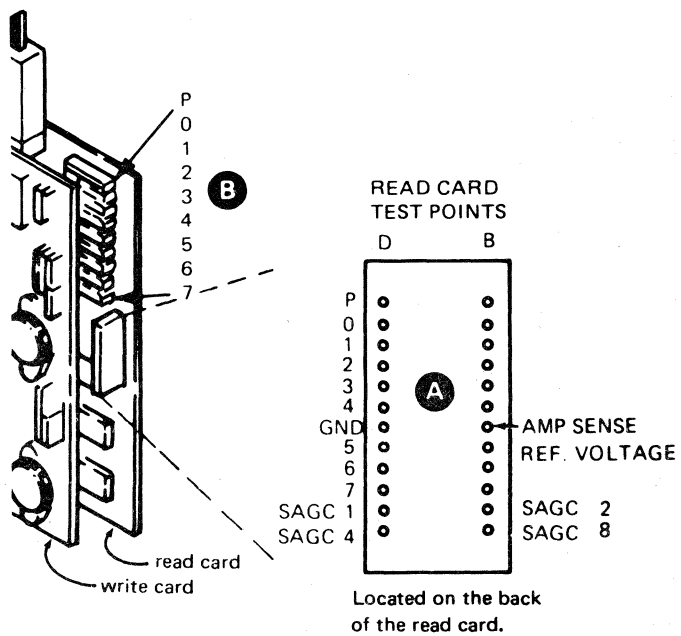
Read Card Test Points

Track	Test Point	Track	Test Point
P	T-A1N3B05	4	T-A1N3B10
0	T-A1N3B06	5	T-A1N3B11
1	T-A1N3B07	6	T-A1N3B12
2	T-A1N3B08	7	T-A1N3B13
3	T-A1N3B09

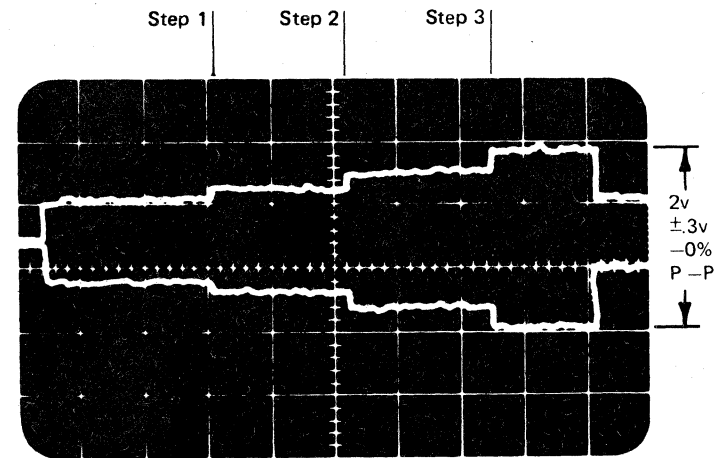
Set the 3420 field tester to write start/stop, and the frequency switch to 64. Install a jumper between T-A1M2D06 and T-A1K2P02. Sync scope minus on Move Command B at T-A1F2P12 and vary the go-up time to observe a full SAGC setup (set Dn/Bkwd all the way to rear of the tester) at the read card test points

Ⓐ. The SAGC setup must be completed in 14 or less steps on all tracks while writing. If the setup in any track exceeds 14 steps, check: (If the SAGC sets up in less than two steps, replace the read/write head)

- 1. Read head card
- 2. Vacuum level for low vacuum
- 3. Write head card
- 4. Read/write head
- 5. Capstan tracking

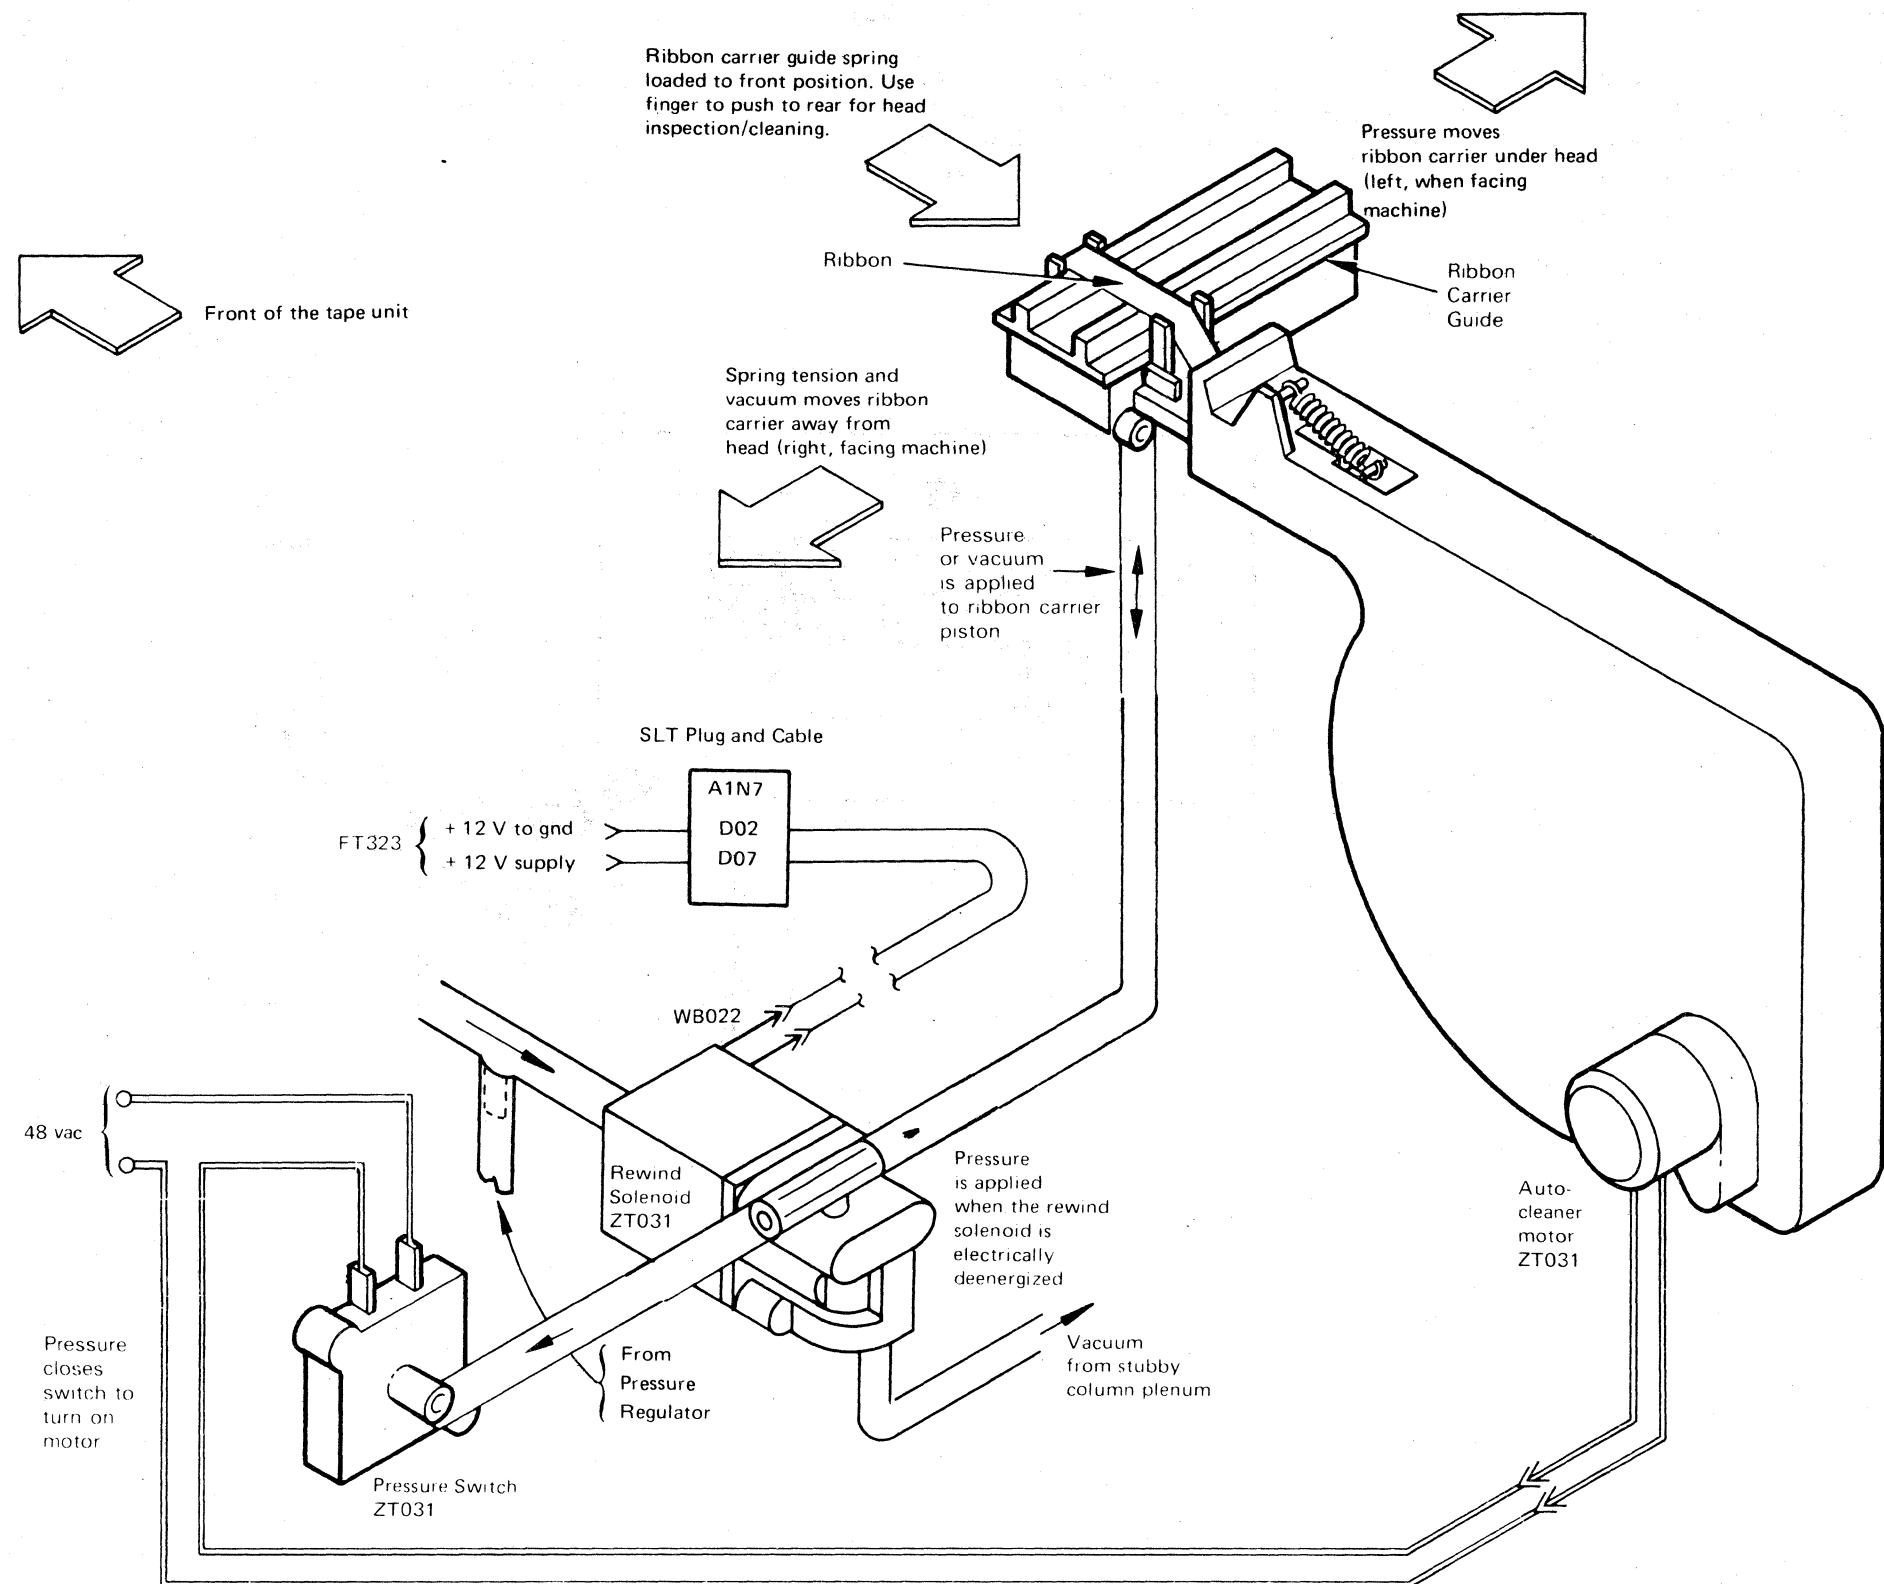
### AUTOCLEANER OPERATION (TAPE UNIT MODELS 4, 6, 8)

The autocleaner protects the read/write head and cleans the tape by means of a cleaning ribbon positioned crosswise to the tape between the tape and the head. Tape is cleaned during:

In use, the autocleaner is self-adjusting. Initial adjustment is necessary only after replacement.

There is a cutout on the plastic cover over the erase head which enables you to see the white ribbon when the autocleaner is not activated.

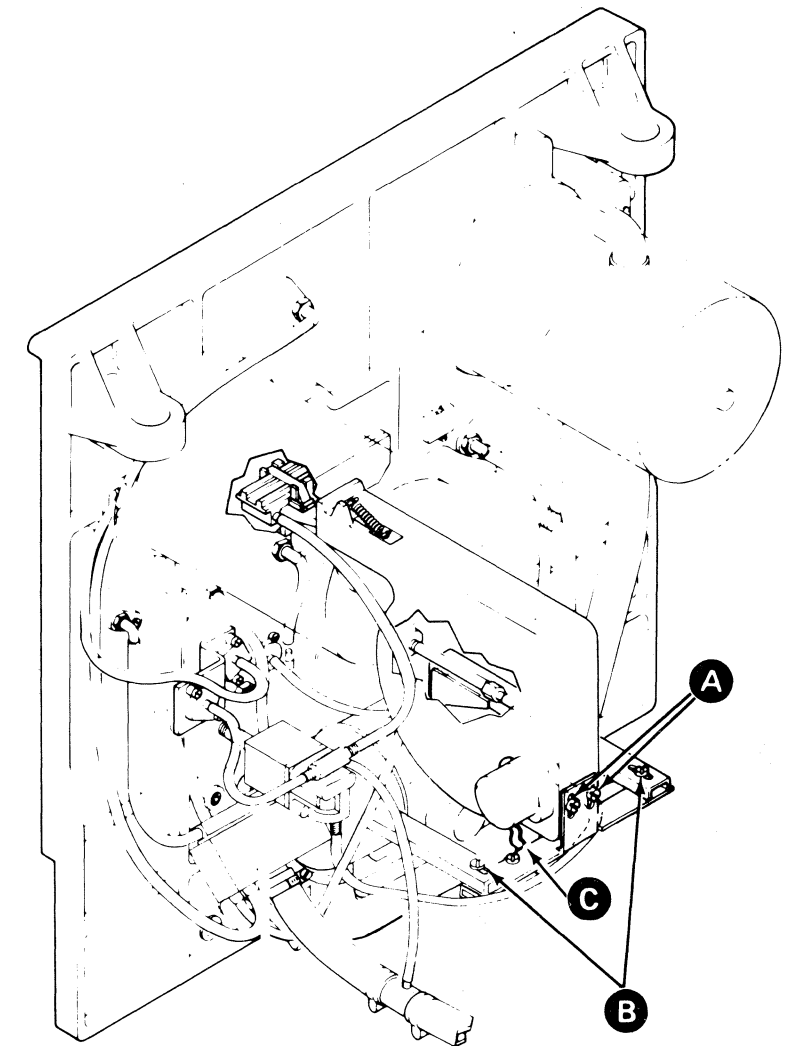
1. If required, take up the loose ribbon by turning counterclockwise the screw located at the rear of the autocleaner on the side opposite the motor.
2. Loosen the two adjustment screws at **A**. Position the screws to the center of their slots and tighten them.

3. Loosen the two adjustment screws at **B**.
4. Observe the autocleaner ribbon position relative to the read/write head surface. The left edge of the ribbon may just touch the head at point **D**. (Maximum clearance 0.015 inches (0.38 mm)). The ribbon should not touch any part of the head between point **D** and point **H**. (If the edge of the ribbon is folded, the ribbon position is too high). If the ribbon is too high, adjust bracket **C** toward the rear of the machine. If the ribbon is too low, adjust bracket **C** toward the front of the machine. To ease the adjustment:

- a. Loosen screw **E** on one side, adjust bracket the desired amount, then tighten the screw.
  - b. Repeat for the other side, moving the bracket an equal amount.

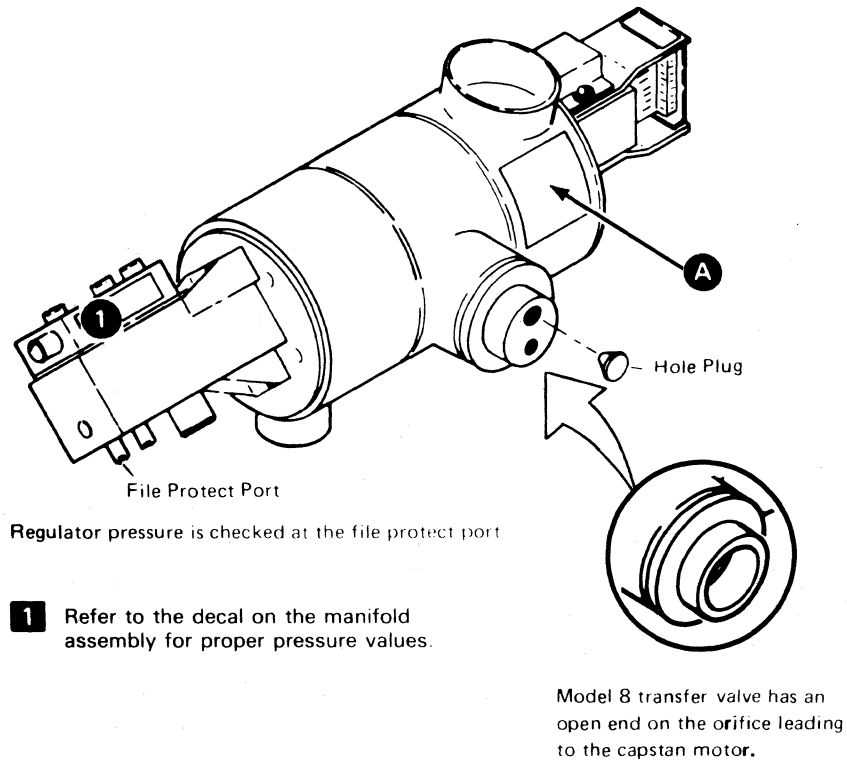
Figure 1.

ALTITUDE VACUUM LEVEL  
ADJUSTMENT

Measure the vacuum as shown on the transfer valve label **A**. (See Figure 1.) If incorrect, check the settings as follows:

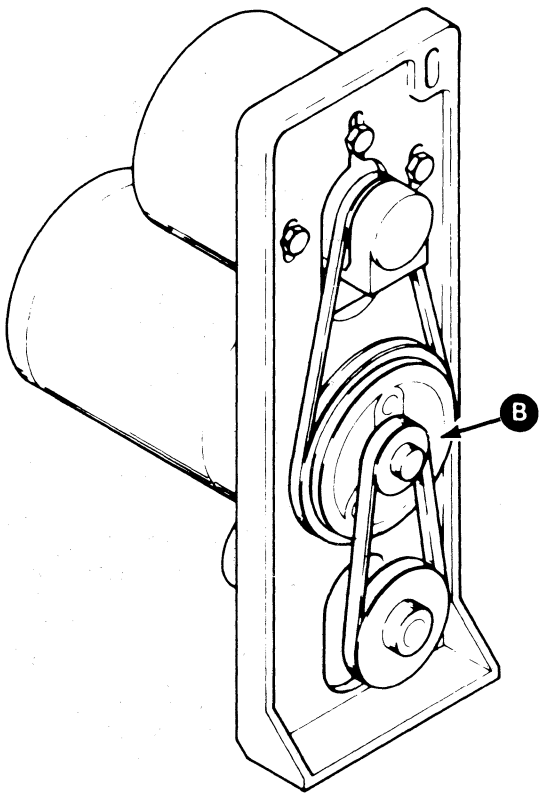
Figure 2.

Altitude	Transfer Valve Plug	Pneumatic Supply Pulley Diameter
	Models 3, 4, 5, 6 and 7 Model 8*	All Models
	Remove the cooling hose leading to the capstan motor at the transfer valve. Determine which hole should be plugged.	Determine which diameter of pneumatic motor stepped pulley should be used <b>B</b> (See Note 1 when changing the pulley diameter on Model 8.)
0-2000 ft (0-610 m) See Note 2	Small	Small
2001-4000 ft (610-1219 m)	Large	Small
4001-6000 ft (1219-2-1829 m)	Small	Large
above 6000 ft (1829 m)	Large	Large

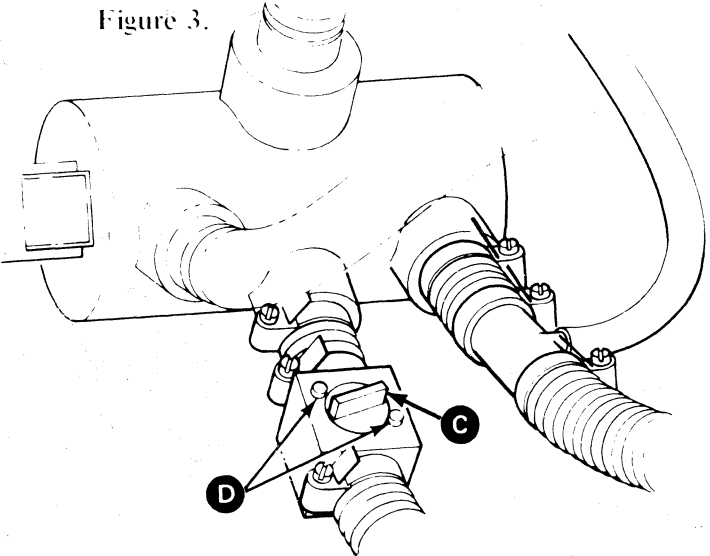
Figure 3.

\*The Model 8 has a restrictor **C**, P N 1765760, in the line between the pump and transfer valve (see Figure 3). The restrictor is adjusted for 31.5 inches (800 mm) of water. If 31.5 inches (800 mm) is unobtainable, adjust to the highest vacuum level between 29.0 and 31.5 inches (737 and 800 mm). If 29.0 inches (737 mm) is unobtainable, check for leaks, pinched hoses, or wrong pulley size.

- Measure the column vacuum (see 08-400).
- Loosen retaining screws **D**.
- Rotate the handle of the restrictor for adjustment **C**.
- Tighten retaining screws **D**.

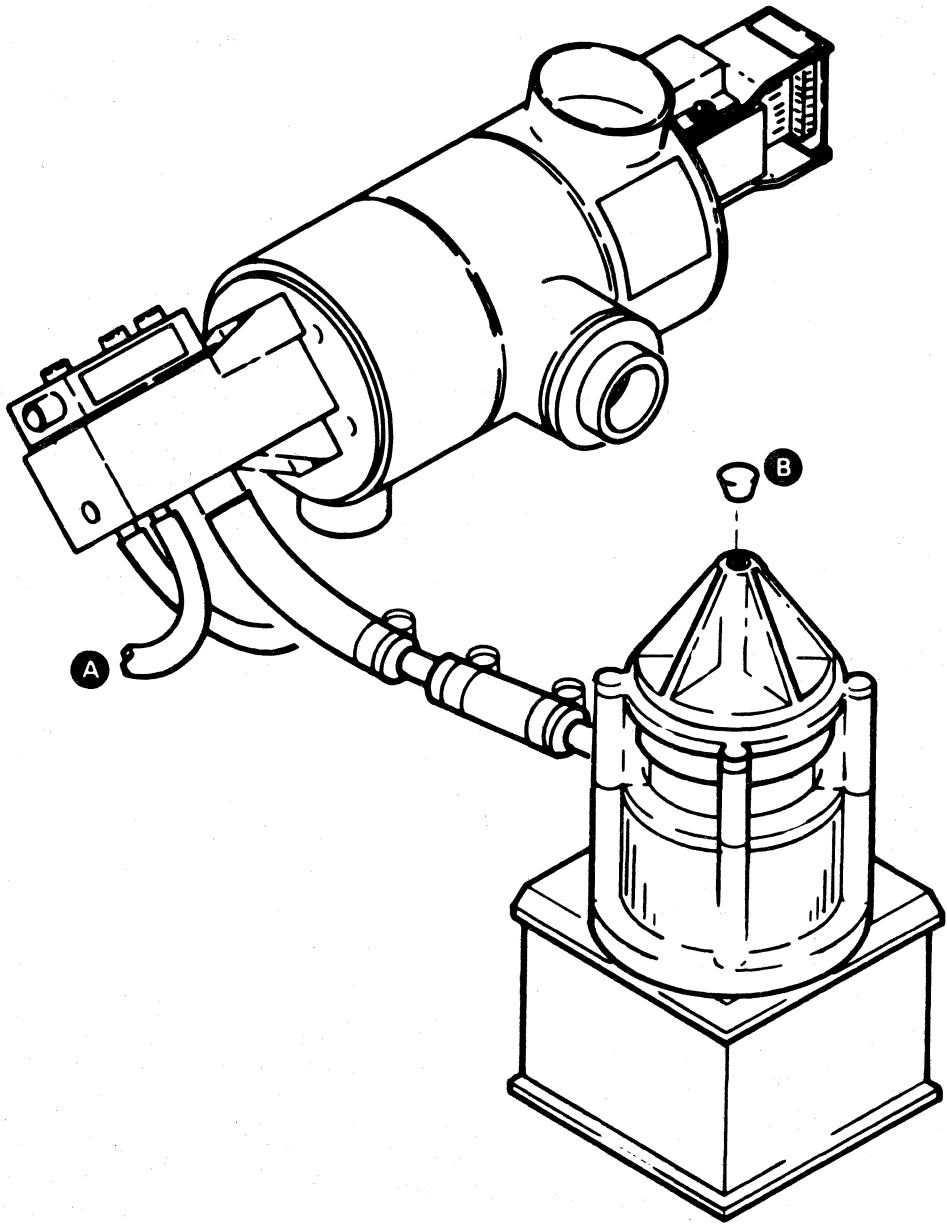
PNEUMATIC PRESSURE LEVEL  
ADJUSTMENT  
(ALL MODEL TAPE UNITS)

The pressure regulator is adjusted before shipment and should not require further adjustment in the field. If you suspect a pressure variation, check the pressure at the regulator test point on the distribution manifold **A**. If the level is not within the specifications listed in the chart on 08-400, check thoroughly for a kinked or leaking hose, a loose clamp or belt, or another faulty component in the pneumatic area.

1. Pry the small plastic plug from the top center of the regulator **B**.
2. Insert a hex wrench in the adjustment port. Engage the adjustment screw inside the port.
3. To decrease the pressure, turn the wrench clockwise; to increase the pressure, turn the wrench counterclockwise.
4. Thread and load the tape unit and measure pressure again at the regulator test point. See 08-400, "Pneumatic Pressure/Vacuum Checks."
5. If correct, replace the plastic plug. If not, repeat steps 2, 3, and 4.
