3803-2 / 3420

Magnetic Tape Subsystem  
Maintenance Manual

CAPSTAN AND TRACKING CHECKS/  
ADJUSTMENTS/REMOVALS/  
REPLACEMENTS

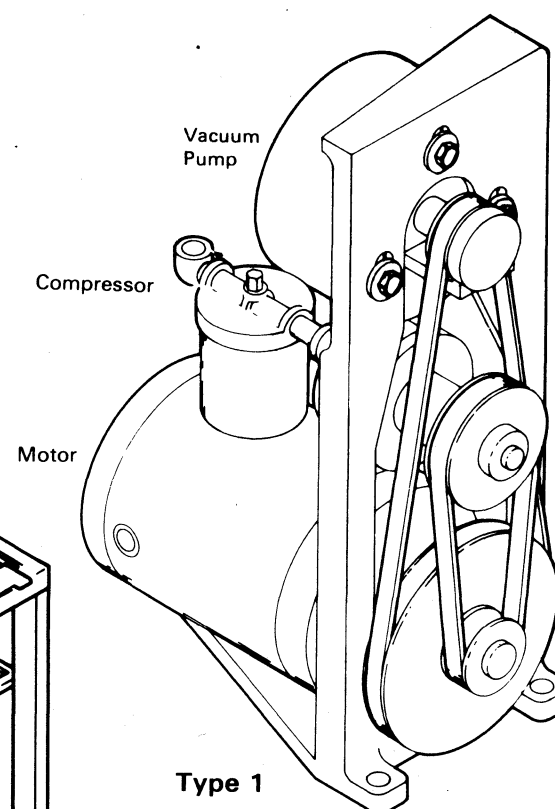
Type 1

**PNEUMATIC SUPPLY STEPPED PULLEY  
REPLACEMENT (ALL TYPES OF  
PNEUMATIC SUPPLIES)**

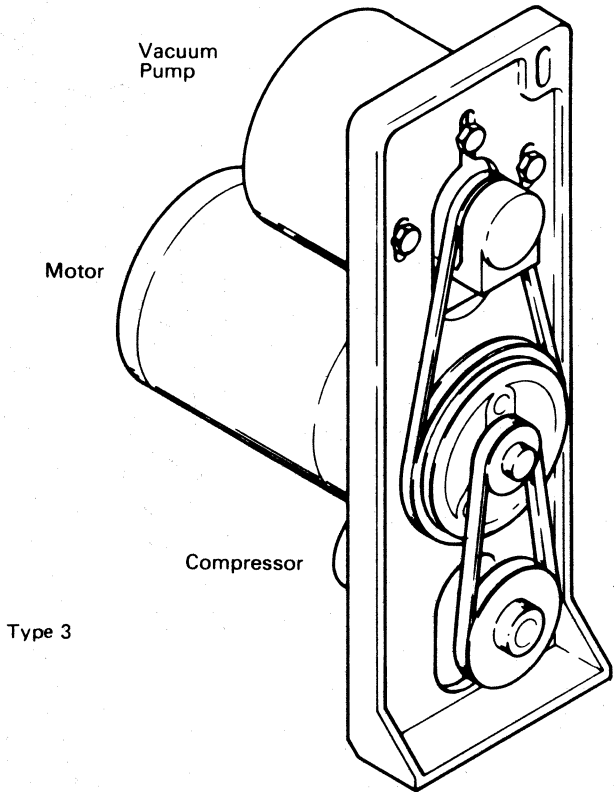
Vacuum Pump Pulley Adjustment

- 1. Check the belt alignment between the vacuum pump pulley and the motor pulley.
- 2. If necessary, remove the drive motor pulley to expose the hub setscrews.
- 3. Adjust by moving the drive motor hub in or out on the shaft after loosening the setscrews.
- 4. Tighten the hub setscrews.
- 5. See 08-430 for the pulley replacement procedure.

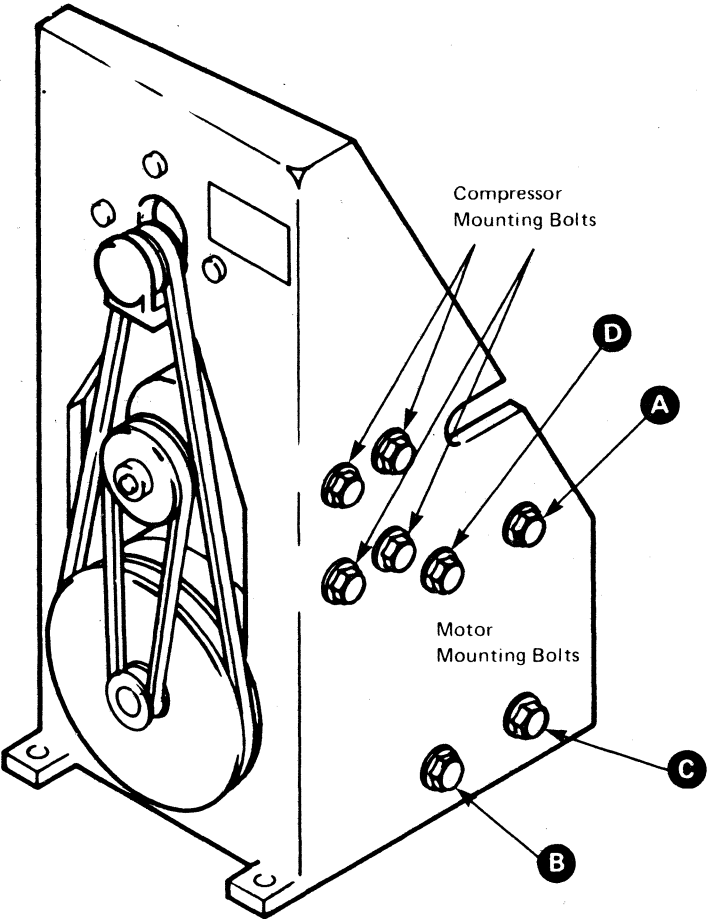
PNEUMATIC MOTOR LARGE  
(STEPPED) PULLEY ALIGNMENT

- 1. Check the belt alignment between the large drive motor pulley and the compressor pulley.
- 2. To adjust, loosen mounting bolts **A**, **B**, and **C** holding the motor mount.
- 3. Slightly loosen mounting bolt **D** and use it as a pivot point.
- 4. Rotate the motor and mount around the pivot bolt until the pulley is parallel to the belt.
- 5. Tighten the mounting bolts.

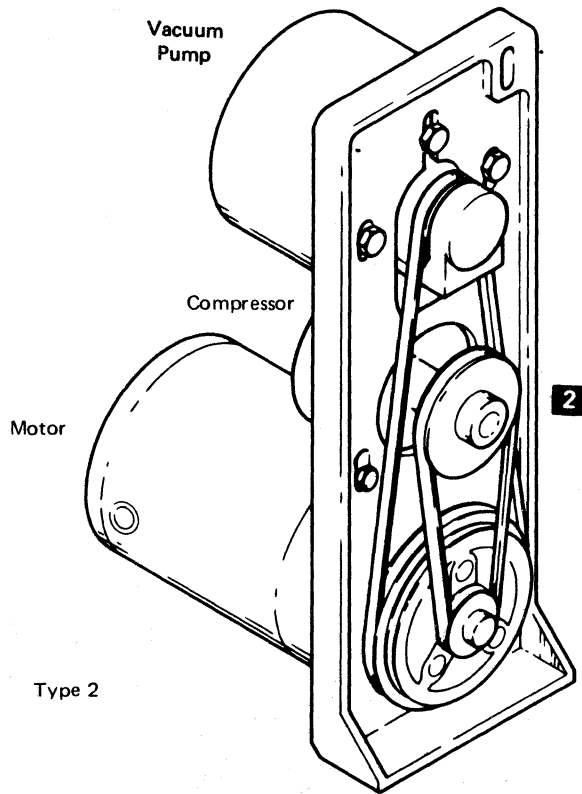
PNEUMATIC COMPRESSOR PULLEY  
ALIGNMENT  
(TYPE 2 SUPPLY)

- 1. Check the belt alignment between the small drive motor pulley and the compressor pulley.
- 2 Adjust by moving the compressor pulley in or out on the compressor shaft after loosening the pulley setscrews.
- 3. Tighten the setscrews.

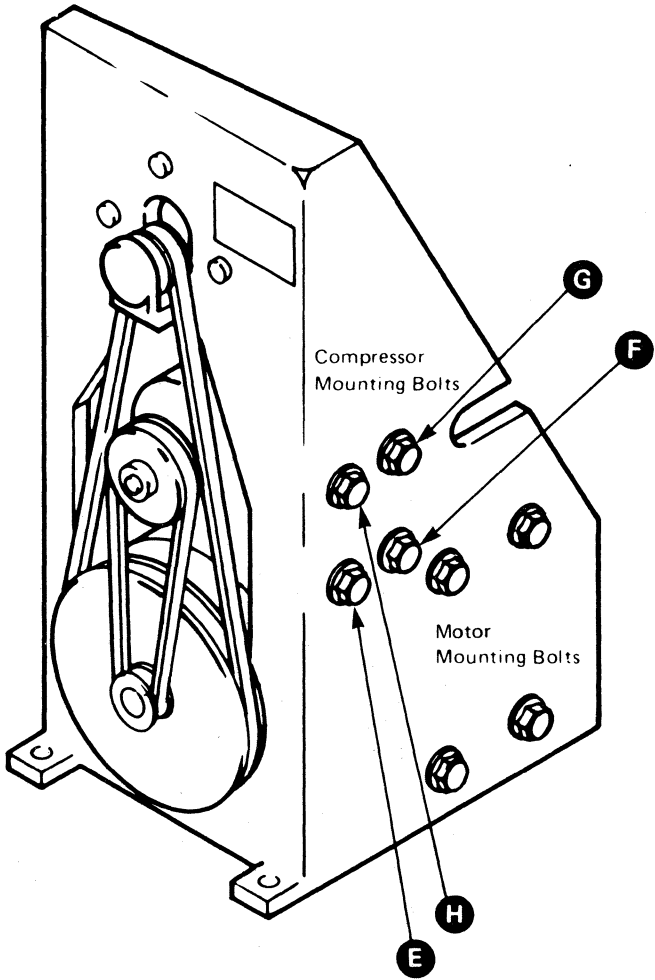
PNEUMATIC COMPRESSOR PULLEY  
ALIGNMENT  
(TYPE 1 SUPPLY).

1. Check the belt alignment between the compressor pulley and the motor pulley.
2. Adjust by loosening mounting bolts **E**, **F**, and **G**.
3. Slightly loosen mounting bolt **H** and use it as a pivot point.
4. Rotate the compressor and mount around the pivot point until the pulley is parallel to the belt.
5. Tighten the mounting bolts.

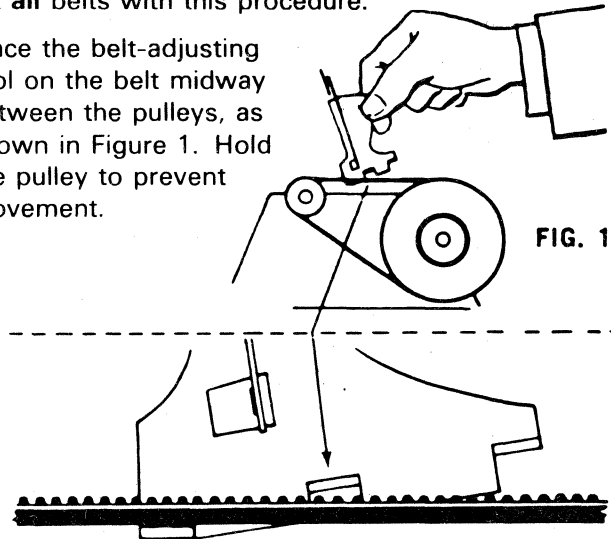
1. Place the belt-adjusting tool on the belt midway between the pulleys, as shown in Figure 1. Hold the pulley to prevent movement.

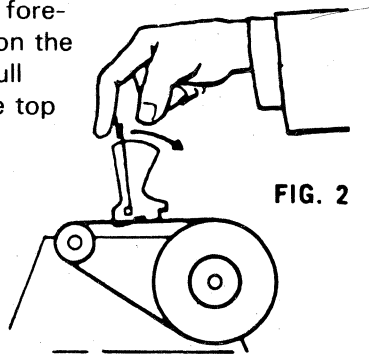
2. With the end of your forefinger on the button on the top of the spring – pull the button around the top circumference of the belt-adjusting tool. See Figure 2.

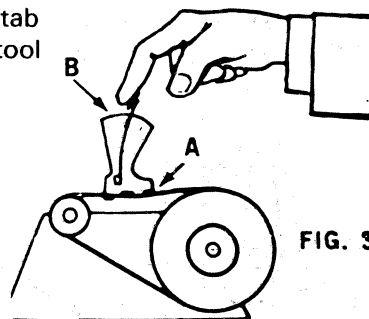
3. When the right-hand tab of the belt-adjusting tool just touches the top of the belt (see A in Figure 3), read the belt tension in pounds on the scale. (See B in Figure 3. Read at left of the spring.)

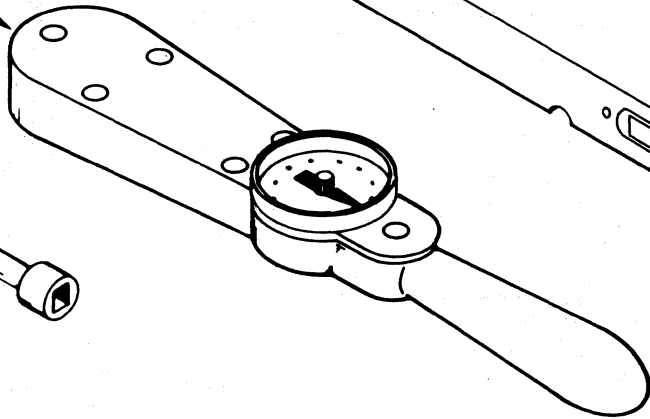
Torque Wrench  
P/N 2515283

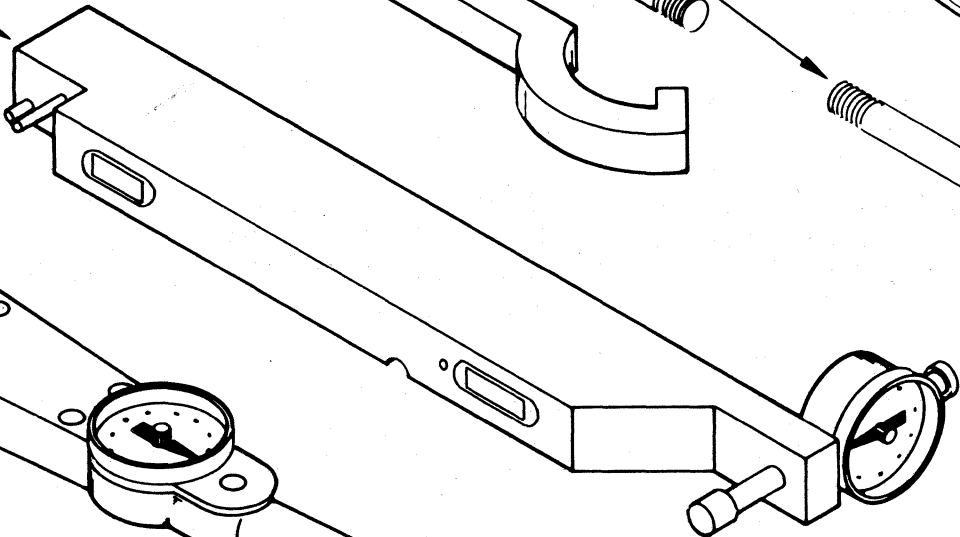
Reel Hub Adjusting  
Tool P/N 2515226

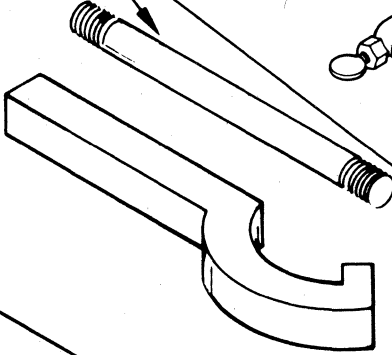
Reel Hub Spanner  
Wrench P/N 2515218

Motor Studs  
P/N 5356446

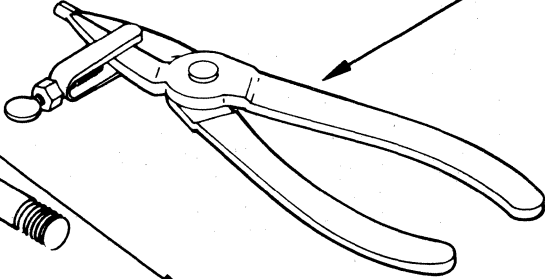
"C" Clip Tool  
P/N 460966

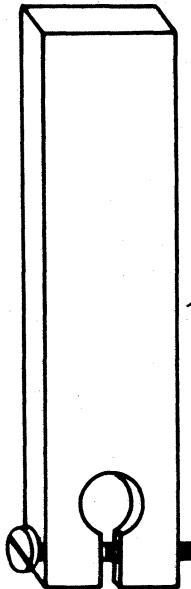
Restraint adjustment tool  
P/N 2515225 (See 08-540).

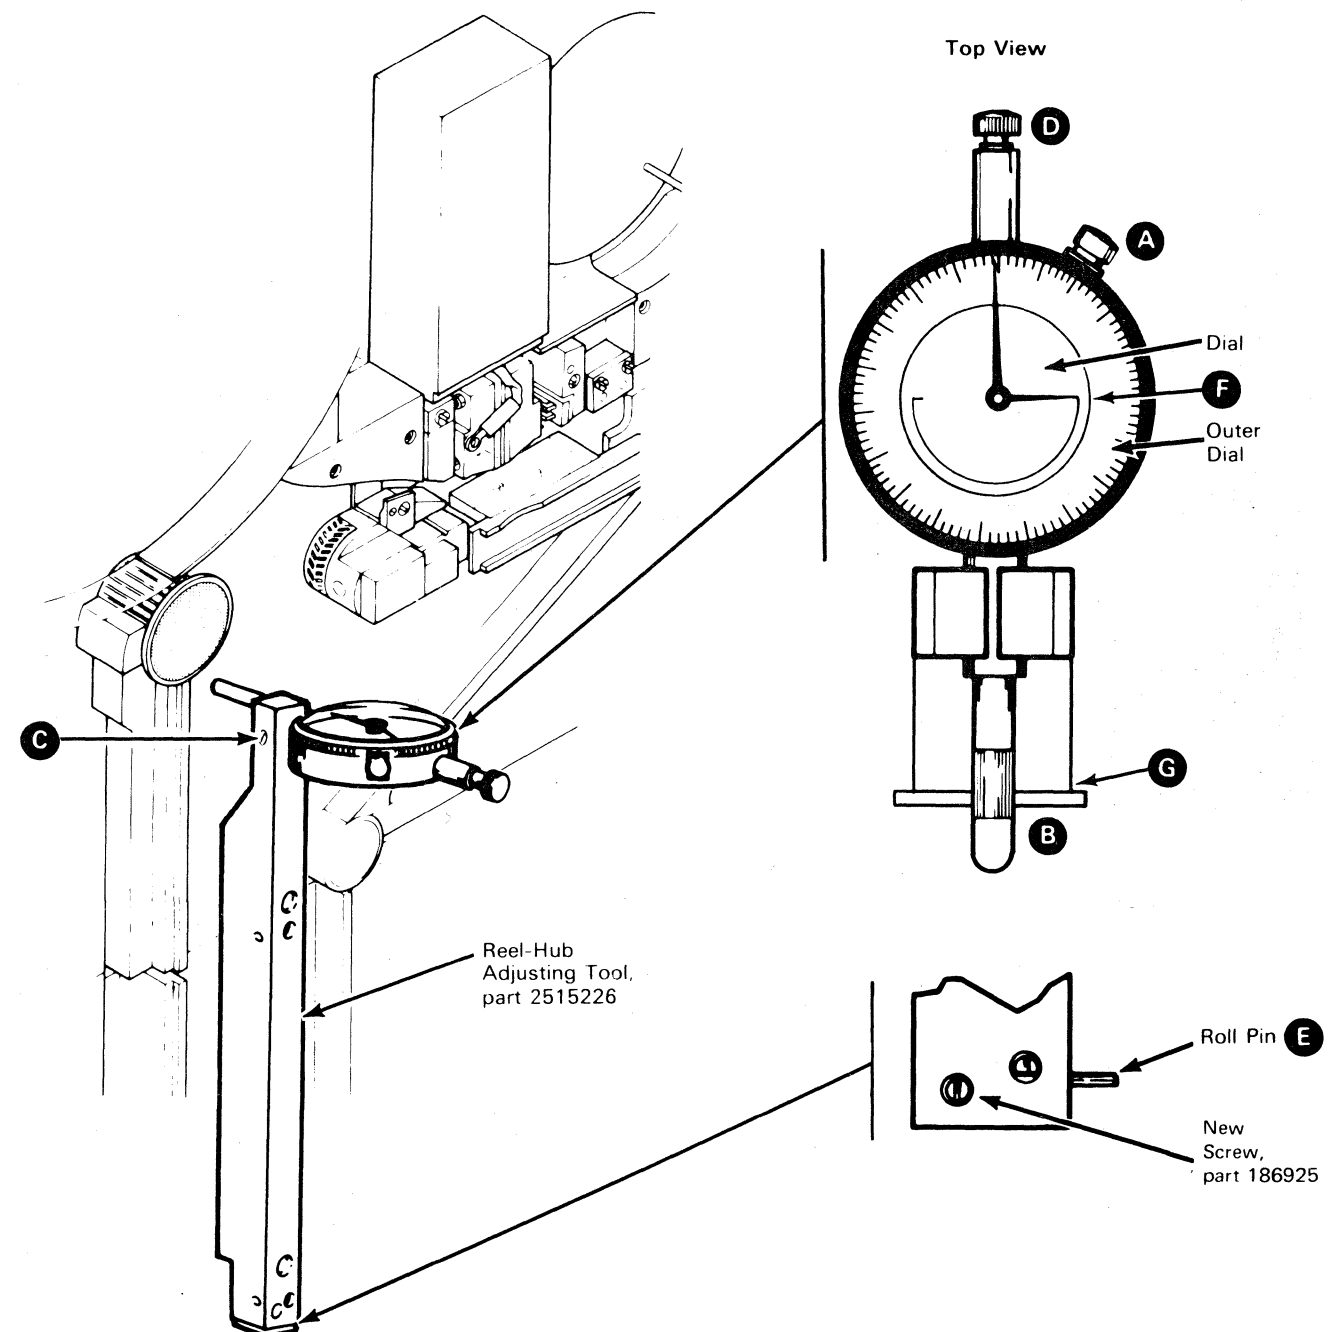
8. Remove the tool from the vacuum column. The large pointer should move only about 90 degrees and both pointers should come to rest positioned approximately as shown **F**.

**Note:** Be very careful when handling and mounting the tool. The gauge's zero adjustment will be lost with rough handling.

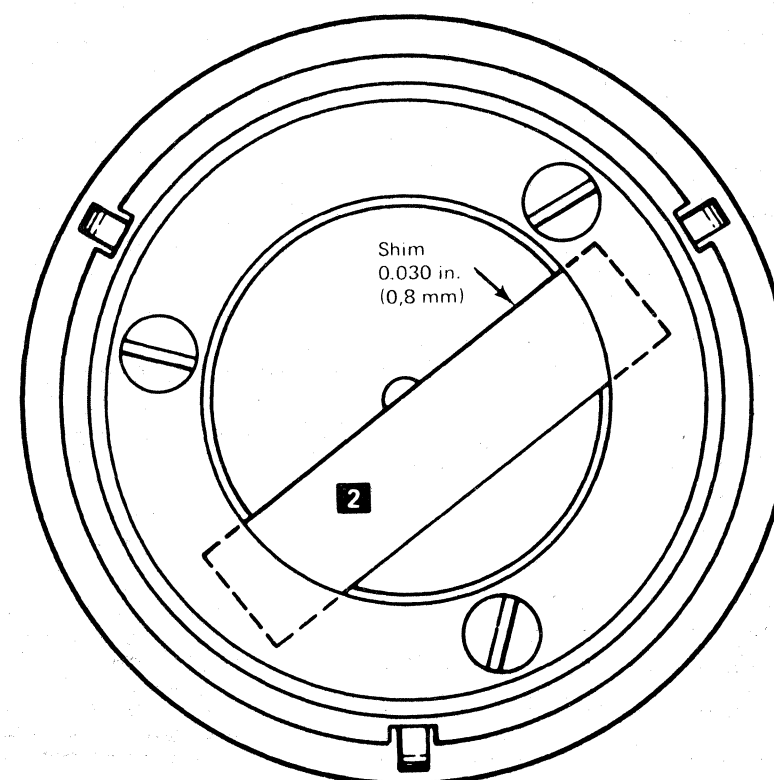
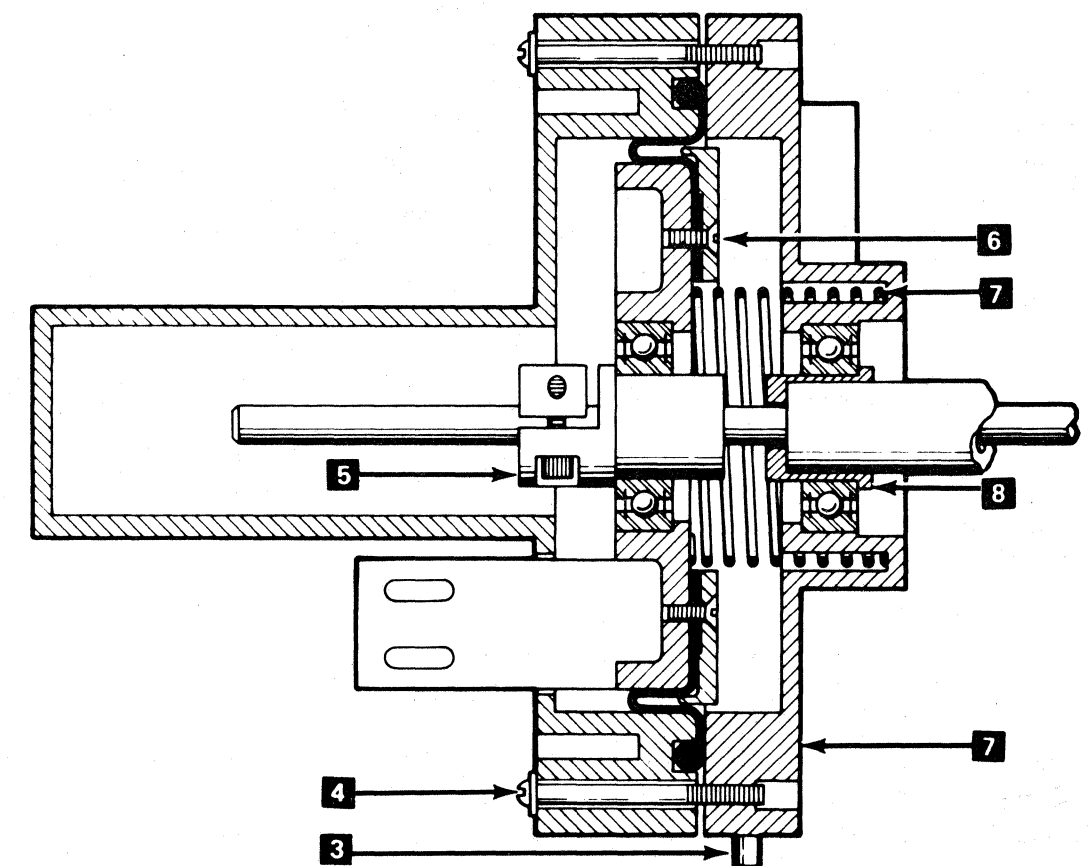
1. Remove the front decorative cover from the latch hub.
  2. Slip the adjustment shim, P/N 1846251, into the latch hub as shown.
- Caution:** This shim must be installed to prevent the camshaft from flying out of the hub when the rear housing is disassembled.
3. Disconnect the two air hoses from the rear housing.
  4. Remove the six cover mounting screws and the rear-housing cover. If necessary, carefully pry the bead of the diaphragm from the channel in the rear cover.
  5. To remove the piston assembly (including the diaphragm), loosen the setscrew on the clamping collar and slide the assembly off the shaft.

6. If only the piston assembly is being replaced, go to 08-510, "Right Reel-Latch Rear Housing Replacement," step 9. If only the diaphragm is being replaced, remove the four flat-head screws that fasten it to the piston assembly. Install the new diaphragm in the same position as the old one and insert and tighten the screws. Install the piston assembly. See 08-510, "Right Reel-Latch Rear Housing Replacement," step 9. If parts other than the piston assembly or the diaphragm are being replaced, continue with the next step.
  7. Slide the rear housing and spring off the reel shaft bushing.
  8. Slide the bushing off the end of the motor shaft.
  9. Remove the shim from the reel hub.
- Caution:** The camshaft is under spring tension — the shim is all that retains it.
10. Slide the camshaft and spring out of the reel hub.

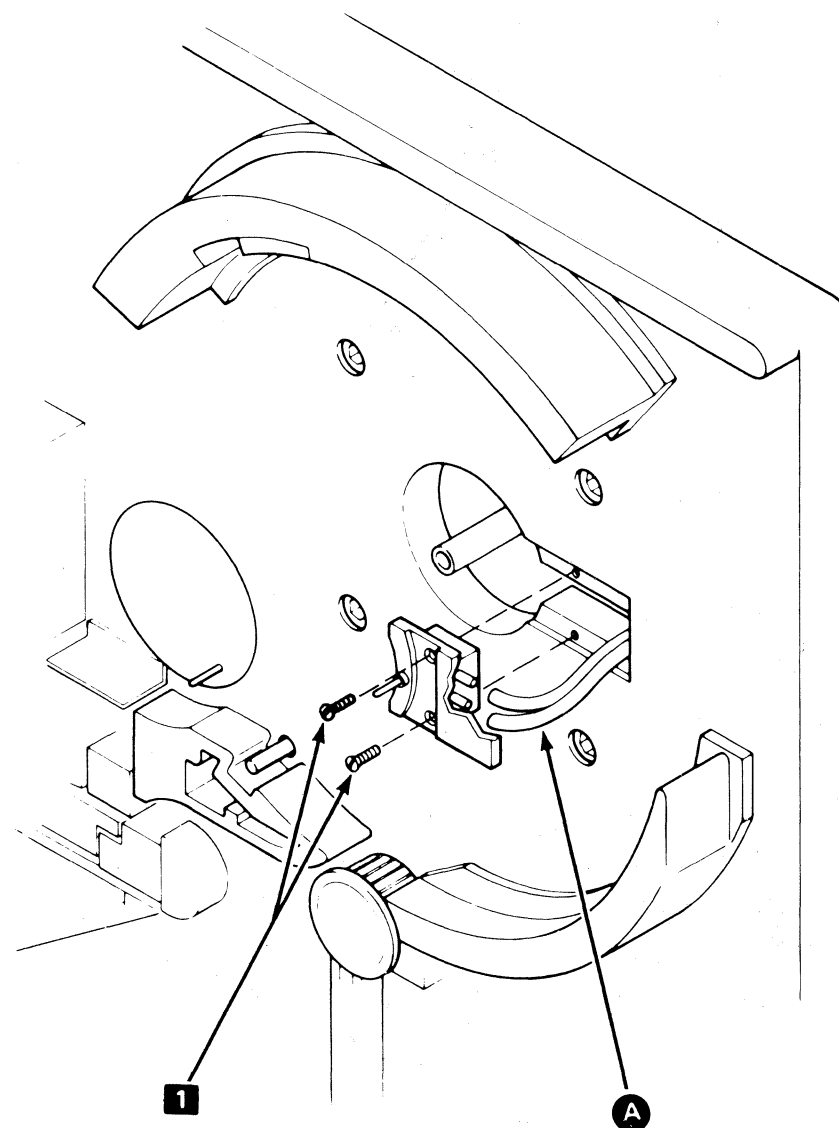
To remove the hub:

- 1 Remove the two mounting screws from the file-protect plunger assembly and slide the assembly out of the front casting. Do not disconnect hoses **A**. Move the assembly out of the way.
- 2 Rotate the hub to allow access to the hub clamp screw through the file-protect assembly casting opening.
- 3 Loosen the clamp screw with a hex wrench, P/N 1846252, and slide the hub off the shaft.
- 4 Go to 08-500, "Right Reel Hub Replacement/Adjustment."

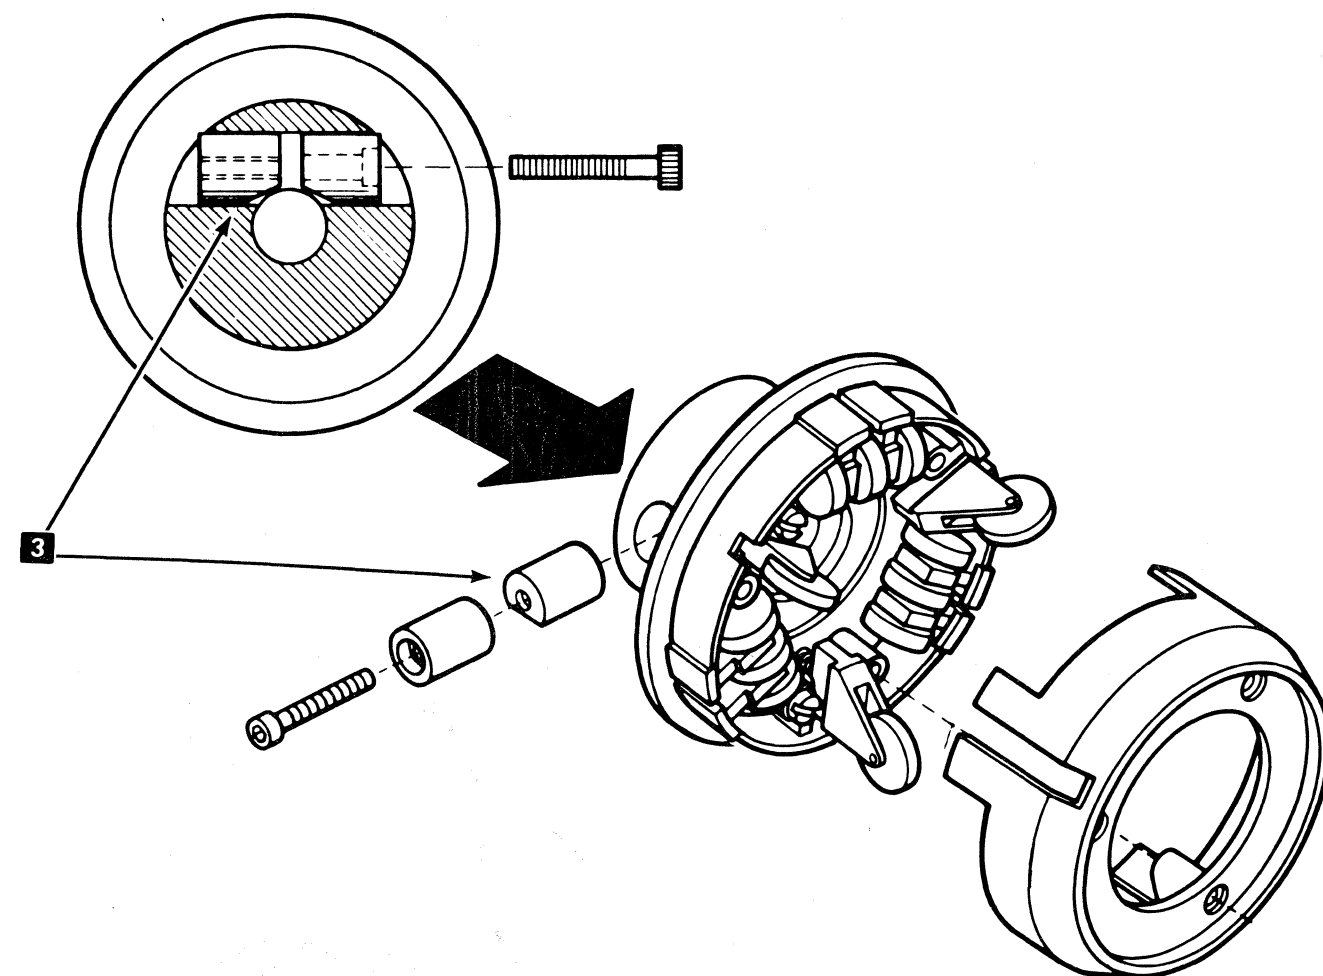
**Note:** Hub shown removed for illustration only.

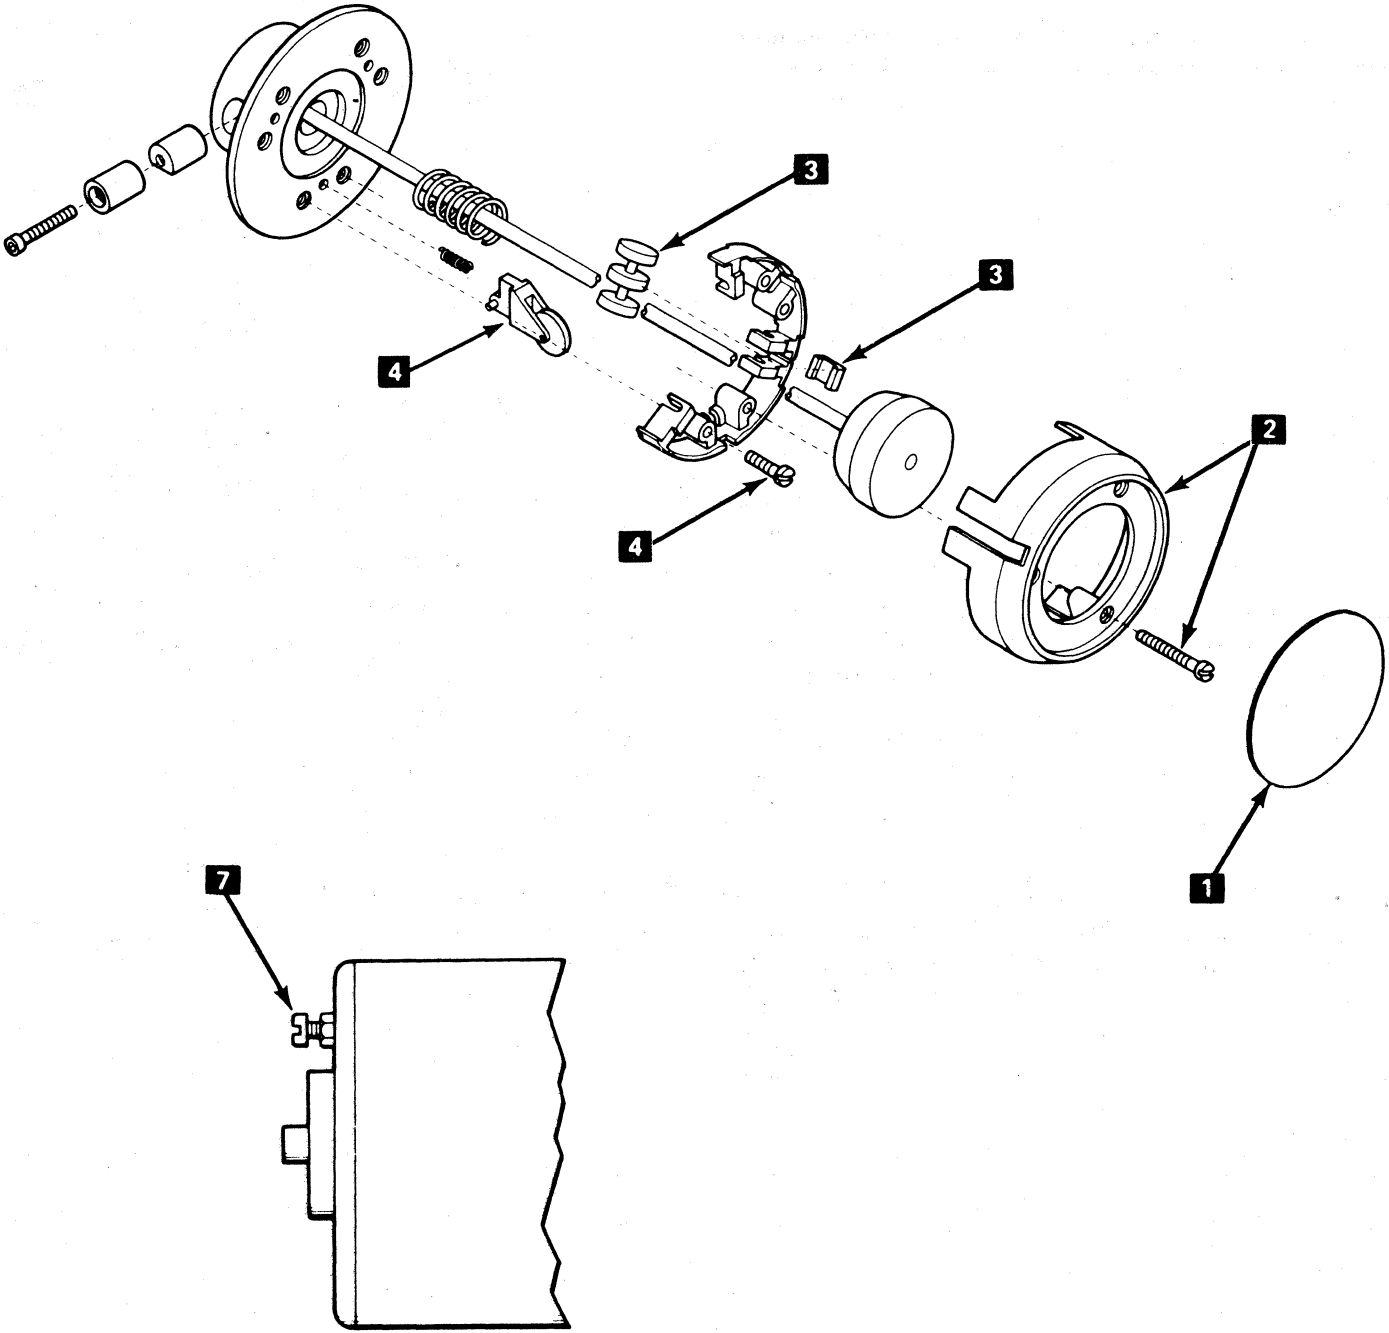
RIGHT REEL HUB INDIVIDUAL PARTS  
REPLACEMENT

To replace the latch segments, friction pads, triple roller assemblies, or single roller assemblies (and their springs), proceed as follows:

- 1 Remove the hub decorative cover.
- 2 Remove the three hub cover mounting screws and the hub cover.
- 3 The friction pads and rollers can be replaced without removing the remaining screws. Carefully "strip" the pads to be replaced off the ends of the latch segments. Replace them carefully.

- 4 To replace the rollers and spring, the screws must be removed.  
**Caution: Take care not to lose the small compression springs located behind the single roller assemblies.**

- 5 After replacing the parts, assemble the hub in the reverse order. The shorter screws must be replaced in the holes located clockwise from the single roller assemblies. As these screws are tightened, ensure that the springs under the single roller assemblies seat in their recesses in the hub.

- 6 Replace the hub cover and tighten the three mounting screws.
- 7 Check the operation of the hub by manually operating the cam assembly. Take care not to unseat the rear housing assembly from its antirotation screw on the back of the right reel motor.

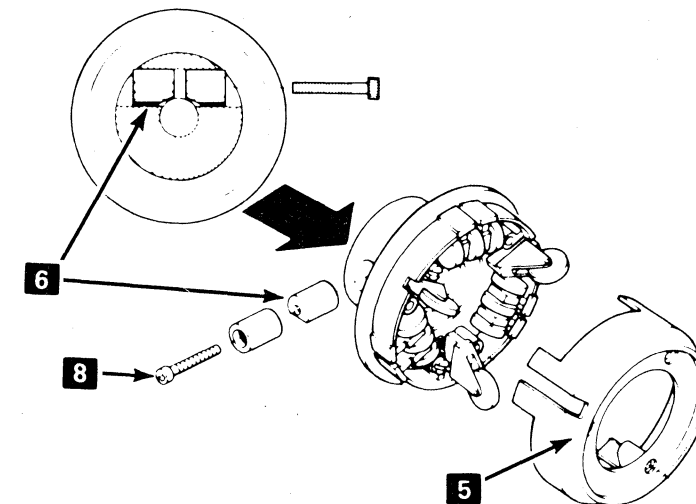
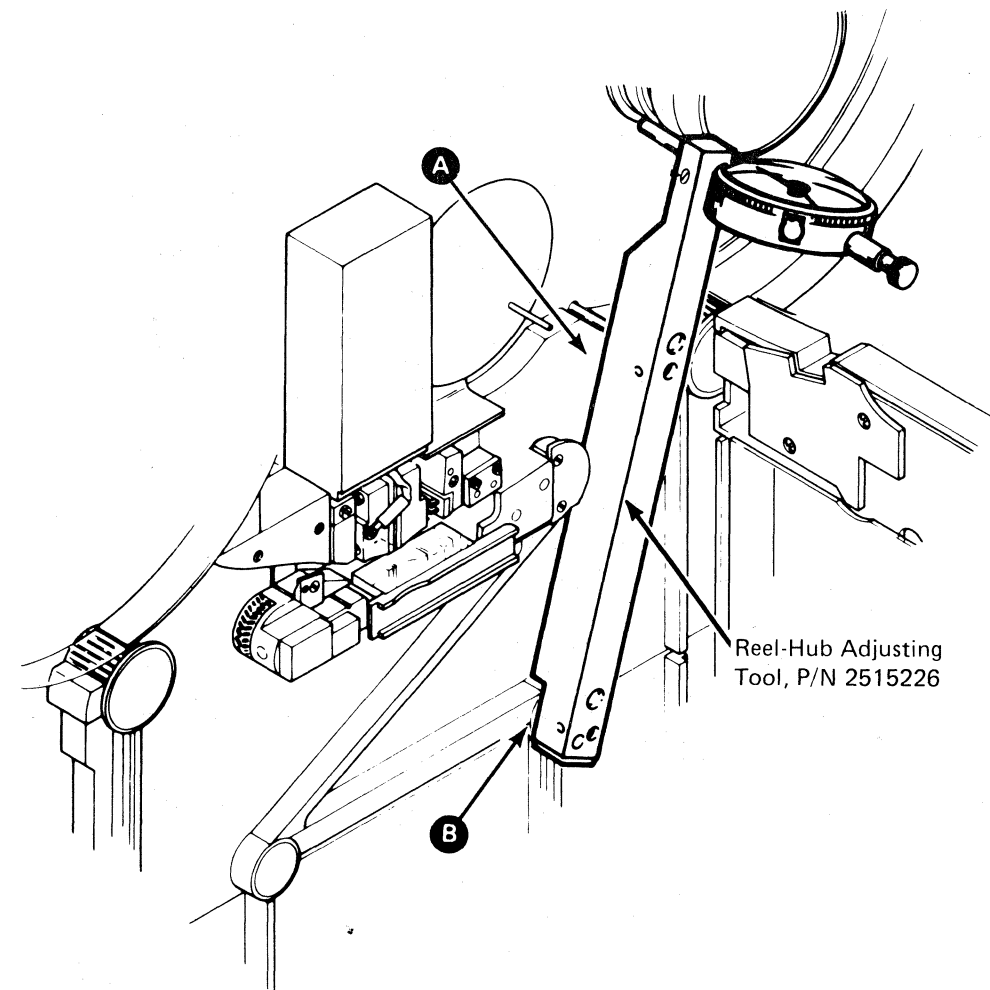
## RIGHT REEL HUB REPLACEMENT/ADJUSTMENT

9. If not done before, remove the file-protect plunger assembly to gain access to the clamp screw. Loosen the clamp screw. Retract the set-up spacers on the reel-alignment tool, P/N 2515226, by rotating the spacers a 1/4 turn and allowing them to return to their recesses.

**Caution:** Care must be taken when tightening the screw to ensure that the wrench does not touch the machine casting. Torque until a slight twist is observed or felt in the small leg of the tool.

13. Maximum runout around the entire circumference of the hub should not exceed 0.002 inch (0.05 mm). If excessive runout is suspected, take readings at a number of places around the hub. Do this by loosening the alignment tool, rotating the hub to another position, tightening tool and taking another reading without disturbing the original gauge setting. All readings should be within 0.002 inch (0.05 mm) of each other. Runout cannot be adjusted. The hub must be replaced if runout is excessive.

14. Remove the reel-alignment tool.
15. Replace the right threading channel. Tighten the screws evenly.
16. Replace the right air bearing. Install a new decorative cover, P/N 2501719.
17. Replace the file-protect plunger assembly. Check that the plunger operates without binding. If it does not, see 08-340, "File-Protect Mechanism Check."
18. Replace the hub cover and its three screws.
19. Install the new right reel hub decorative cover.

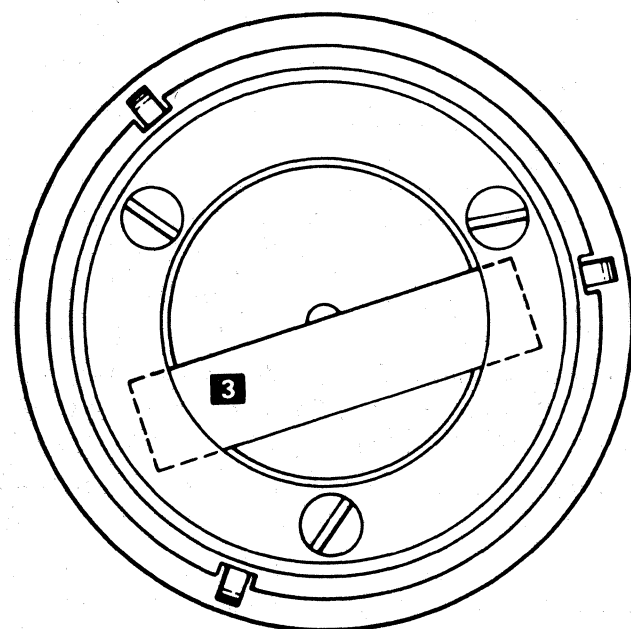
1. Slide the 1.19 inch (30.2 mm) diameter spring onto the camshaft.
2. Insert the camshaft assembly through the hub into the motor shaft. Ensure that the spring seats correctly in the hub recess.
3. Install the adjustment shim 0.030 inch (0.8 mm), P/N 1846251, as shown.

**Note:** This shim must be installed to retain the camshaft until the rear housing is installed. It also supplies the correct clearance adjustment for the cam.

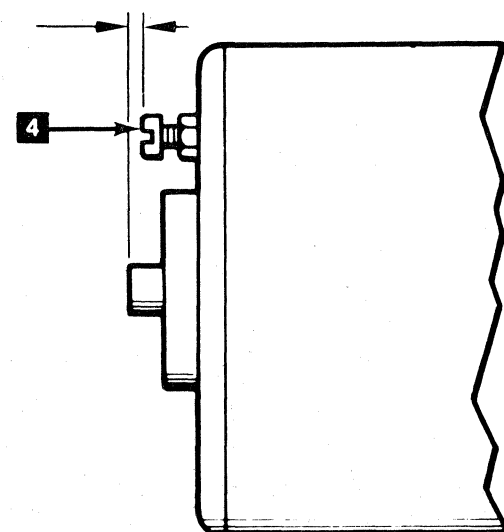
4. Ensure that the antirotation screw on the rear of the right reel motor is adjusted flush to 0.25 inch (6.4 mm) below the end of the reel motor shaft, as shown.

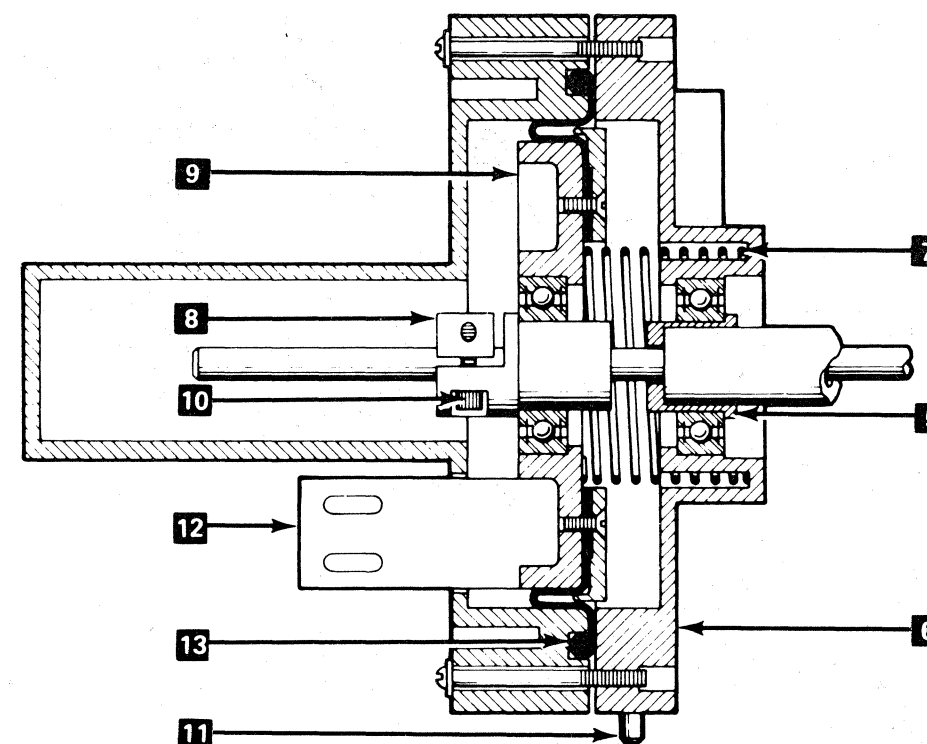
5. Install the bushing on the end of the reel motor shaft, as shown.
6. Install the rear housing over the bushing. Ensure that the antirotation screw enters the slot in the rear of the housing.

7. Insert the 1.75 inch (44.4 mm) diameter spring into the recess inside the rear housing, as shown.
8. Insert the clamping collar into the bearing of the piston assembly from the side with the guide extension.

11. Rotate the piston assembly to position the guide extension between the air connections on the rear housing.
12. Position the cover so that its slot is over the guide extension.

13. Ensure that the bead of the diaphragm fits into the cover channel.

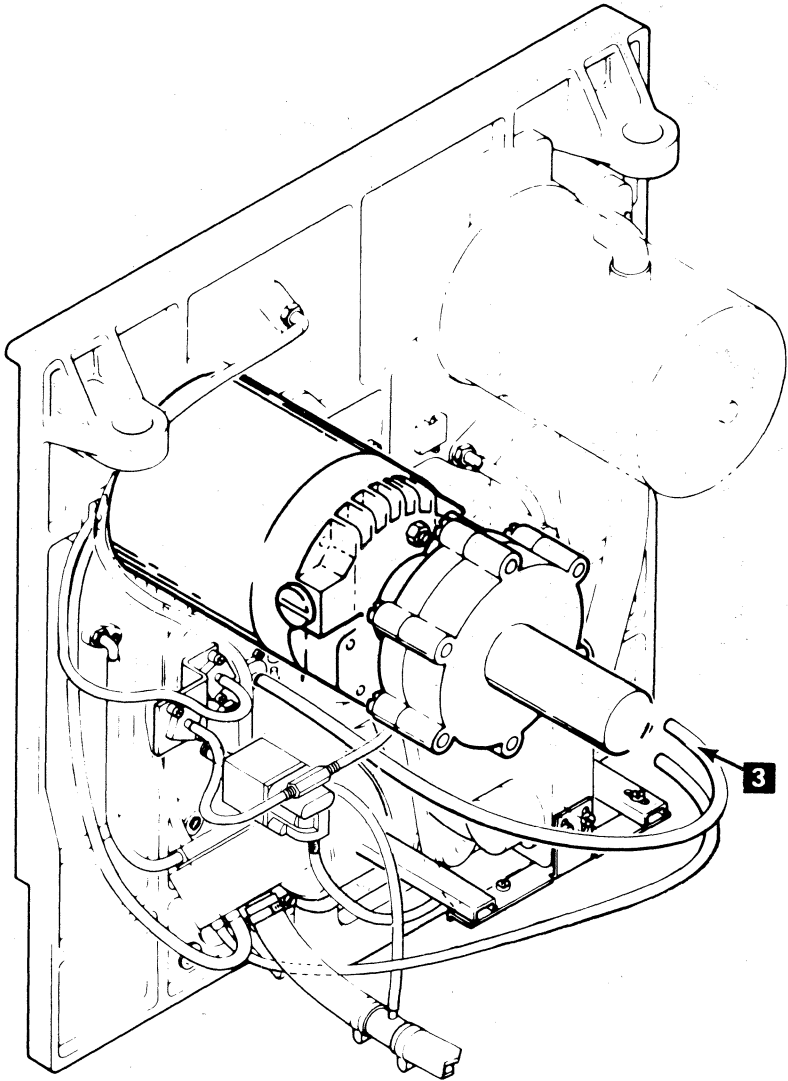
To check the rear housing for leakage:

- 1. Load the tape unit with a CE work tape.
- 2. Jumper A-A5B13 to ground to bypass the pressure switch so that the vacuum and pressure stay up.
- 3. At the rear housing, disconnect the hose to the pressure sensing switch. This causes the tape unit to drop READY.
- 4. Attach a pressure/vacuum gauge, P/N 5495384, or a water manometer with a pressure divider to the same rear housing air connection.
- 5. With the tape loaded in the columns, minimum pressure should be:

- 6. If the pressure is not correct, first check the pneumatic adjustment. See 08-420, "Pneumatic Pressure Level Adjustment." If the problem remains, replace the piston assembly (including the diaphragm). See 08-470, "Right Reel-Latch Rear Housing Removal." If the problem still remains, replace the rear housing. See 08-470, "Right Reel-Latch Rear Housing Removal" and 08-510, "Right Reel-Latch Rear Housing Replacement."
- 7. If the pressure is below 40 inches (1016 mm) of water on any model tape unit, and the monitoring circuits did not indicate a failure, replace the pressure sensing switch. If the failure is still not corrected, check the monitoring circuits.

- 8. Remove the jumper installed in step 2 and replace the hose removed in step 3.

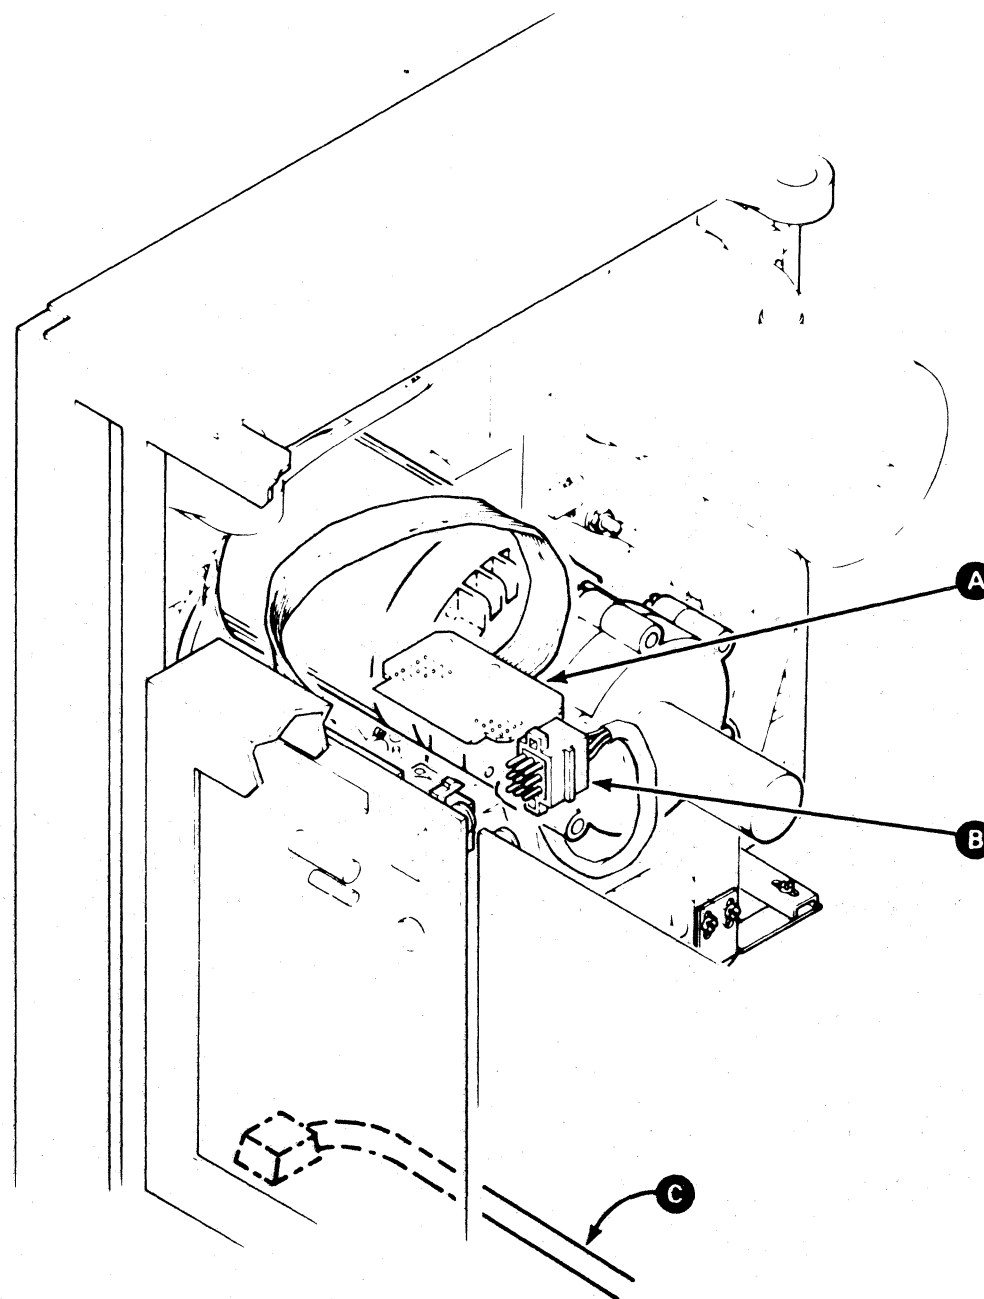
## RIGHT REEL MOTOR REMOVAL/REPLACEMENT

10. Reverse the procedure to install a new motor.
11. Replace the hub assembly. See 08-500, "Right Reel Hub Replacement/Adjustment."
12. Replace the rear-housing assembly. See 08-510, "Right Reel-Latch Rear Housing Replacement."

13. Test the housing pressure. See 08-520, "Right Reel-Latch Rear Housing Pressure Test."

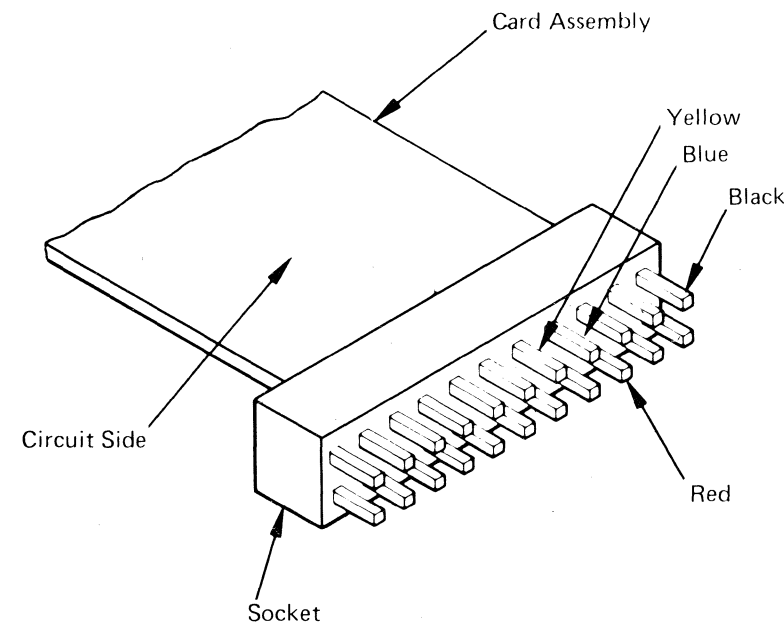
Figure 1.

4. Loosen the top 2 screws of cartridge motor, lift off SMS socket assembly. Remove the four cartridge motor leads noting their location (see Figure 1). Move assembly out of the way.

9. Install new motor and loosely install screws.
10. Replace colored motor leads on the back of the SMS card connector (see Figure 1).
11. Install SMS socket assembly on top 2 screws.

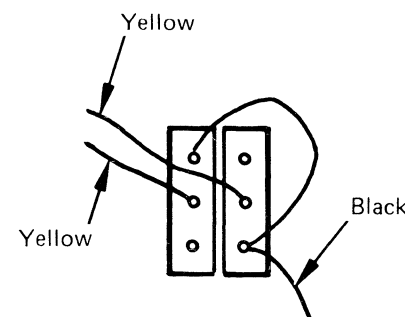
6. Mark the yellow and black wires so they can be easily replaced (see Figure 2). Unsolder yellow and black wires.
7. Remove the defective motor.
8. Rest the new motor on the transfer valve and resolder wires removed in step 6. See Figure 2.

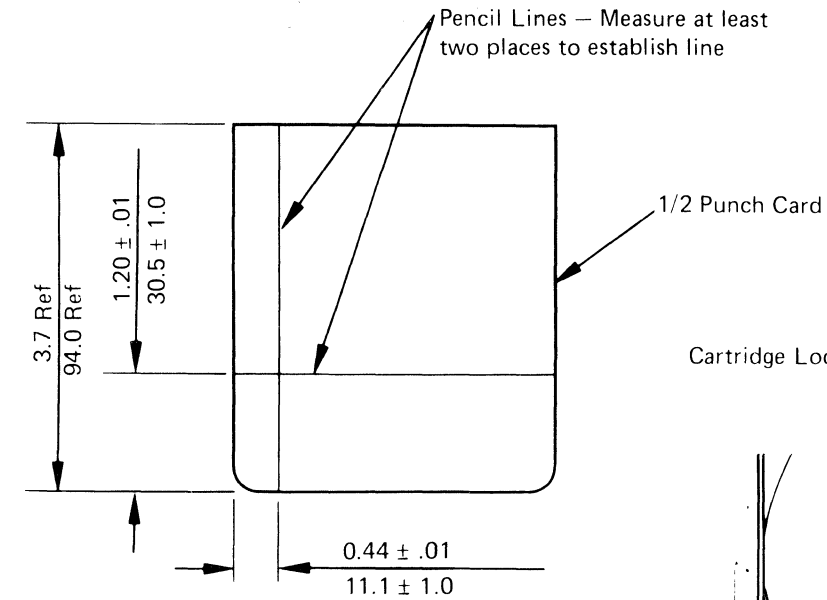
Figure 3.

12. Remove the right threading channel and cartridge opener cover if not removed.
13. Construct a template from a punch card (see Figure 3).
14. Tape the cartridge present plunger flush to the base plate (see Figure 4).

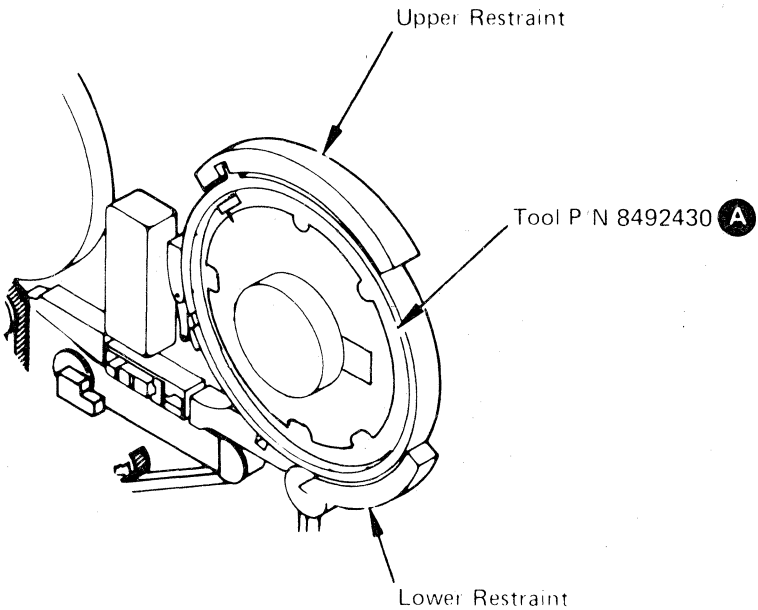
1. Open power window door and bypass the door interlock.
2. Attach the manometer or pressure gauge hose to the upper restraint cartridge leakage tool.
3. Install the upper restraint cartridge leakage tool **A**. Tool will be held in place when cartridge motor goes to the cartridge open position.

4. Push RESET and LOAD REWIND. Pneumatics will come up and cartridge motor will open tool.
5. Pressure should be between 18-32 inches of water, if not check the list of probable causes below.

- a. Regulator pressure incorrect (see 08-400).
  - b. Tool not properly seated against upper restraint port.
  - c. Loose or leaking hoses.
  - d. Upper restraint mounting screws loose or tightened in wrong sequence.

- e. Defective transfer valve (see 04-400).
  - f. Defective upper restraint (see 08-540).
  - g. Upper restraint set screw loose or missing. This set screw does not exist on all models of upper restraint.

6. Push RESET and UNLOAD REWIND.
7. Remove tool and gauge or manometer.

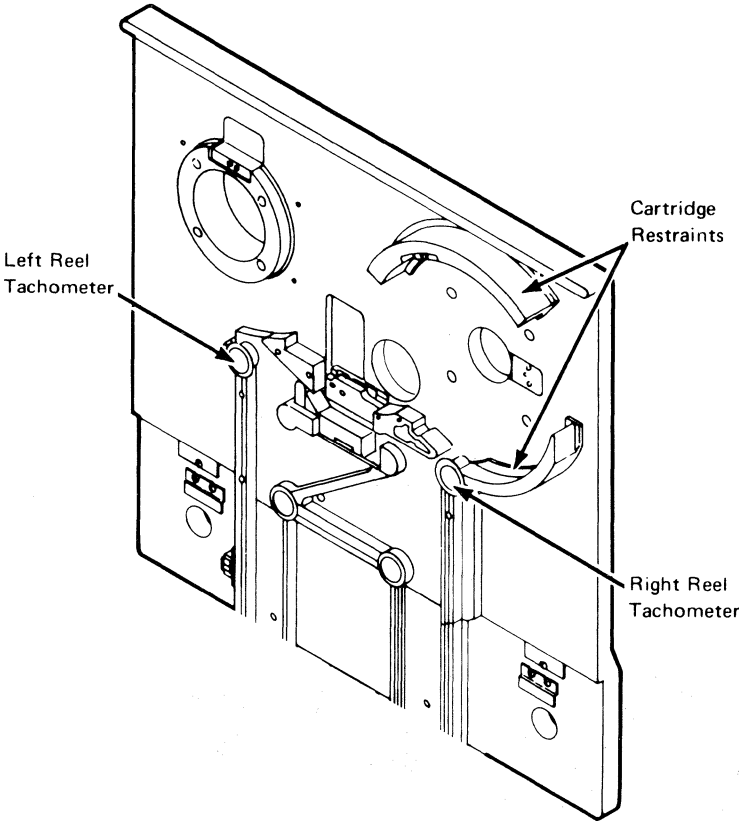
CARTRIDGE RESTRAINT  
REMOVAL/REPLACEMENT  
(NON-90,000 SERIES TAPE UNITS)

The cartridge restraints are mounted on straight dowel pins through the casting to avoid alignment problems when removal or replacement is necessary.

Red	0.002 inch (0.05 mm), P/N 2513186
Green	0.003 inch (0.07 mm), P/N 2513187
Tan	0.004 inch (0.10 mm), P/N 2513188
Brown	0.010 inch (2.5 mm), P/N 2513189

Replace any broken shim with a new one of the same thickness.

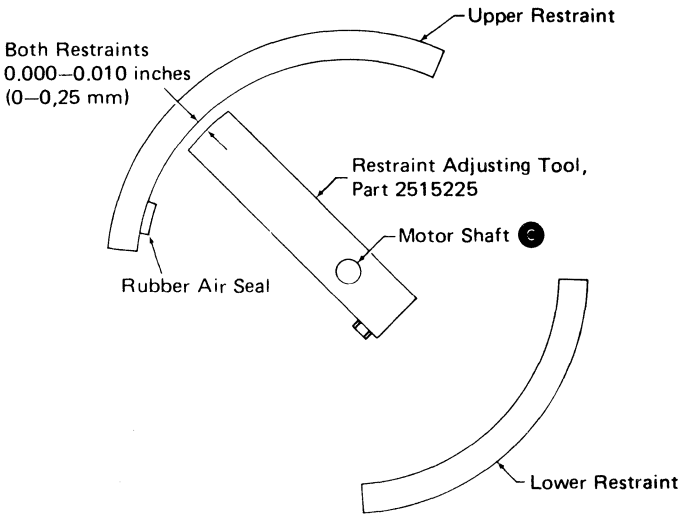
CARTRIDGE RESTRAINT  
REMOVAL/REPLACEMENT  
(90,000 SERIES TAPE UNITS)

**Caution:** Press the rubber air seal when rotating the adjusting tool or the seal may be damaged. Do not allow the tool to rotate by its own weight until the clearance to both restraints is ensured.

6. Adjust upper and lower restraints so tool will turn 360° and clear by 0.000-0.010 inch (0-0.25mm) surfaces **A** and **B**.
7. Replace the top cover.
8. Install the right reel hub. See 08-500, "Right Reel Hub Replacement/Adjustment."
9. Install the right reel latch. See 08-510, "Right Reel-Latch Rear Housing Replacement."
10. Do the right reel-latch pressure check. See 08-520, "Right Reel-Latch Rear Housing Pressure Test."
