3803-2 / 3420

Magnetic Tape Subsystem  
Maintenance Manual

CAPSTAN AND TRACKING CHECKS/  
ADJUSTMENTS/REMOVALS/  
REPLACEMENTS

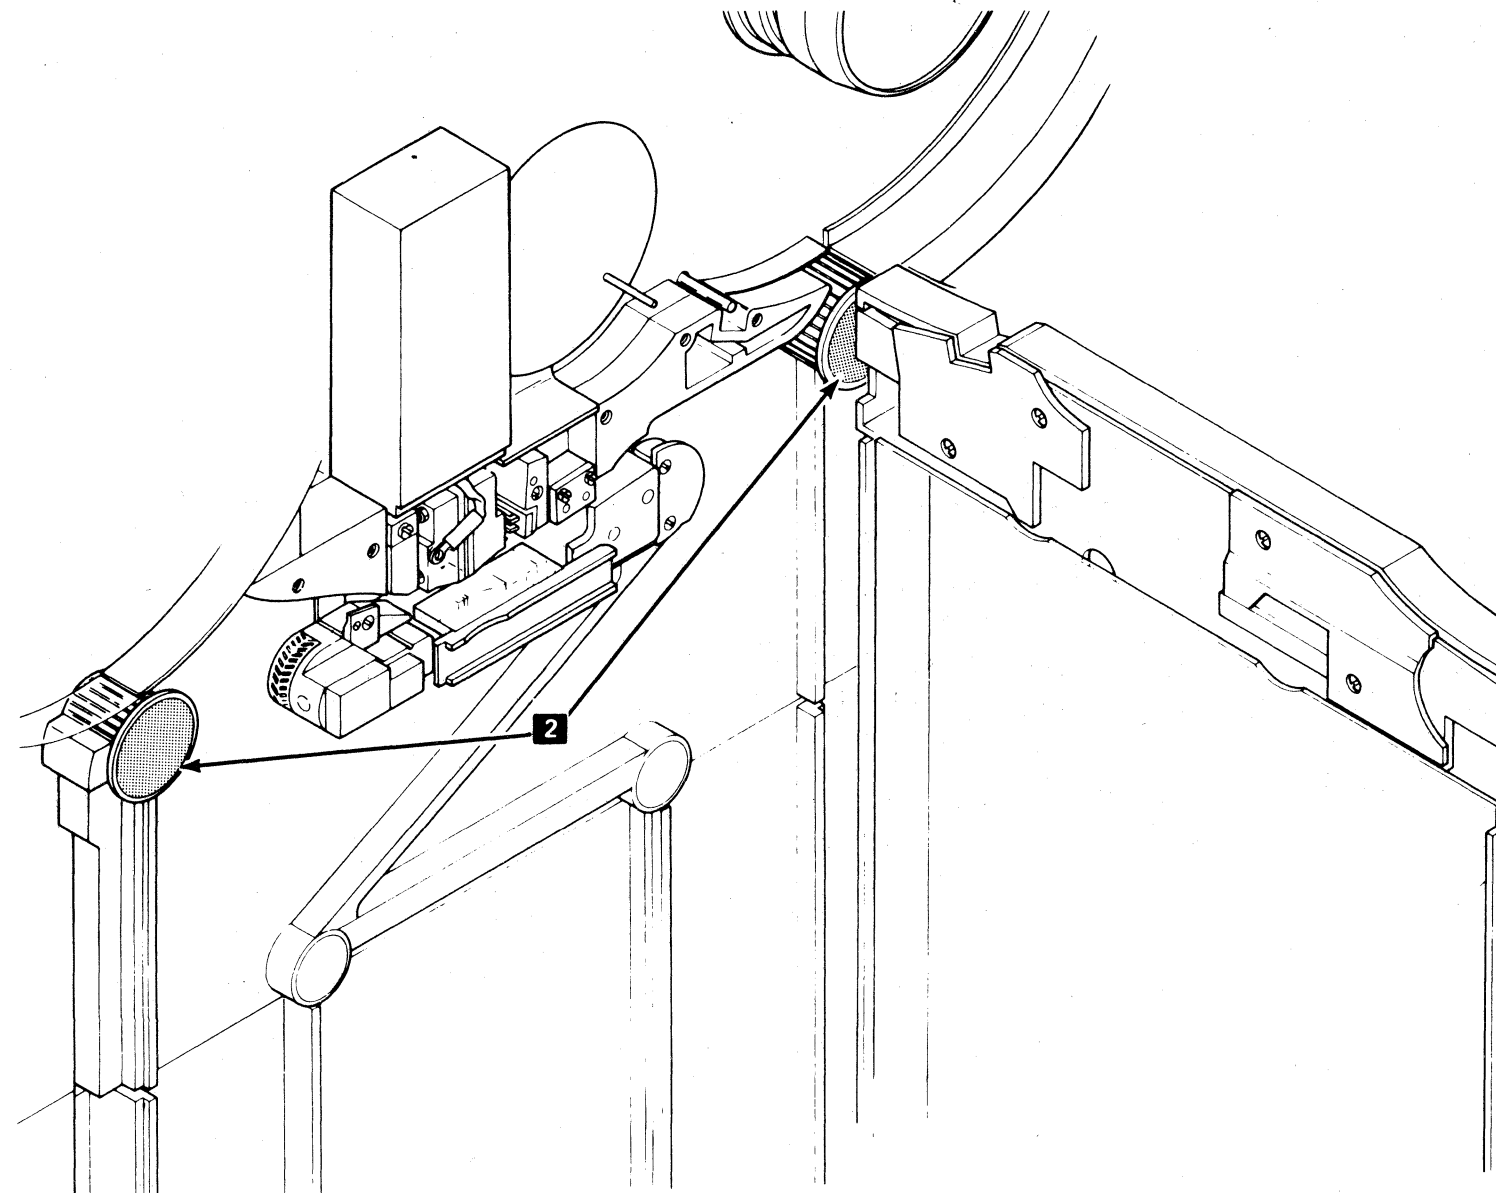
**REEL TACHOMETER  
REMOVAL/REPLACEMENT**

**Caution:** Do not pinch, kink, or stretch the fiber optic bundle.

5. Remove the fiber optic bundle by loosening the large nylon retaining screw.
6. Loosen the bracket that fastens the phototransistor wires.
7. Remove the small nylon screw and take out the phototransistor.
8. Reverse the procedure to replace a reel tachometer.
9. Install a new decorative cover, P/N 2501719.

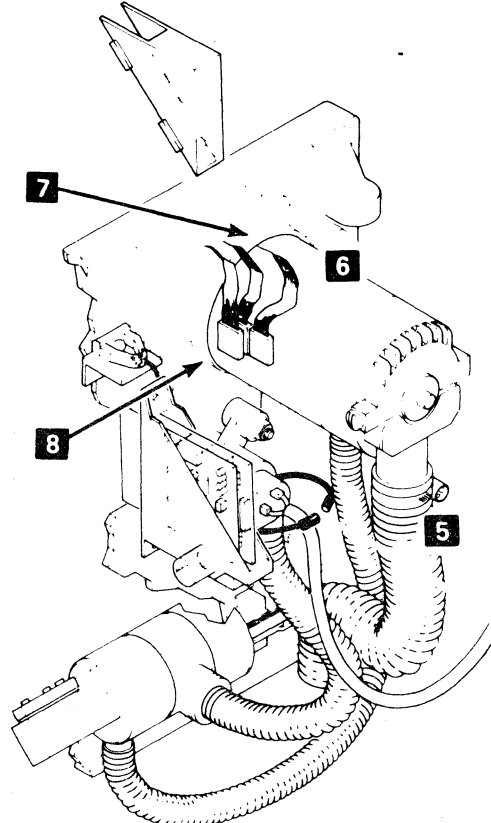
LEFT REEL HUB AND MOTOR  
REMOVAL/REPLACEMENT/ADJUSTMENT

**Note:** If the motor is replaced, the hub can remain mounted on the motor shaft during removal. The hub will be fastened to the shaft by either one or two screws. Torque the screws to the specifications shown in step 11f.

**Caution:** The weight of the motor is not supported when the guide studs clear the main casting.

9. Slide the motor out to the rear.
10. To replace the left reel motor, reverse steps 4 through 9.

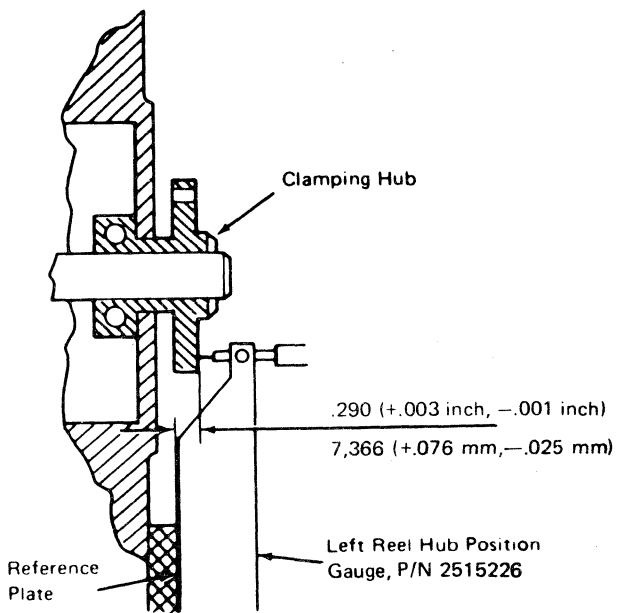
11. If the hub is loose, adjust it as follows:
  - a. Remove the left reel tach (see 08-550) for reel-hub adjustment tool clearance.
  - b. Place the reel-hub adjusting tool, P/N 2515226, on a flat surface and set it to 0.100 inch (2.54 mm).

- g. Recheck the dimension and runout on the hub face. Adjust if necessary.
12. Install the reel, tightening the screws to 50 ±5 inch-pounds (57.6 ±5.7 cm-kgf).

Figure A. Left Reel Setup

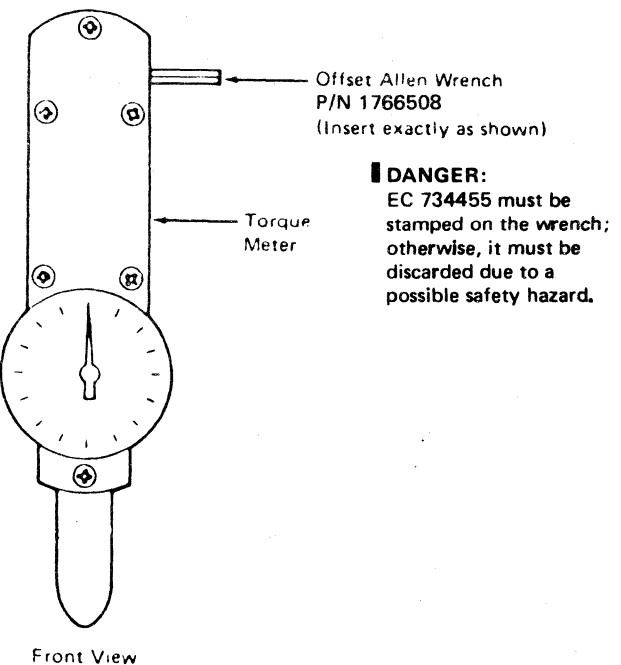
Figure B. Torque Meter

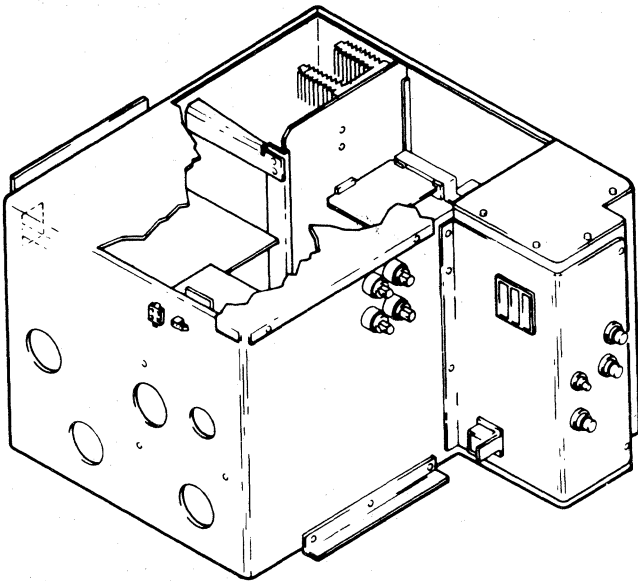
Basic Power Supply

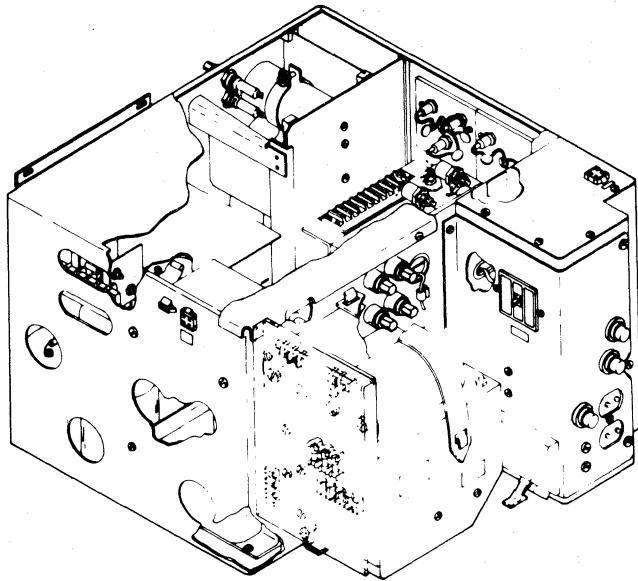
Modified Power Supply

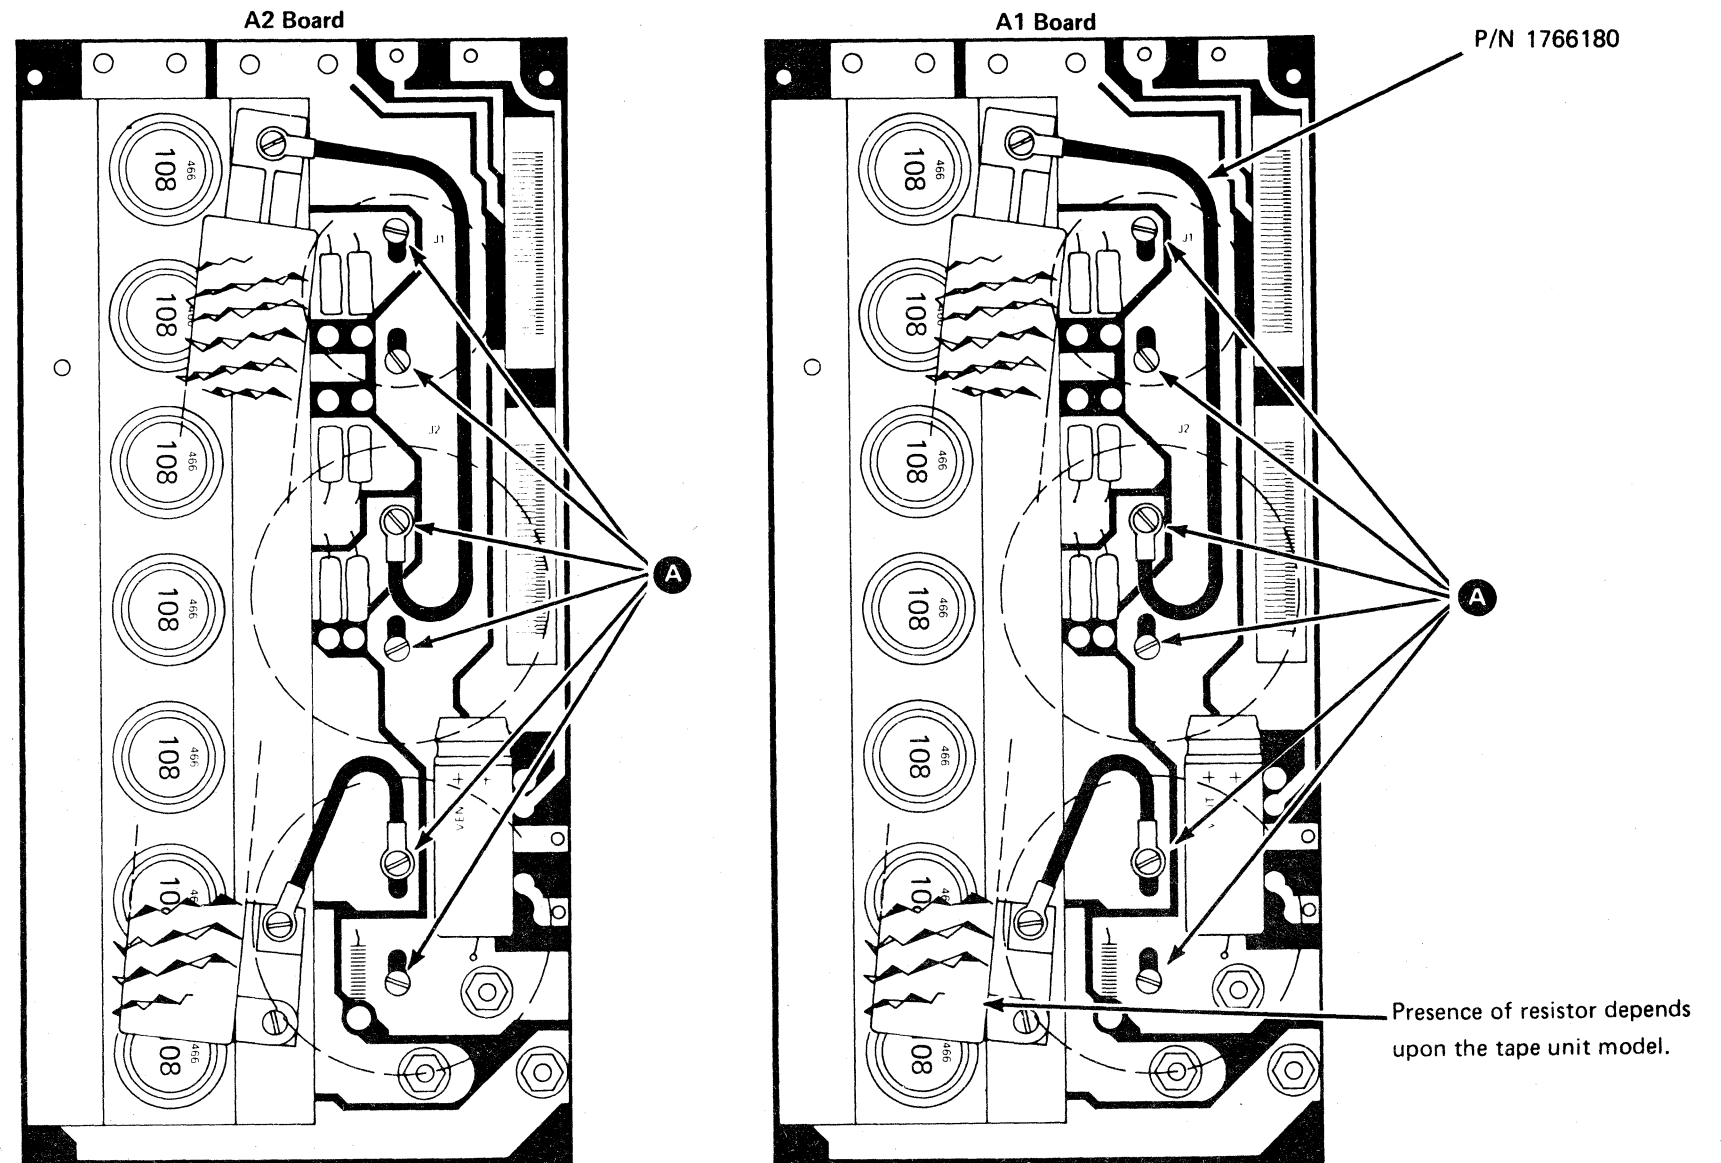
1. Remove all power from the tape control unit (TCU) by tripping main line CB1, and remove the power plug.
2. Remove the plastic cover from the power supplies.
3. Remove the regulator cards to prevent damage. Note their location for later replacement.
4. Remove all external cables and laminar bus connections from the power supply board to be removed (A1, A2, A3). Note their locations for later reassembly.
5. Remove the ground strap at the top of the power supply.
6. Remove the six screws **A** that fasten the printed circuit board to the three large capacitors behind the board. Note the location of each of the screws as some are slightly longer than the others. Also, note the cable dress position of the jumper wires on the A1 and A2 PCB. See Figure 1.

8. To reassemble, perform steps 7 through 1 above. When installing the six screws in the capacitors, use a torque screwdriver (P/N 453570) to torque the screws to  $18 \pm 5$  inch-pounds ( $20.74 \pm 5.76$  cm-kgf).
9. Perform the voltage checks on 08-570.

Figure 1. 3803 MODEL 2 -4V SUPPLY

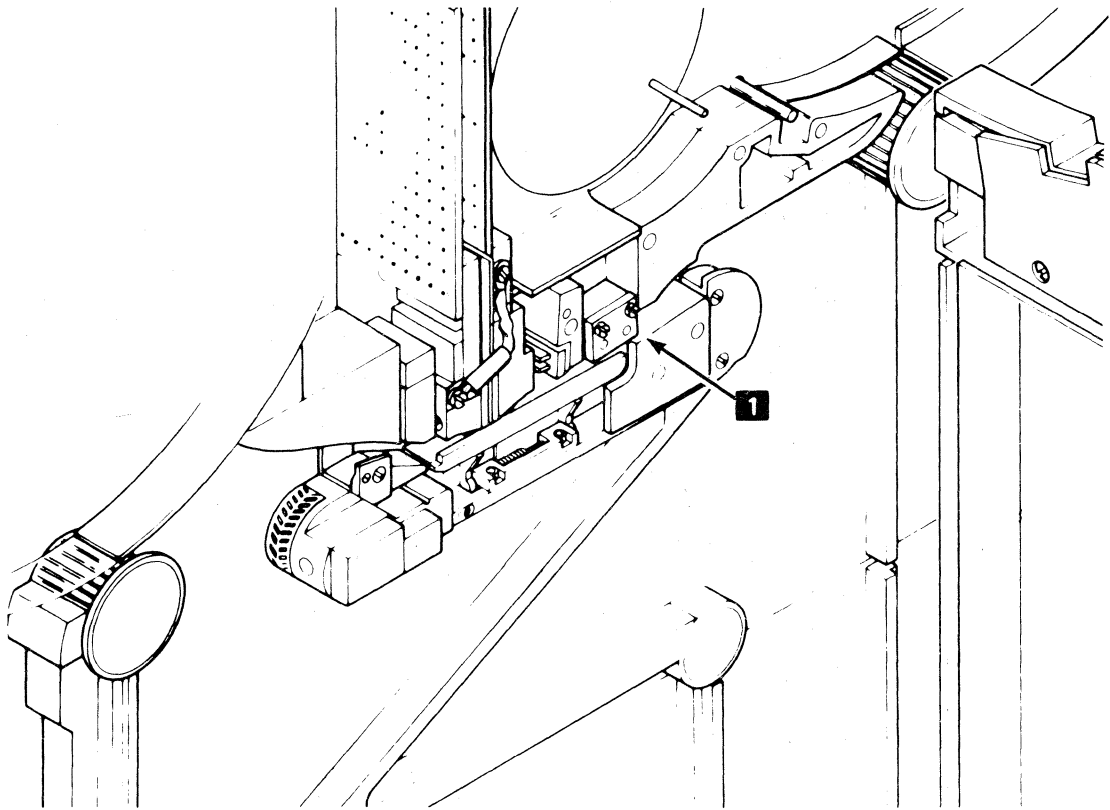
- 1 Turn off tape unit power. Clean the dust off the ends of the fiber optic bundle at the BOT/EOT block, the phototransistor lens, and the reflective mirror. Wipe with a lint-free cloth if necessary. (See 85-001.)
- 2 Clean the fiber optic lamp. Use a cloth lightly moistened with water. (See 08-620, "Fiber Optics Lamp Cleaning Procedure.") Inspect the inside of the fiber optic lamp for any sign of discoloration. Replace if necessary (see 08-620).
- 3 Turn on the tape unit power and allow the lamp to warm up for 20 to 30 minutes before continuing. Load a customer good-quality representative tape to ensure an average light reflectivity of the tape backing.

- 8 Adjust the EOT pot on the upper portion of card T-A1D2 for 4.7 +0.1, -0 volts.

- 9 Remove the tape from the BOT/EOT area so that the light falls on the reflective mirror.
- 10 Measure the BOT and EOT voltages again. The voltages should be 1.5 volts or less. Ensure that there is dc common to the BOT/EOT phototransistors by measuring 0 ohms between the center pin on the EOT/BOT block and any D08 pin on the logic panel. It may be necessary to remove the EOT/BOT block (see 08-590). If not, replace the BOT/EOT assembly (see ALD ZT031).
- 11 Perform the Capstan Tachometer Check/Adjustment procedure on 08-120 or 08-130.

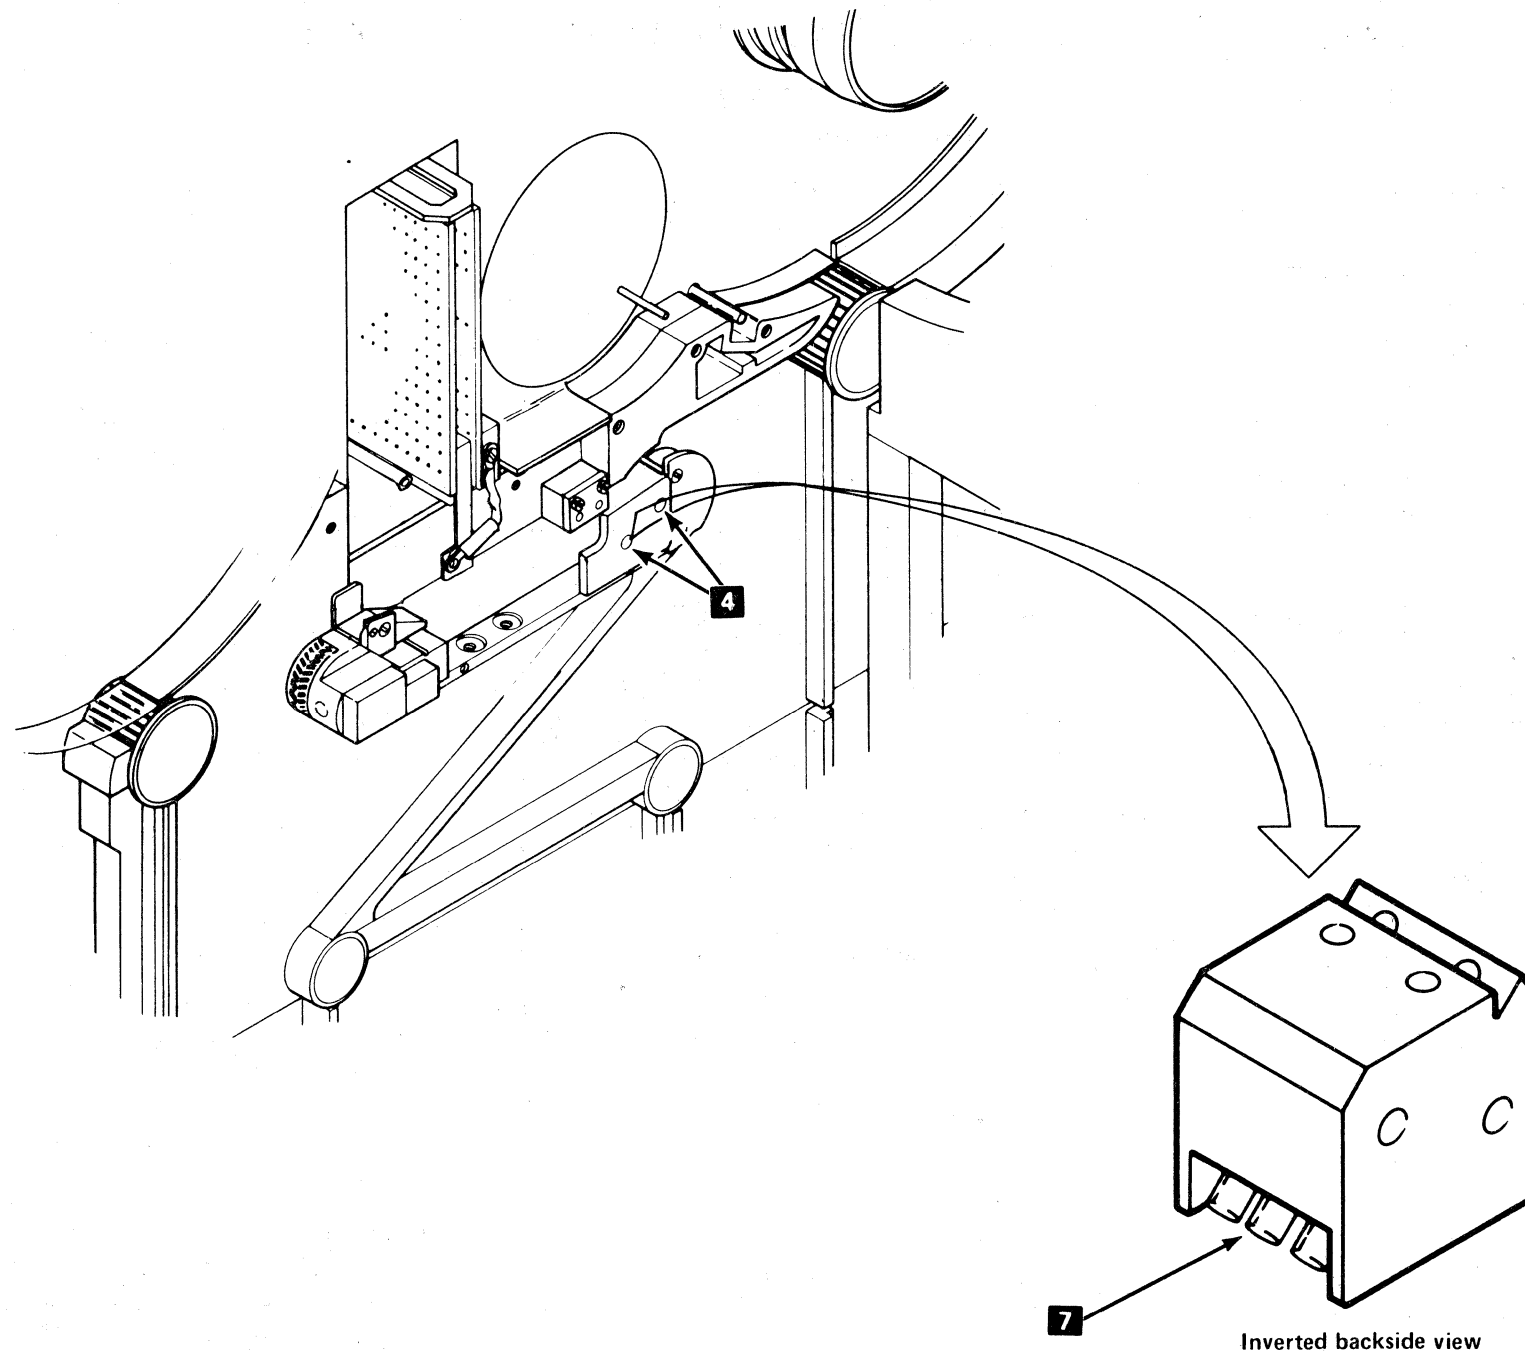
## BOT/EOT BLOCK REMOVAL/REPLACEMENT

1. If the old fiber optic bundles are being used, blow dust off both ends (wipe with lint-free cloth if necessary) and install the clips which hold them to the BOT/EOT assembly.
2. Solder the wires to the assembly. Ensure that they are positioned as before.
3. Push the fiber optic bundles carefully back into the tape unit.
4. Attach the assembly with the two mounting screws.
5. Route the fiber optic bundles back to the manifold. Be careful to route them away from the autocleaner on Models 4, 6, and 8.
6. Insert the bundles into the light manifold and replace the retaining wedge.
7. Adjust the BOT/EOT voltages. See 08-580.

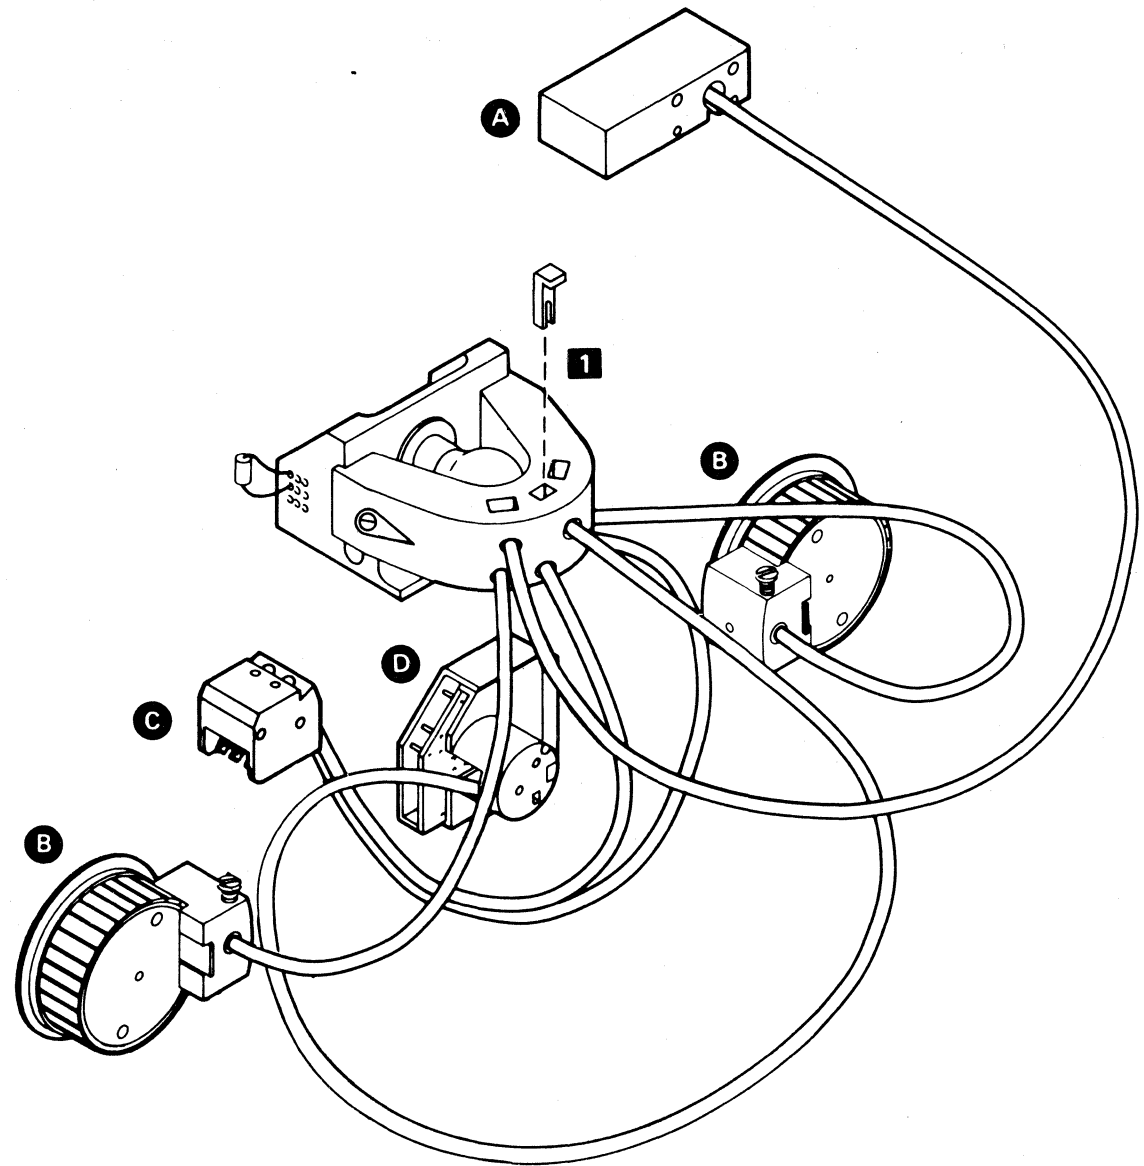
FIBER OPTIC BUNDLE  
REMOVAL/REPLACEMENT

- 1. Pry the retaining wedge from the light manifold.
- 2. Pull the defective bundle out of the manifold.
- 3. Disconnect the other ends of the bundle by removing or loosening each retainer.
  - A The radius sense assembly uses the same type of wedge as the manifold.
  - B The reel tachometers use a nylon setscrew.
  - C The BOT/EOT assemblies use metal clips that are held in place by screws.
  - D The capstan tachometer uses a plastic taper pin on earlier parts. On later models the fiber optic bundle is not removable.
- 4. Reverse the procedure to install a new bundle.

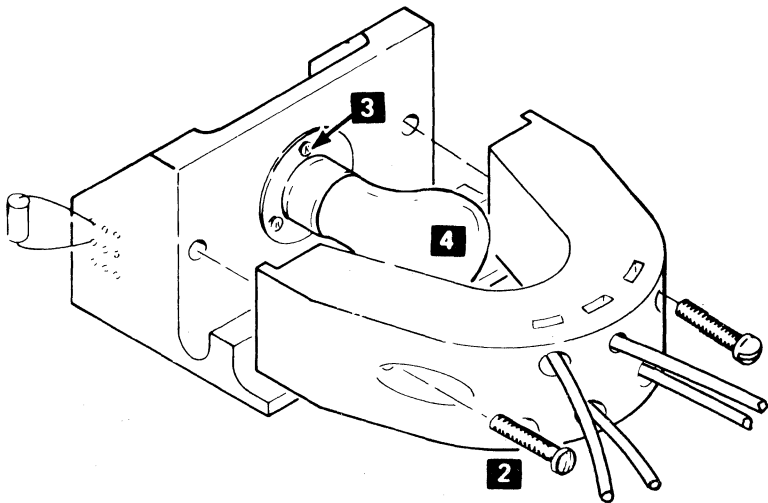
FIBER OPTICS LAMP  
REMOVAL/REPLACEMENT

**Note:** Power on the unit and allow at least 20 to 30 minutes warm-up time before doing step 7.

7. Perform the Capstan Tachometer Check/Adjustment procedure on 08-120 or 08-130 and the BOT/EOT Voltage and Adjustments procedure on 08-580.

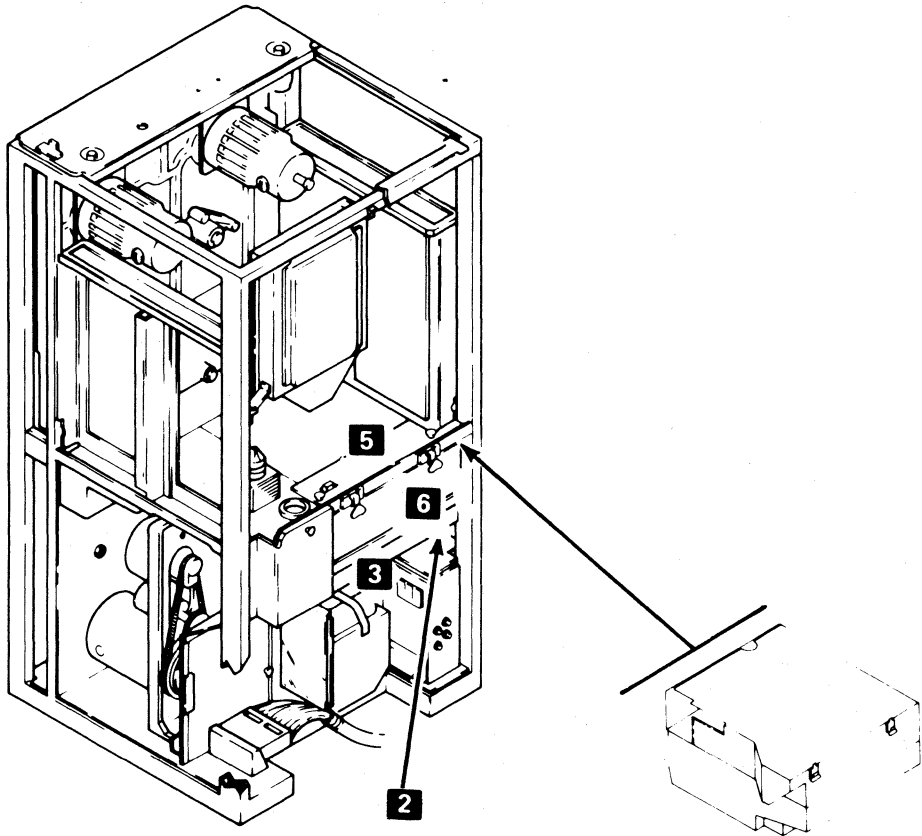
**COOLING FAN ASSEMBLY  
REMOVAL/REPLACEMENT**

1. Turn off tape unit power.
2. Disconnect the blower motor plug from the power supply.
3. Remove the air filter.
4. From the extreme rear of the blower assembly, unplug the cable that leads to the resistor frame.
5. Unlatch the two fasteners that hold the resistor frame and move the entire resistor assembly out of the way.
6. Unlatch the two fasteners on the rear vertical surface of the blower assembly.
7. Reach under the blower assembly and pull on the motor housing with one hand, while guiding the assembly out with the other hand.
8. After partially inserting a new assembly into its holder, push up from beneath the motor and lift the front end.
9. Push the assembly completely into place. Ensure that the front mounting lip slides over the front-edge frame.
10. Reverse steps 2 through 6 to complete the installation.

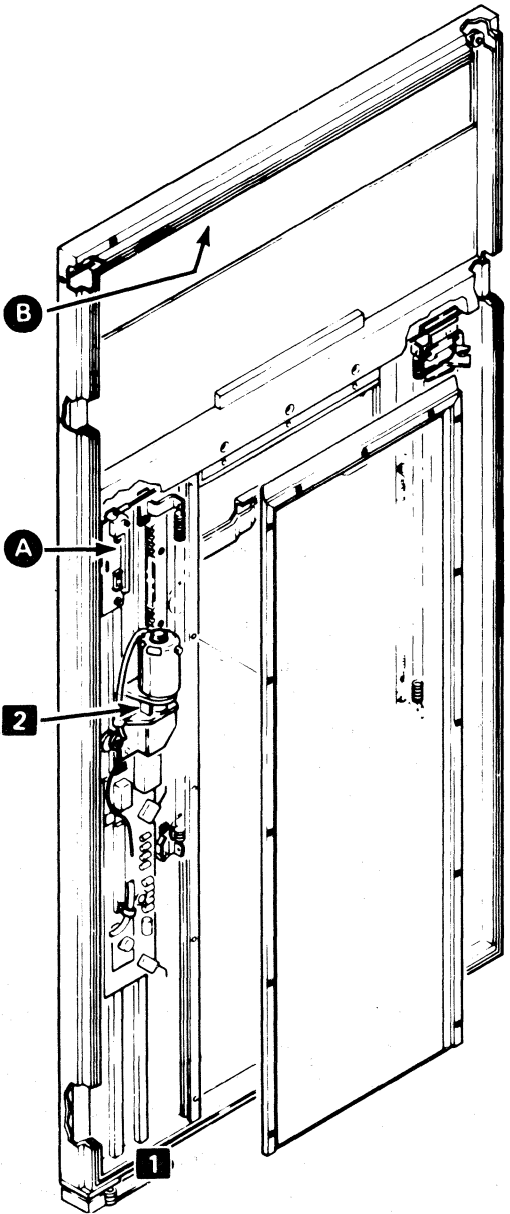
**Note:** If removed, replace the door glass panel. Ensure that the beveled bottom edge of the glass is aligned with the beveled lower door frame member.

Install the top and side retaining strips and tighten the screws.
4. Reinstall the inner cover.

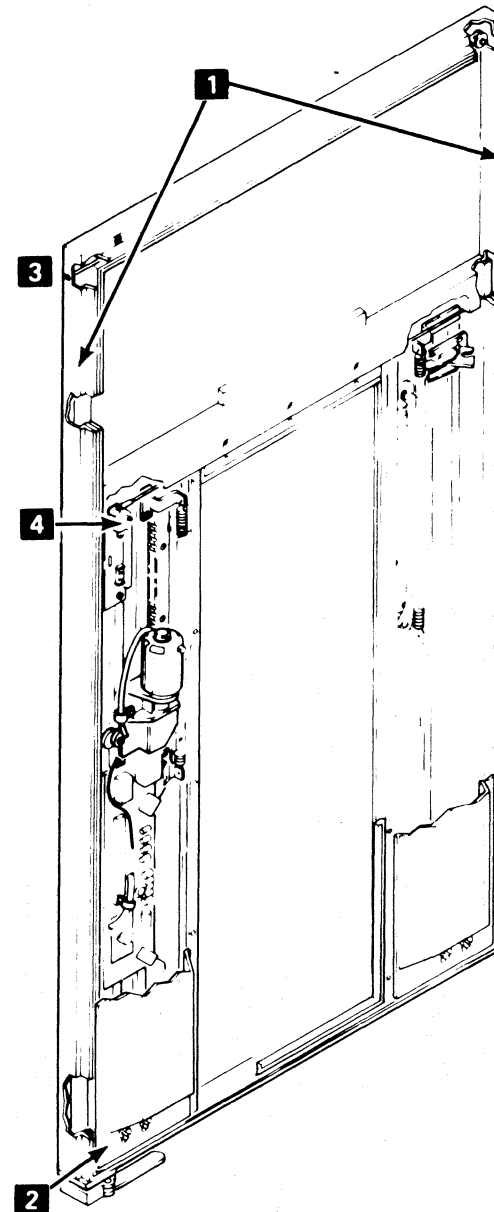
### POWER WINDOW SAFETY-BAIL CABLE REMOVAL/REPLACEMENT

- 1** Remove the left and right door trim by loosening the setscrews beneath the outer edge of the rubber door seal. Hold back the rubber seal to expose the setscrews.
- 2** Remove the access cover to expose the window motor and gear rack by removing the two screws at the bottom.

1. Position or remove the bail actuator mounting bracket to provide cable slack.
2. Pull outward on the extruded rubber safety bail to expose the cable on the outside edge of the door.
- 3** Push the cable through the safety bail until enough cable is exposed on the other end to install the terminator.
- 4** Install the terminator and mount the actuator bracket.
5. Perform the Power Window Safety Bail Adjustment procedure on 08-640.
6. Replace the covers and trim.

1. Remove the left door access cover.
2. Disconnect the terminators and remove the broken cable.
3. Thread the new cable. Be careful not to fray the end.
4. Connect the terminators.
5. Perform the Power Window Safety Bail Adjustment procedure on 08-640.
6. Replace the covers and trim.

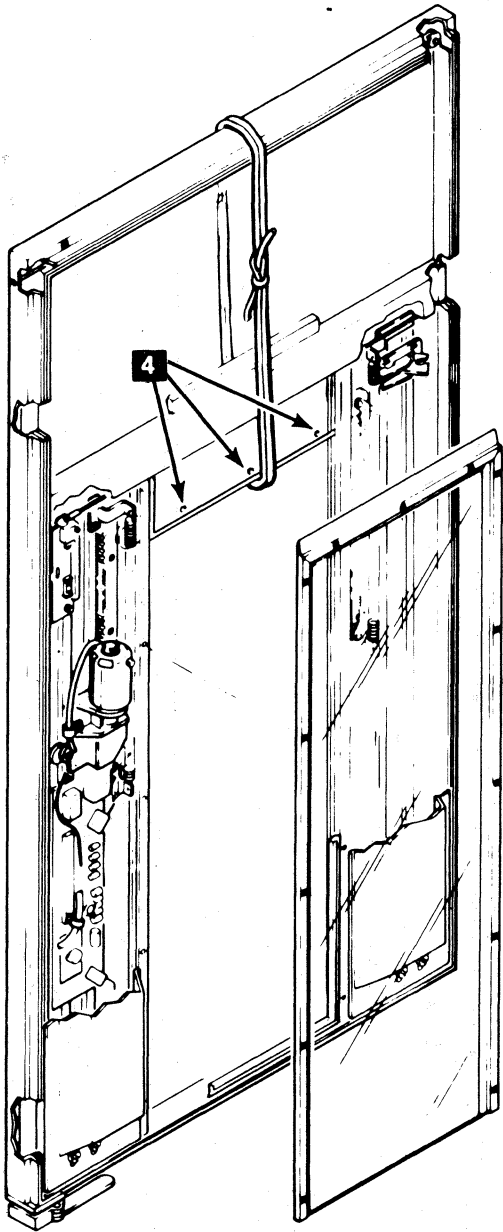
POWER WINDOW GLASS REMOVAL/  
REPLACEMENT

- 4** Support the glass with a rope or belt as shown. Remove three screws and two hex-head nuts from the window support.
- 5. Lower the window to where you earlier removed the felt strip and lift the glass out.
- 6. Replace the glass and reverse steps 1 through 5.

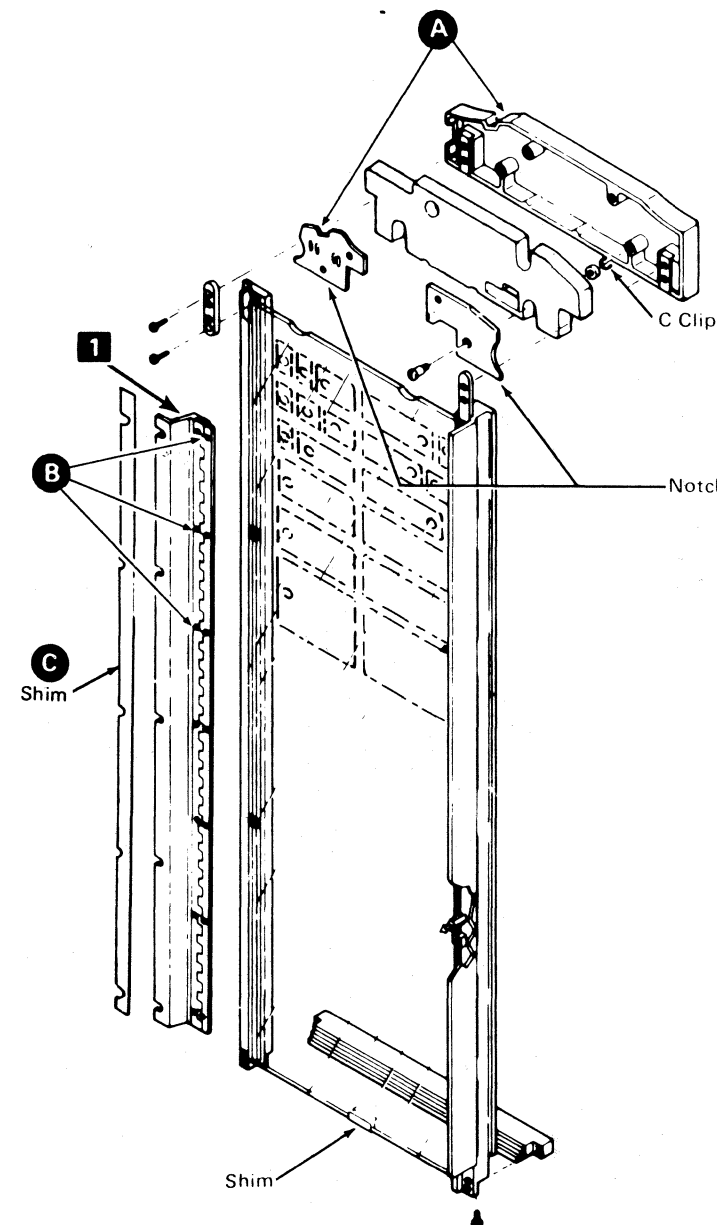
Non-molded Glass Door

### VACUUM COLUMN DOOR REPLACEMENT AND ADJUSTMENT

- 4 Adjust the door up or down so that the top of the notch float plate and the right threading channel are flush within  $\pm 0.01$  inch (0.25 mm). Open the vacuum column door and loosen the seven hinge mounting screws **B** on the Z bracket, and slide the door up or down within the slots.

- 5 With the five screws in the Z bracket loose and with the door latches loose, move the entire door in or out to obtain a tight glass-to-column fit under vacuum-up conditions.

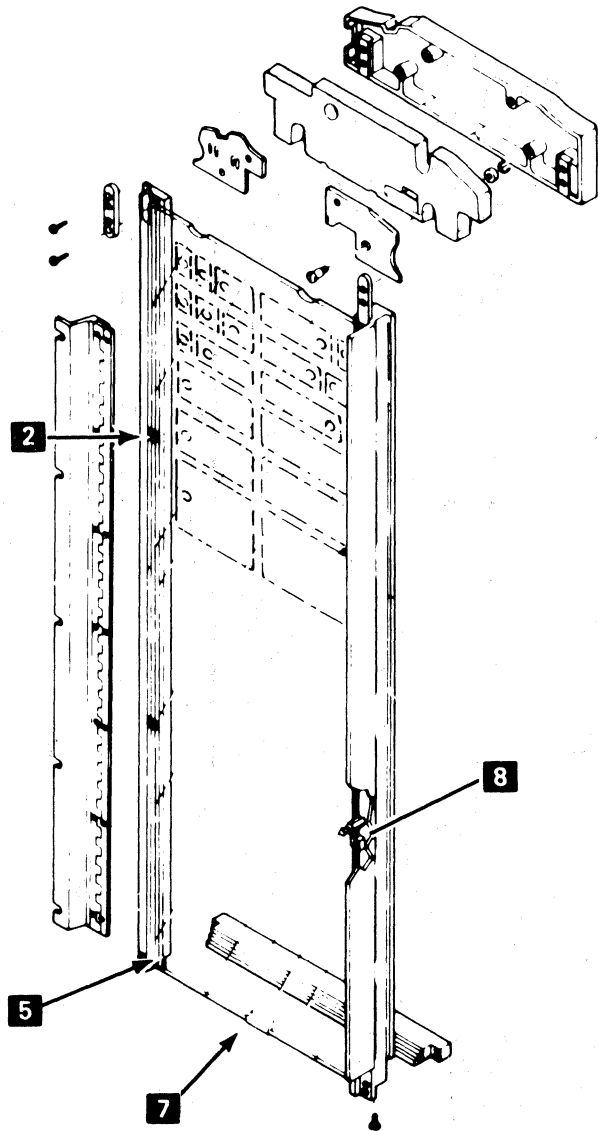
Non-molded Glass Door

VACUUM COLUMN DOOR GLASS  
REMOVAL/REPLACEMENT

1. Open the door.
- 2 Loosen the screws and remove the clamps on the hinge side only. This will maintain the adjustment.
3. Slide the glass horizontally toward the hinge side until it clears the nonhinge side clamps.

**Note:** Install the shim package in the center or the glass will bind and not seal correctly.
- 8 Ensure that the glass is firmly held by the nonhinge side clamps and reinstall the clamps on the hinge side. There should be 0.001 to 0.013 inch (0.025 to 0.33 mm) gap.

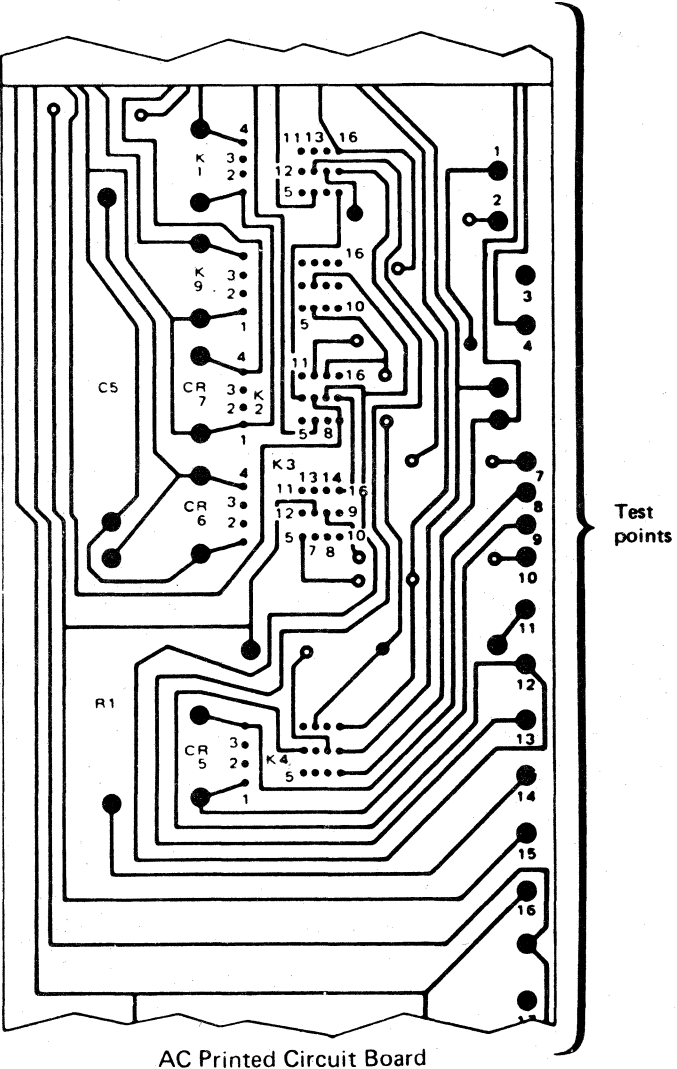
AC Printed Circuit Board

14	The test points referred to in the following instructions are on the back of the ac printed circuit board. (See drawing.) Remove the cover below the four toggle switches. Measure from the test point specified to test point 16.	
15	Is -24 Vdc present at test point 13?	Repair or replace K7 (YF030).
16	Is -24 Vdc missing at K1-10?	Go to Seq 11.
17	Is -24 Vdc present at K1-4?	Repair or replace K1 (YF030) and go to 00-030.

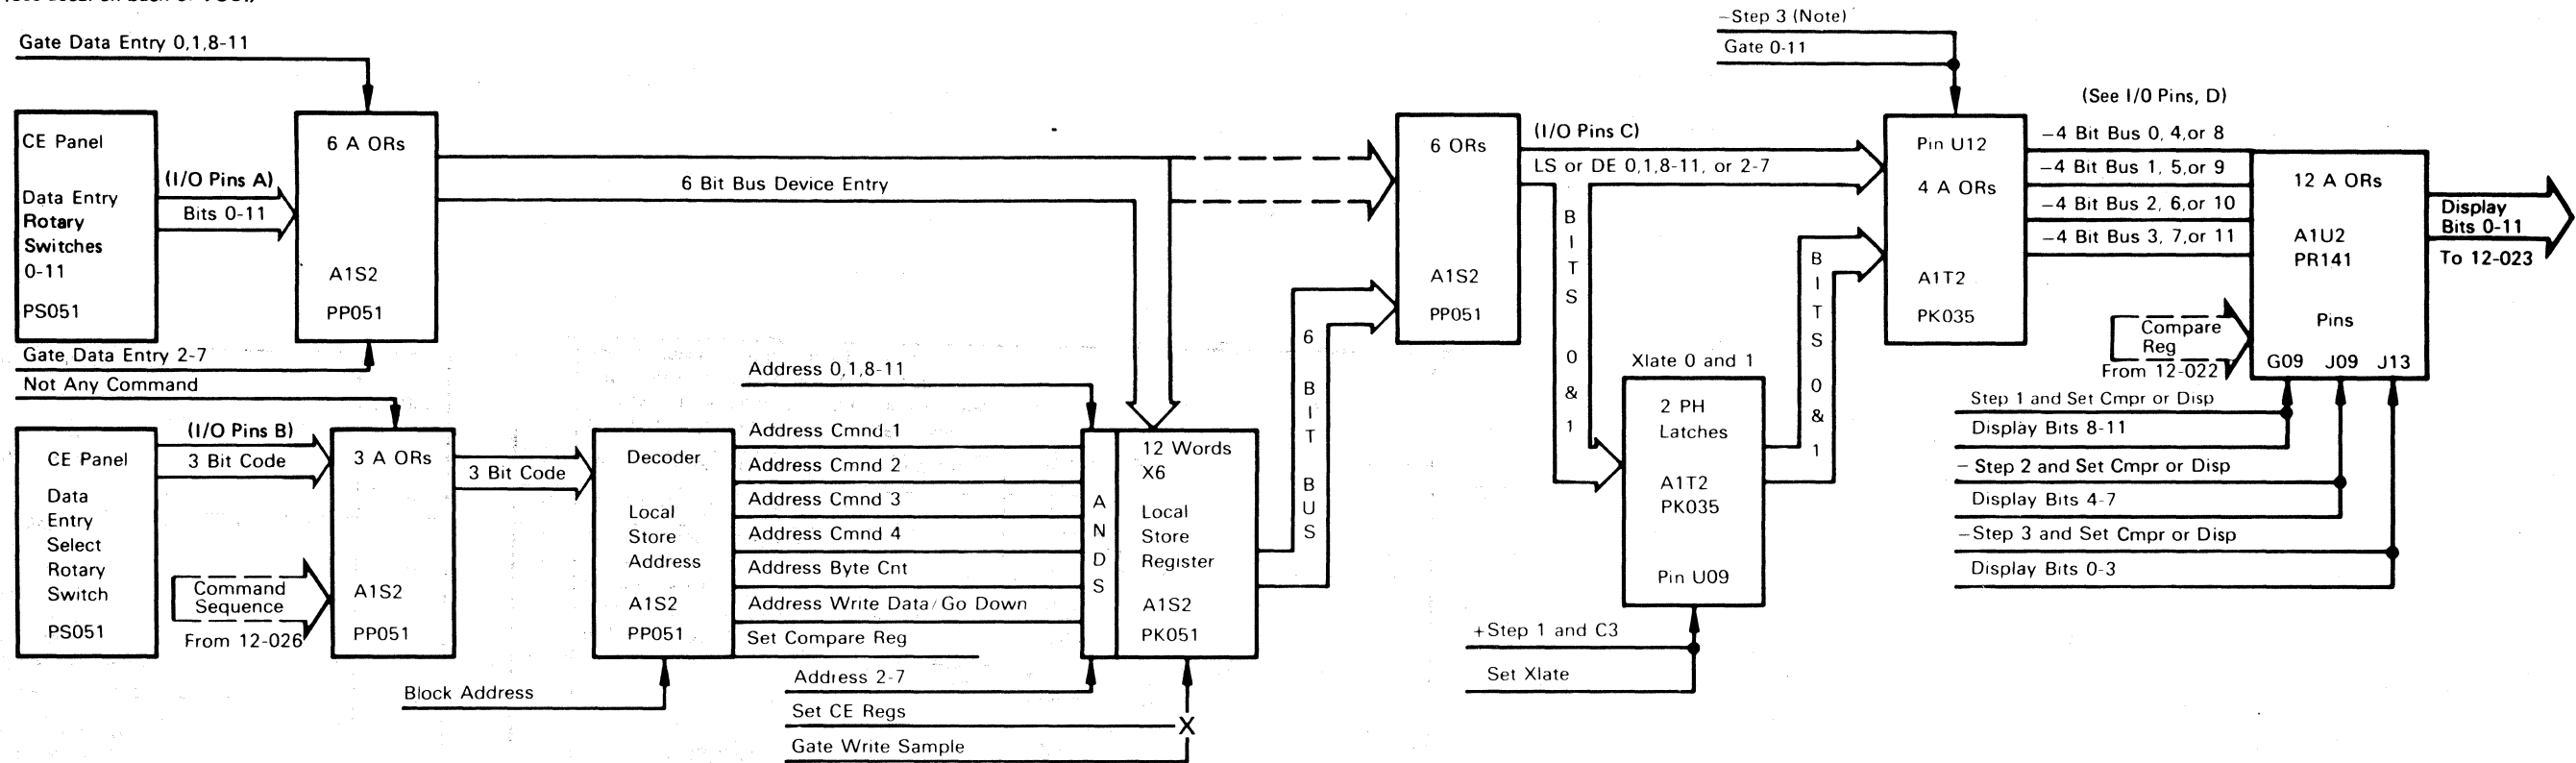
Timing Chart

Note:  
During -Step 3, Bits 2,3 and Xlate Bits 0 and 1 are gated.  
During Not Step 3, Bits 4-7 are gated.

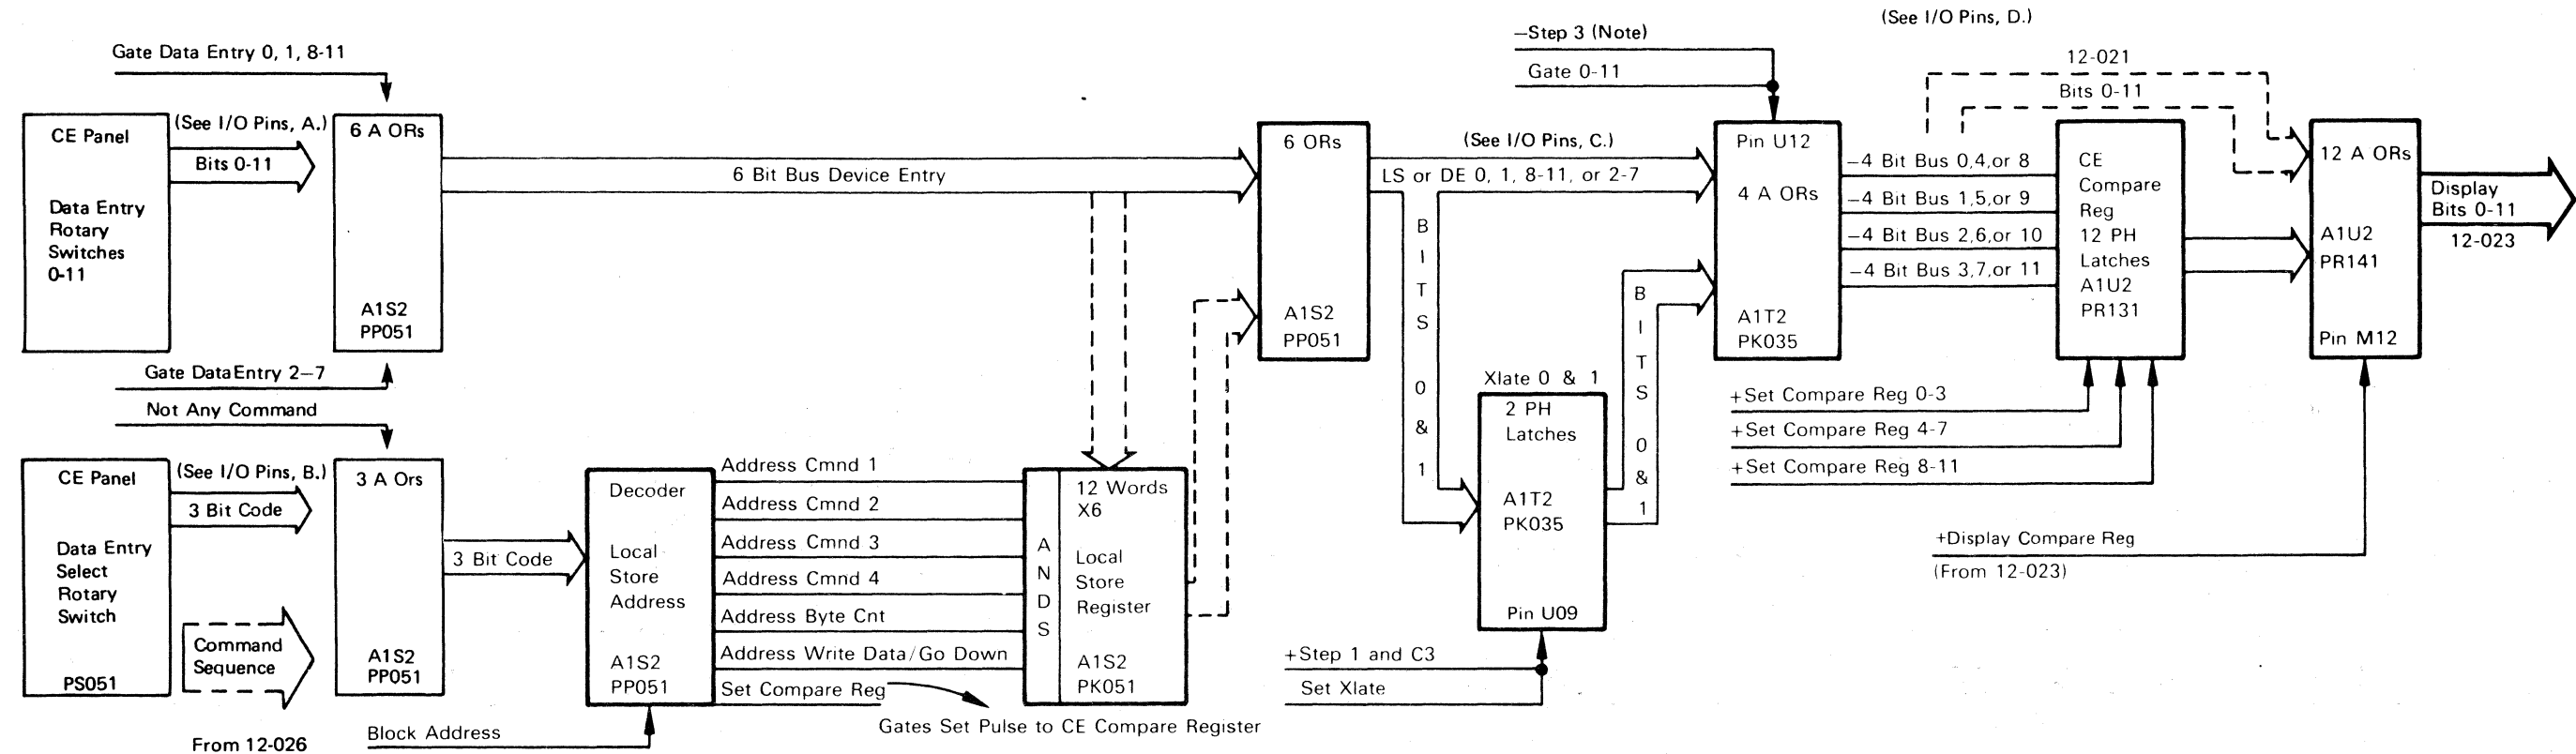
Timing Chart

Note:  
During —Step 3, Bits 2,3 and Xlate Bits 0 and 1 are gated.  
During Not Step 3, Bits 4-7 are gated.
