3803-2 / 3420

Magnetic Tape Subsystem  
Maintenance Manual

CAPSTAN AND TRACKING CHECKS/  
ADJUSTMENTS/REMOVALS/  
REPLACEMENTS

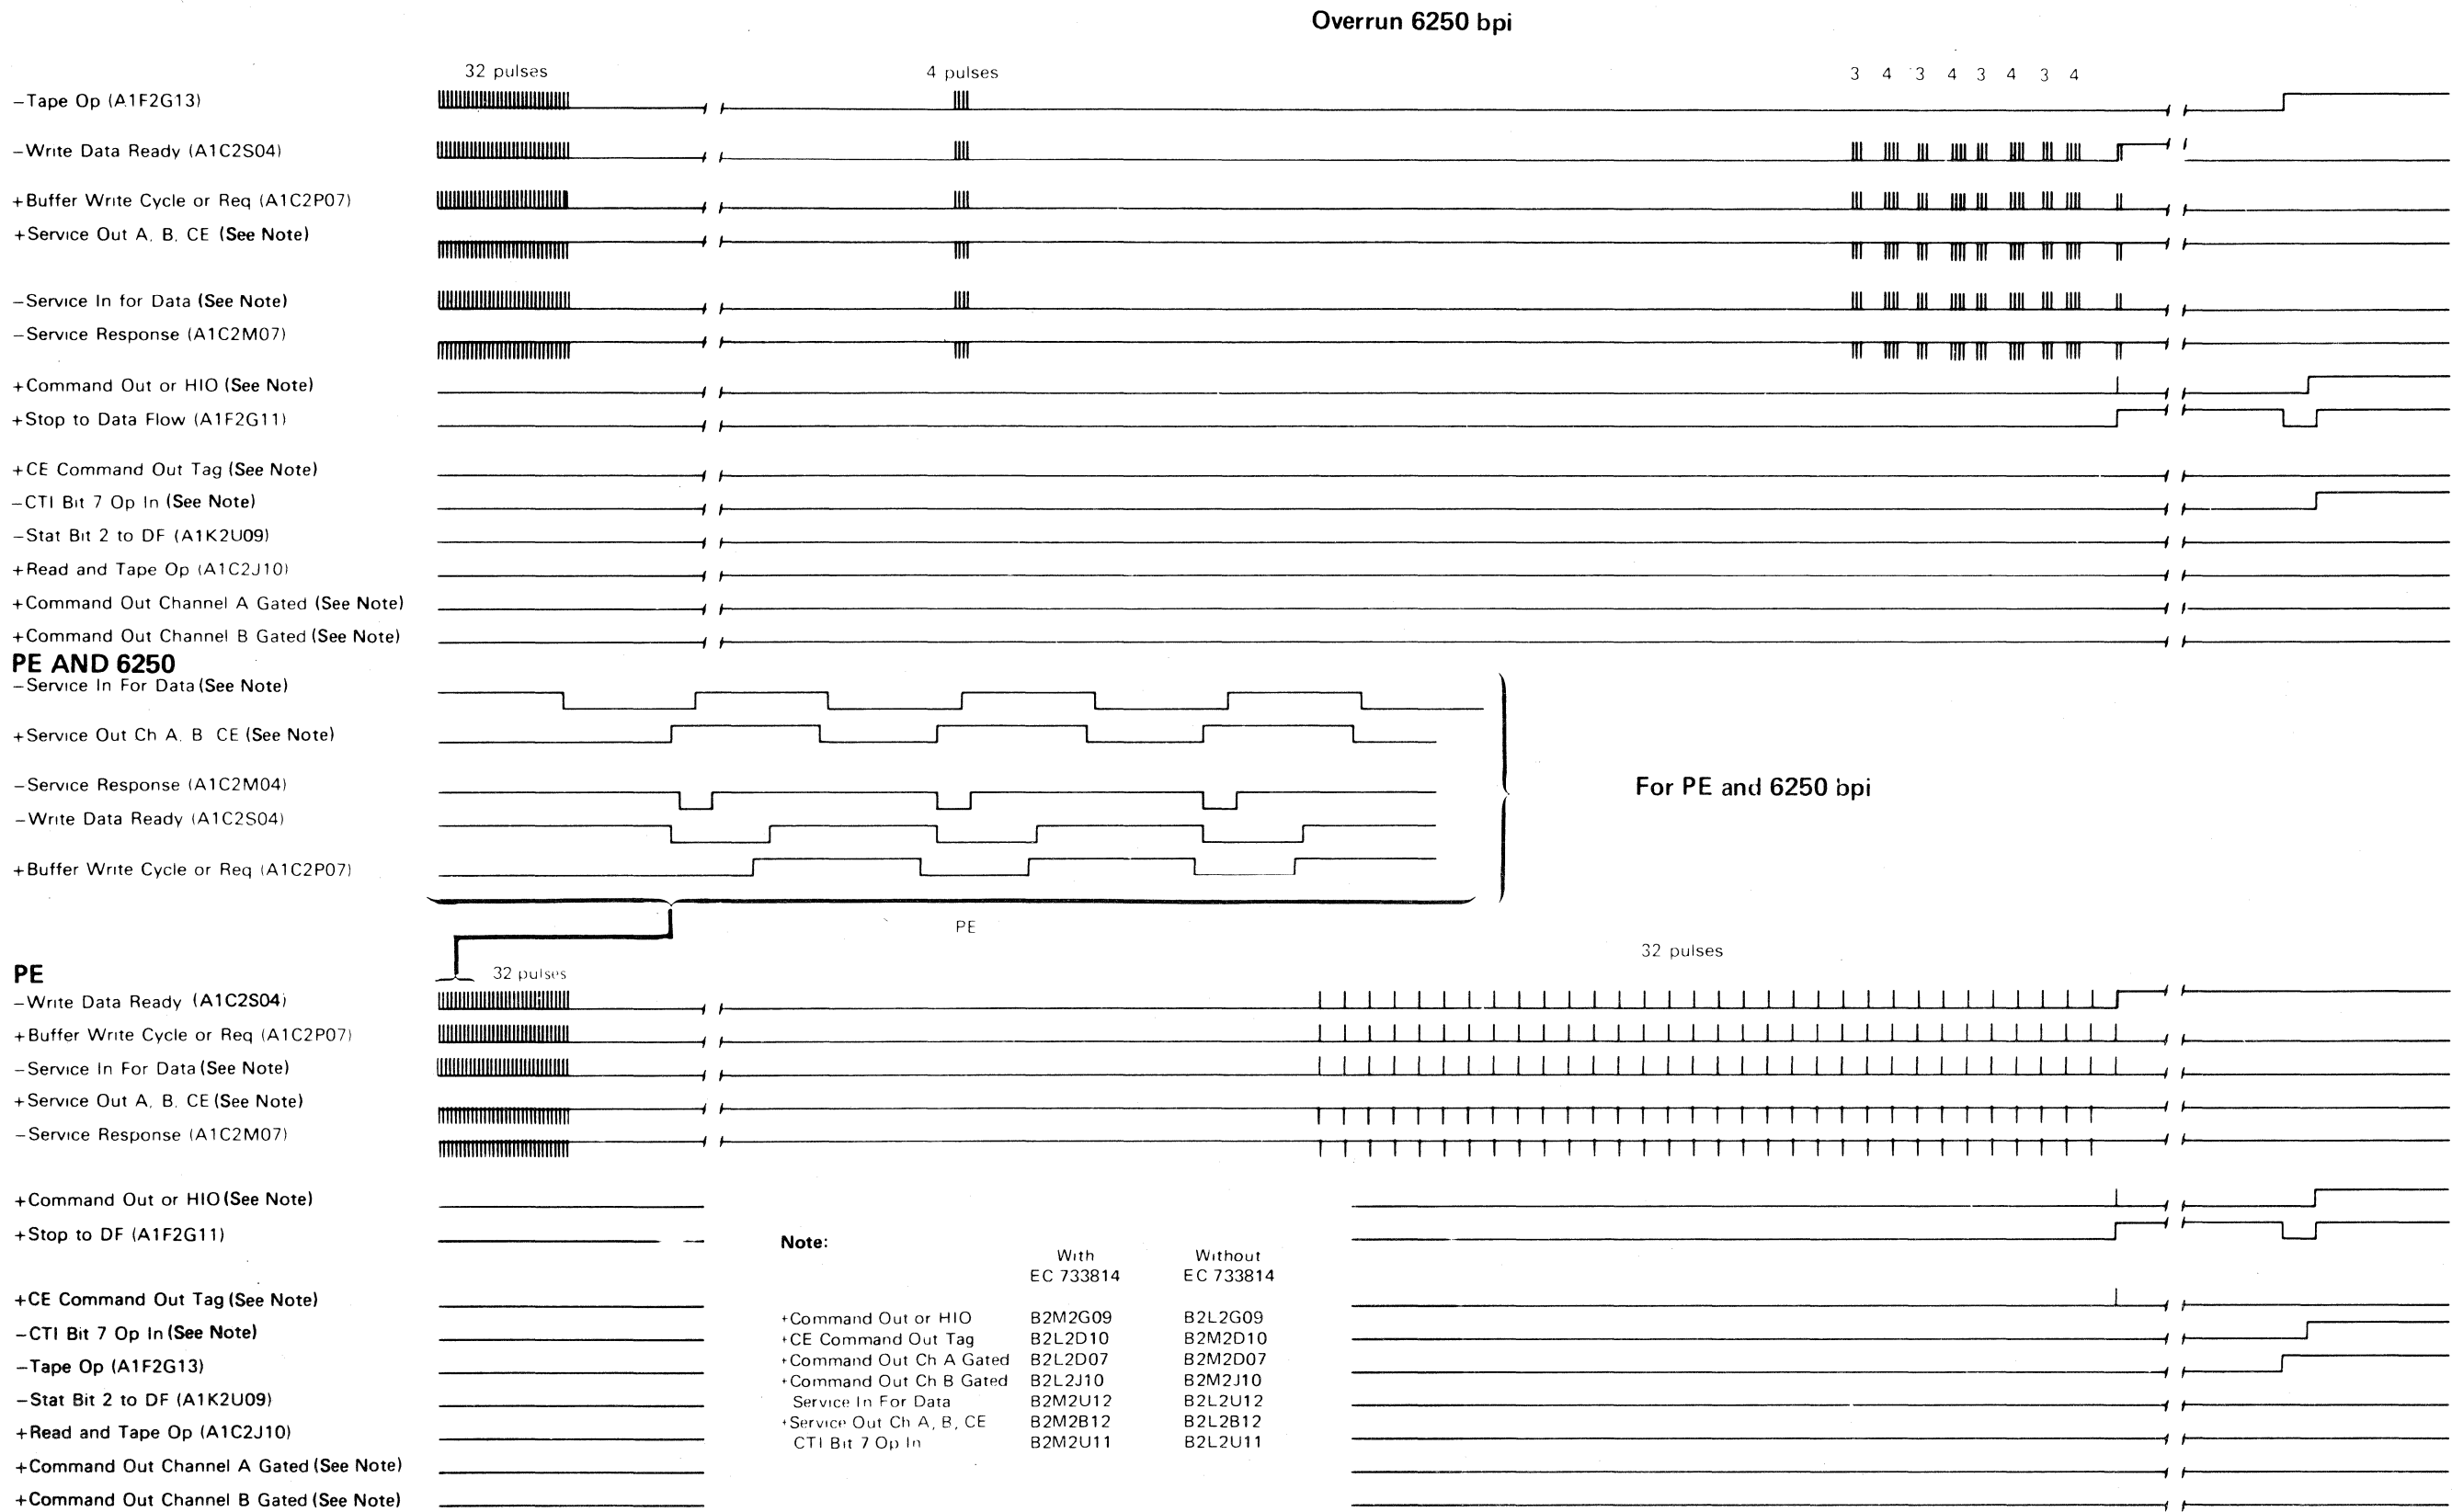
TIMING CHART FOR OVERRUN

Overrun can occur with three possible conditions.

- 1. Channel buffer full on a Read operation. Data is not removed from the channel buffer fast enough.
- 2. Write buffer is empty. There are six or fewer bytes left in the channel buffer. Data is removed from the channel buffer too fast.
- 3. On a Read operation, if there is a P Compare or a CRC Error.
