IBM 3420/3803

Magnetic Tape Subsystem

Reference Guide

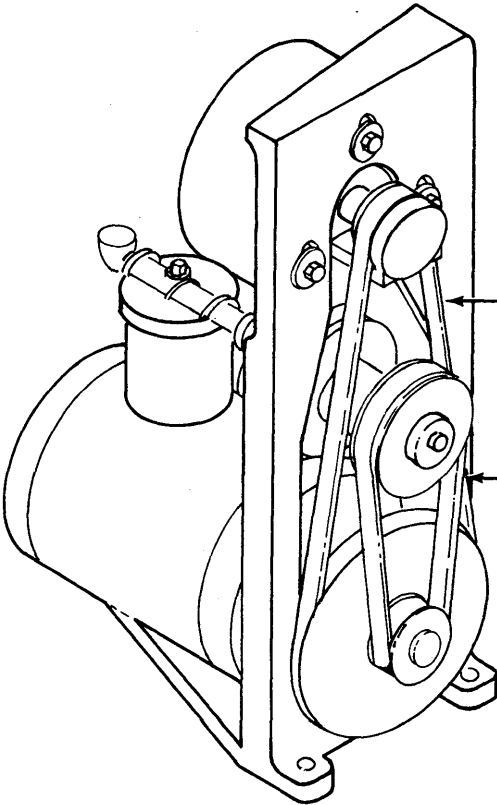
**Note:** When installing belts, use procedure as described in maintenance documentation.
