Problem Determination Guide

IBM 3745 Communication Controller
Models 130, 150, 170, 210, 310, 410, and 610

SA33-0096-5

IBM 3746 Expansion Unit
Models A11, A12, L13, L14, and L15

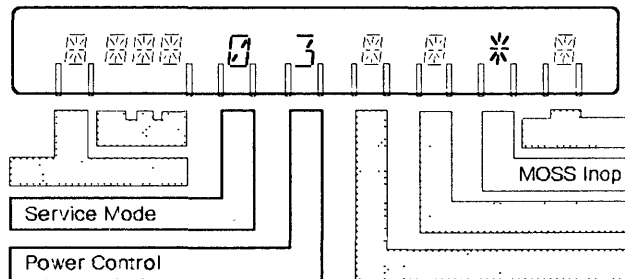
This drawing represents the control panel display. The control panel is fully illustrated and explained in the *3745 Basic Operations Guide* and on the *3745 Control Panel Reference Card*. (See Appendix A, "Control Panel.")

The highlighted name (for example: Service Mode) identifies the display position or the indicator to look at.

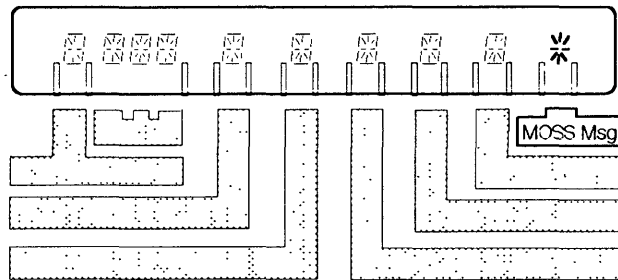
When an alarm is generated, the MOSS Msg indicator is lit on the control panel.

- If the console operator is logged on, the alarm is displayed and an audible signal is emitted.
- If the console operator is not logged on, log it on (refer to the 3745 *Advanced Operations Guide*).

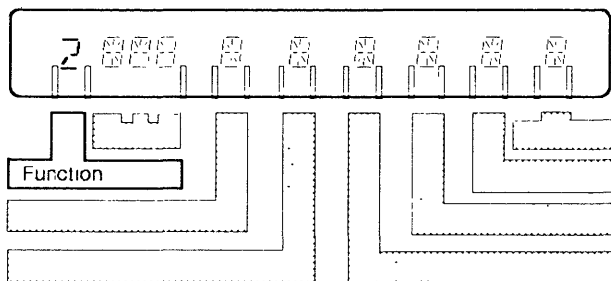
- Dump MOSS from the control panel. Press **Function** repeatedly until **2** is displayed; then press **Validate**:

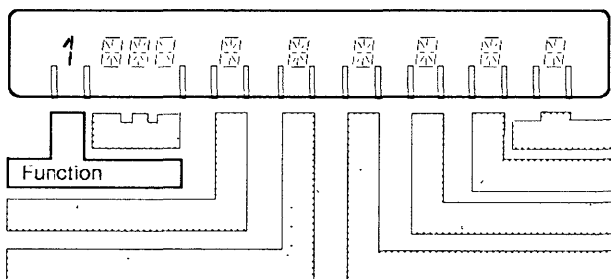
- Re-IML MOSS from the control panel. Press **Function** repeatedly until **1** is displayed; then press **Validate**:

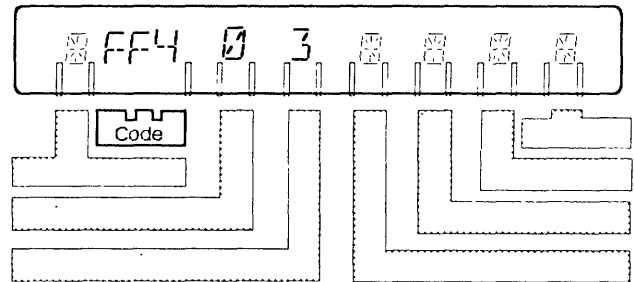
- The progression of a function (for example, IPL).
- The status of the components.
- An error. In this case, the code blinks.

Code	Explanation and Action
0 0 0	3745 IPL has been successfully completed. The control program is loaded and MOSS is online.
0 0 1 or 0 0 2

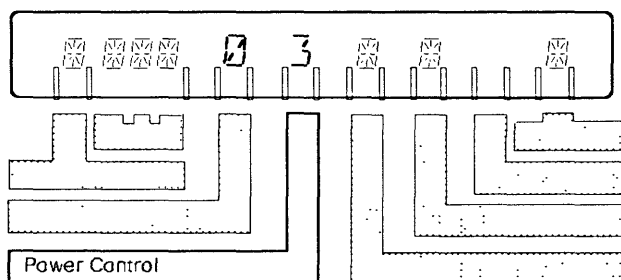
Power control on the control panel display is: **1, 2, or 3**

- If **1** Go to page 4-2
- If **2** Go to page 4-3
- If **3**
 - Power off
 - Wait 10 seconds
 - Select the function 1 (MOSS IML)
 - Power on
 - If the problem persists:

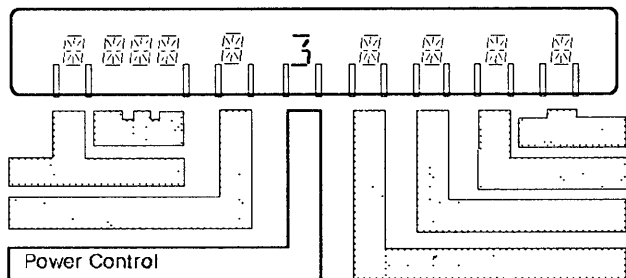
Power Control Display = 3

Make sure that you pressed **Power Off** correctly.

- If you have to power off the 3745 just after a power on, wait 10 seconds before pressing Power Off.

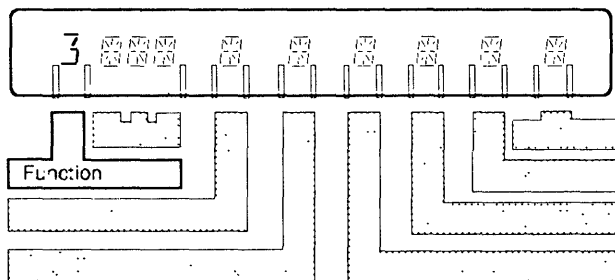
- 1** Press **Function** repeatedly until 3 is displayed, then press **Validate**.
This informs the remote or RSF operator that you want to log on.

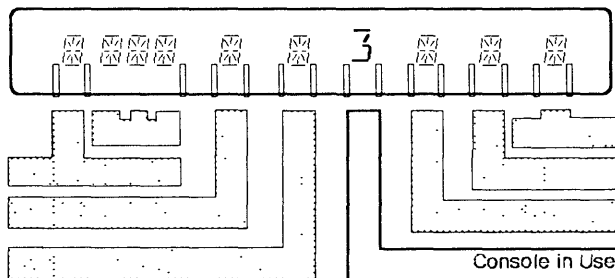
- 2** When **Console in Use** displays 3, the remote or RSF console is disconnected. You may log on at the local console.
If **3** does not appear, go to next step.

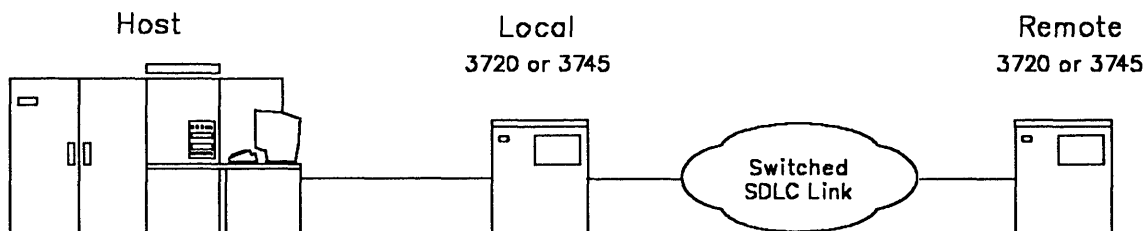
Figure 8-1. Initial Loading on Switched/Nonswitched SDLC and Nonswitched X.21 Links

- The remote initial loading can be performed by using VTAM* commands from the host.
- A link IPL port (LKP) must be defined in the remote controller.

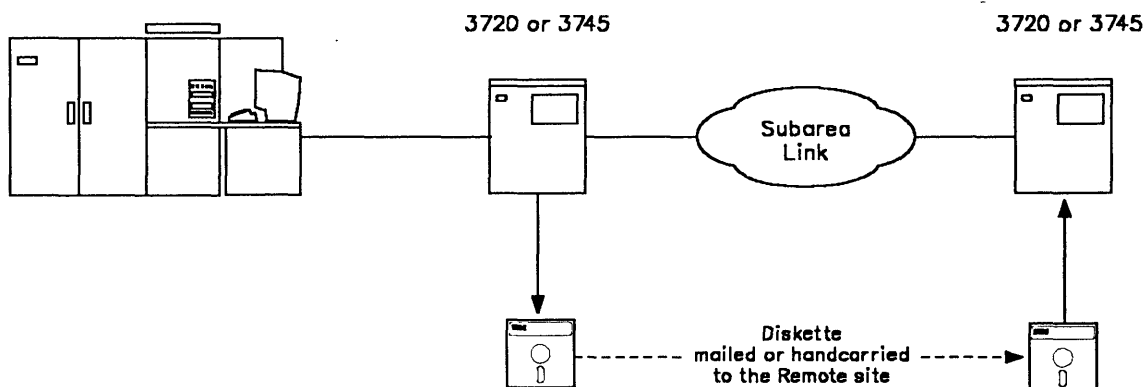
Figure 8-2. Initial Loading on Switched X.21, X.25 (SVC/PVC), and Token-Ring Links

- The remote initial loading can be performed only by using the diskette management procedure. Refer to the *3720/3745 Remote Loading/Activation Guide* or to the MOSS DII function described in the *3745 Advanced Operations Guide*.
- Those links do not require a link IPL port (LKP) definition in the remote controller.

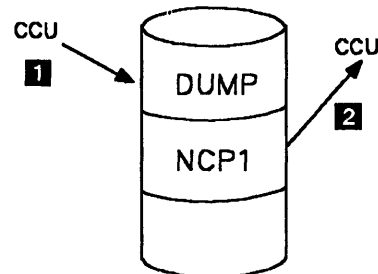
If the NCP1 fails or a hardcheck occurs:

- **1** The controller dumps NCP1 (which failed) onto the hard disk.
- **2** The controller reloads NCP1 from the hard disk, and you do not have to reload NCP using a diskette or an SDLC link.

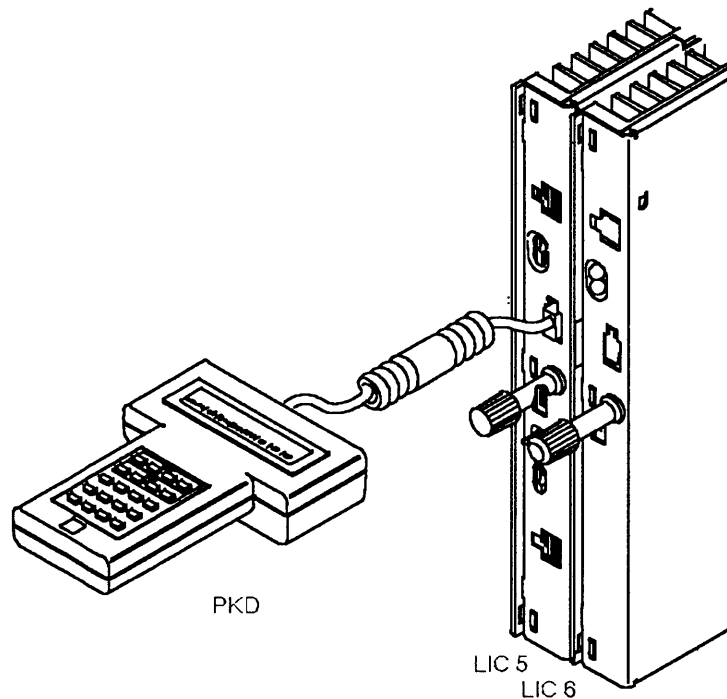
Figure 9-4. IBM 5869 Portable Keypad Display (PKD) plugged to a LIC5 or a LIC6.

8 Locate the LIC to be tested and plug in the IBM 5869 Portable Keypad Display (PKD) as described in the *3745 Connection and Integration Guide*.

- To check the lights, plug the PKD in (refer to Figure 9-4 on page 9-48 for connection); press the **Go** or **Stop** key; then the green and yellow lights should be on.

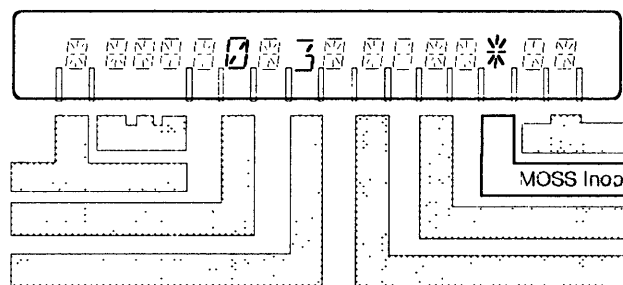
1 Note the hex code on the control panel, if:

- **000** or **blank**, go to the next step.
- Not **000** or **blank**, perform action required for that code. (See Chapter 3, "Hexadecimal Codes on the Control Panel.")

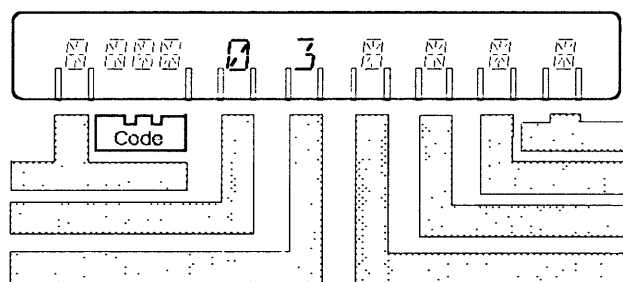
2 Try to take a MOSS dump from the control panel:
Refer to the *3745 Basic Operations Guide*.

- Press **Function** repeatedly until **2** is displayed.
- Press **Validate**.
- When the hex code is **F01** (MOSS dump complete), go to step 3.
- If the hex code is not **F01** after 2 minutes, go to Chapter 3, "Hexadecimal Codes on the Control Panel" and follow directions for the appropriate code.

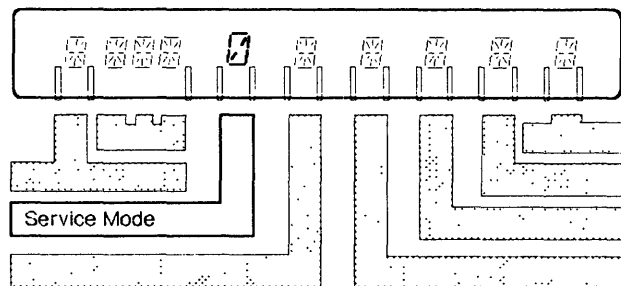
4 Press **Function** repeatedly until **5** blinks.

- If **5** does not blink or is incorrectly displayed, press

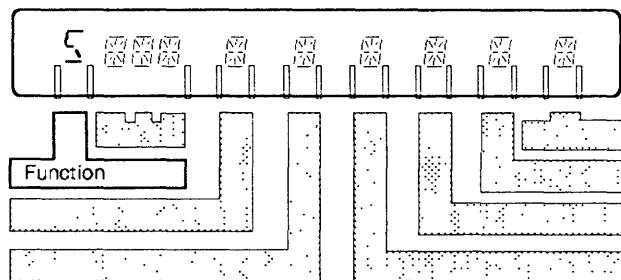
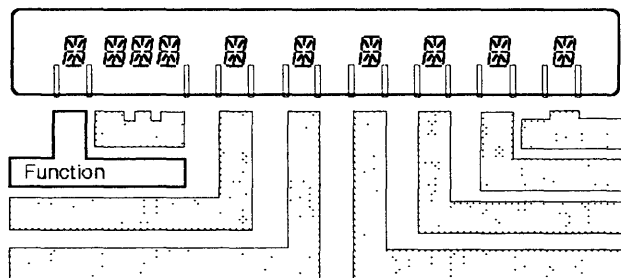
All segments of all the displays and indicators of the control panel should be lit, as illustrated.

5 Press **Function** once.

- If all segments of the Function display are lit, go to next step.
- If at least one segment is not lit, press **Exit** and

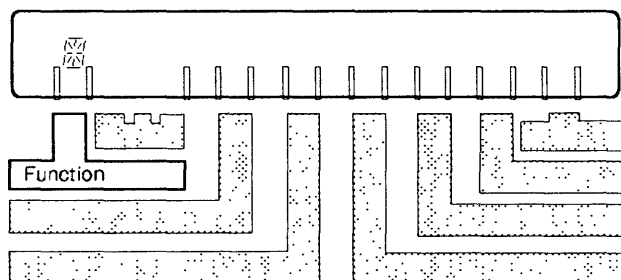
- 6** Press **Function** a second time. The three digits of the Code display are tested one after each other. Press **Function** again to test the next digits.

- If all segments of the Code display are lit, go to next step.
- If at least one segment is not lit, press **Exit** and

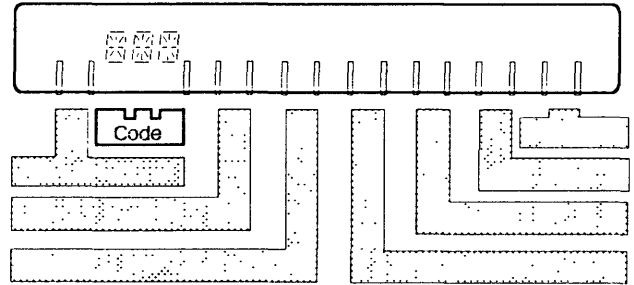
- 7** Press **Service Mode** once.

- If all segments of the Service display are lit, go to next step.
- If at least one segment is not lit, press **Exit** and

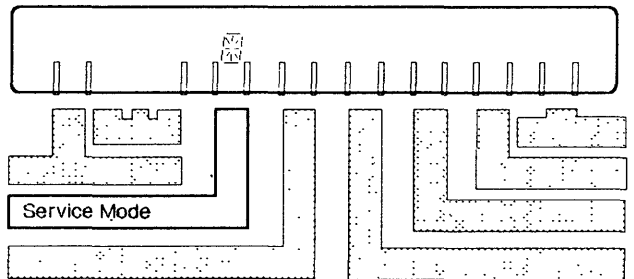
- 8** Press **Service Mode** a second time.

- If all segments of the Power Control display are lit, go to next step.
 - If at least one segment is not lit, press **Exit** and

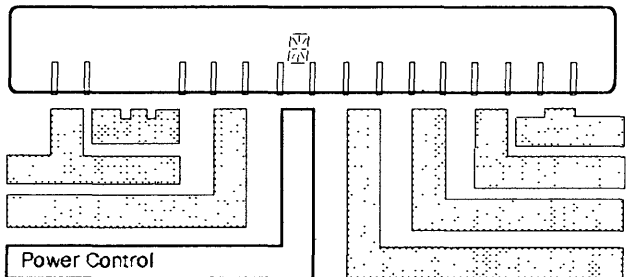
9 Press **Power Control** once.

- If all segments of the Console display are lit, go to next step.
- If at least one segment is not lit, press **Exit** and

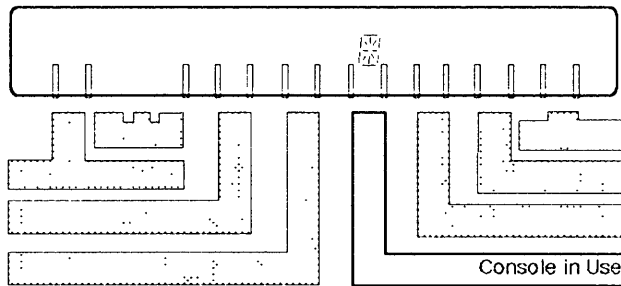
10 Press **Power Control** a second time.

- If all segments of the All CAs Disabled display are lit, go to next step.
- If at least one segment is not lit, press **Exit** and

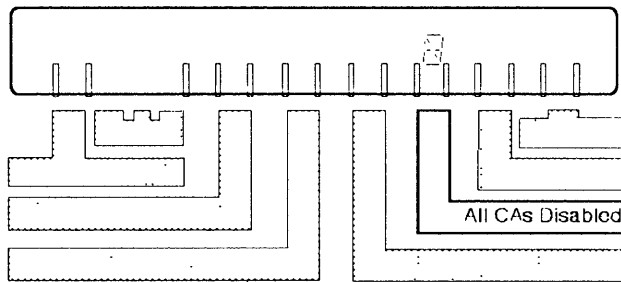
11 Press **Power Control** a third time.

- If all segments of the MOSS Inop display are lit, go to next step.
- If at least one segment is not lit, press **Exit** and

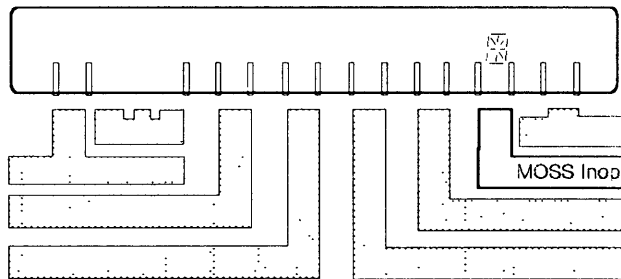
12 Press **Power Control** a fourth time.

- If all segments of the MOSS Msg display are lit, go to next step.
 - If at least one segment is not lit, press **Exit** and

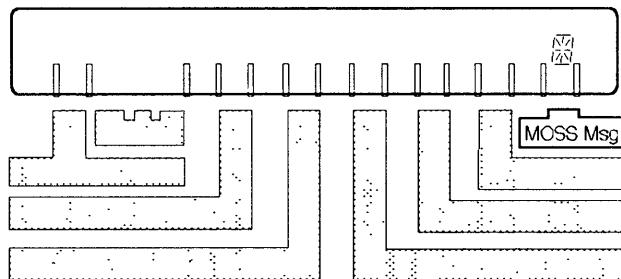
13 Press **Power On Reset** once.

- If **8** does not blink in the Function display go to next step.
- If **8** blinks in the Function display, press **Exit** and

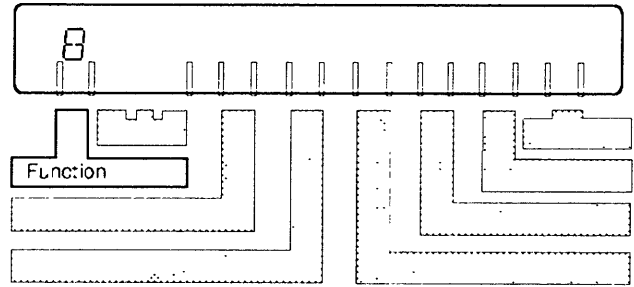
**14** Press **Power Off** Once.

- If control panel displays and indicators are completely blank, go to next step.
- If control panel displays and indicators are not completely blank, press **Exit** and

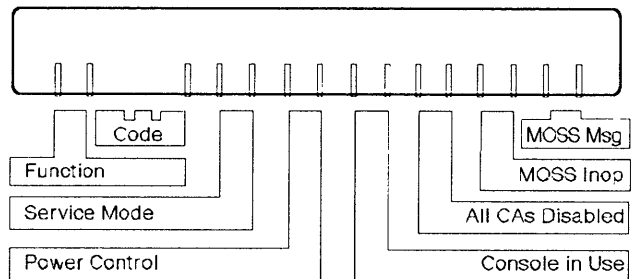
**15** Press **Exit** once.

- If **Power Control** and **Service Mode** displays are set as before the test: The test is successfully completed, and no errors have been detected. The control panel returns to normal operational mode.
- If **Power Control** and **Service Mode** displays are not set as before the test, press **Exit** and

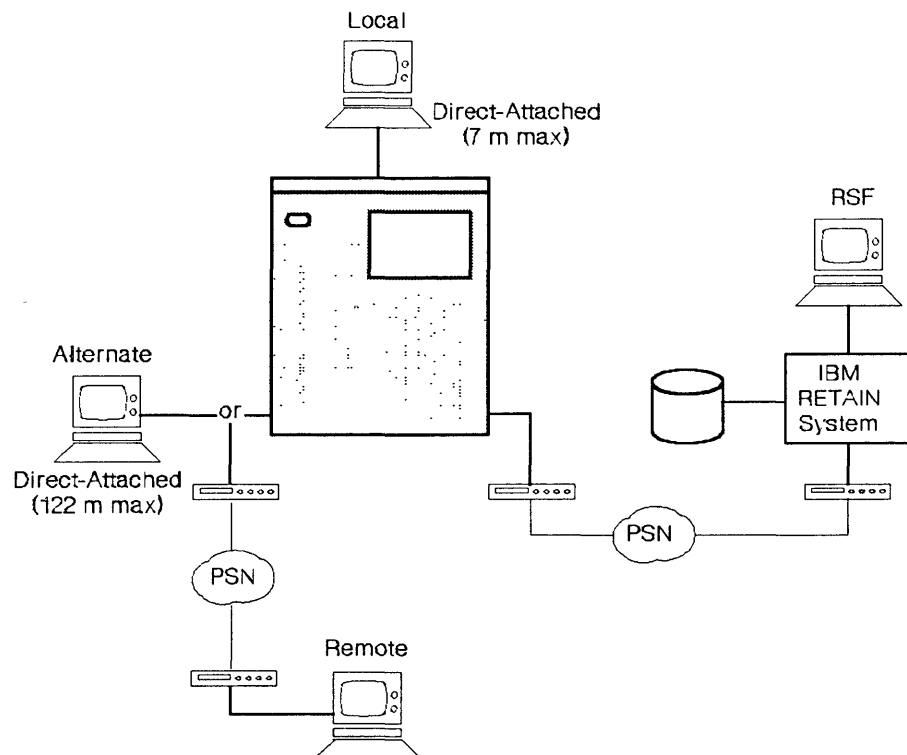
Figure 17-1. IBM 3745 with its Four Different Types of Consoles

- Local console
- Alternate console
- Local modem (at the 3745 end) for a remote console
- Local modem (at the 3745 end) for an RSF connection.

1 means remote or alternate console.
2 means RSF console.
3 means local console.

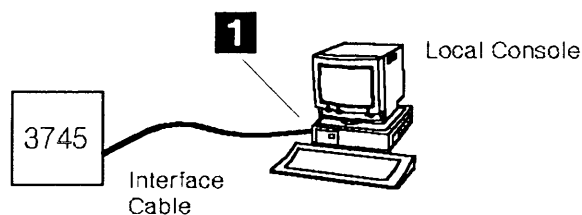
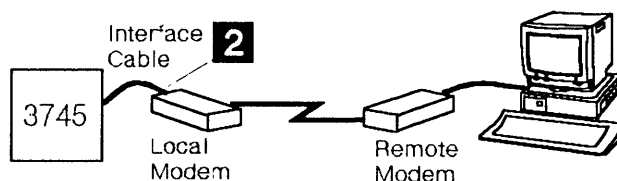
Figure 17-2. Local, Remote, and RSF Console Links

4 For the local or alternate console: Disconnect the cable **1** from the local or alternate console.

For the remote console or the RSF connection: Disconnect the cable **2** or **3** from the local modem at the 3745 end.

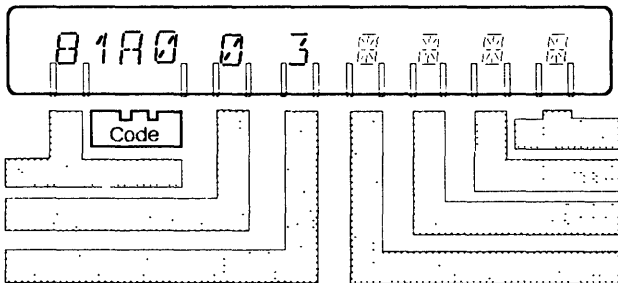
Hex Display Codes are 1A0, 1A3, or 1A6

- 1** **1A0** = Problem on local console cable or cable connector.
1A3 = Problem on remote or alternate console cable or cable connector.
1A6 = Problem on RSF console cable or cable connector.

- Console cable missing
- Console cable incorrectly plugged
- Wrong console cable
- Console cable connector damaged.

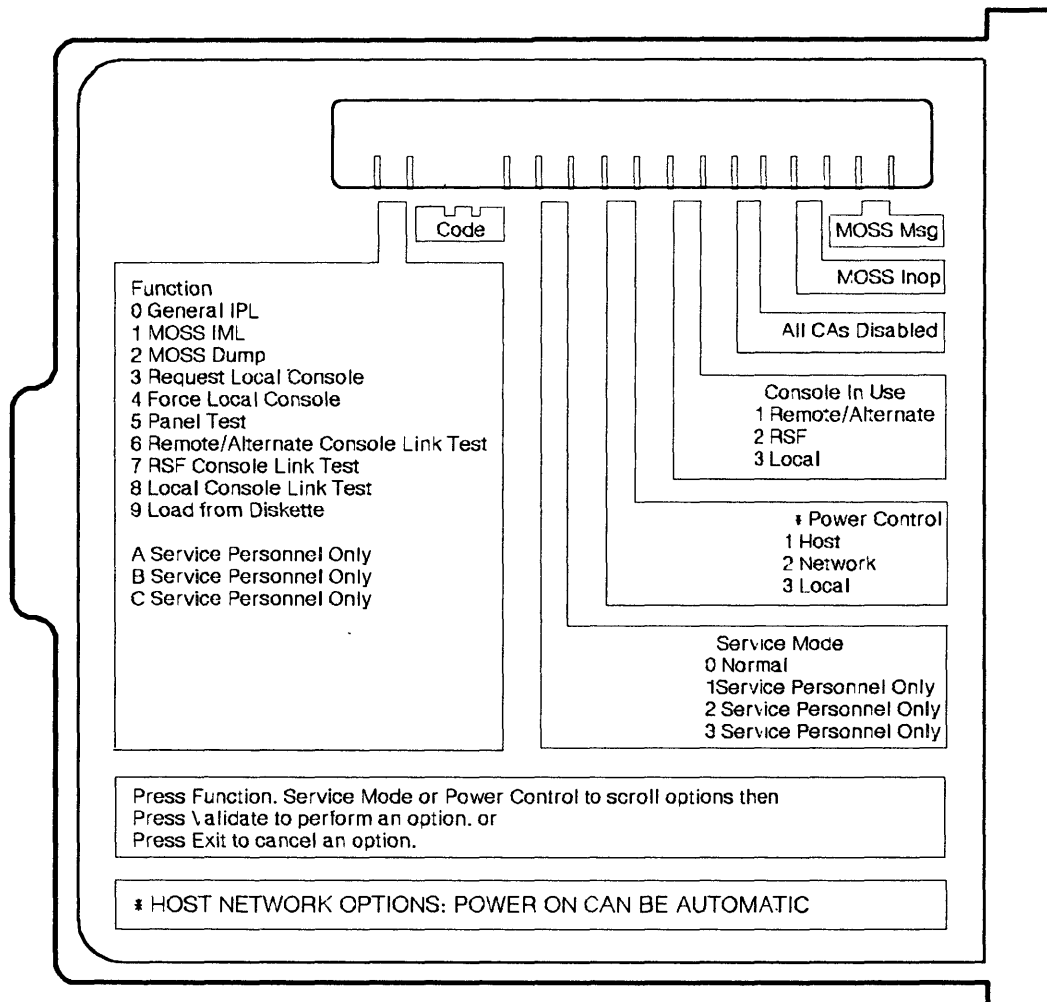
Figure B-1. IBM 3745 Control Panel Reference Card

The following control panel reference card (PN 65X8930) is attached to the diskette housing of the 3745 front panel and can be slid out for reading.

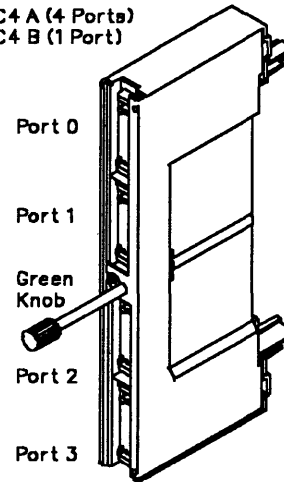
LIC4 A (4 Ports)
LIC4 B (1 Port)

- Use upper port for DCE attachment.
- Use lower port for direct attachment.

- LICs 4A and 4B are physically identical, the choice being made at configuration time.
- LIC 4B uses port 0 only.

Figure C-1. LIC Types

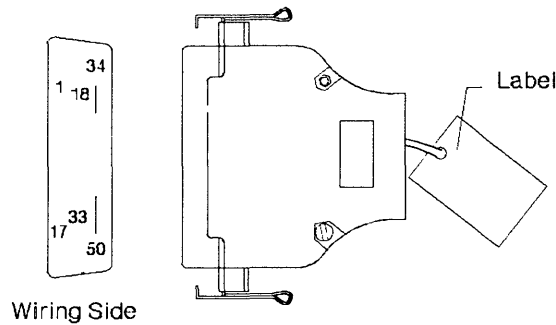
Figure C-5. HSS Lines Wrap Test Plug

HSS wrap plug for V.35 lines, P/N 58X9349

HSS wrap plug for X.21 lines, P/N 58X9354

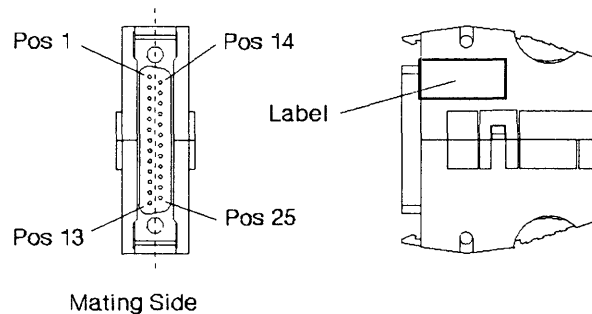
Figure C-6. Console Wrap Plug

Wrap plug for the 31xx console, P/N 6398697
