IBM 3745 Communication Controller
All Models

Problem Determination Guide

IBM 3746 Expansion Unit
Models A11, A12, L13, L14, and L15

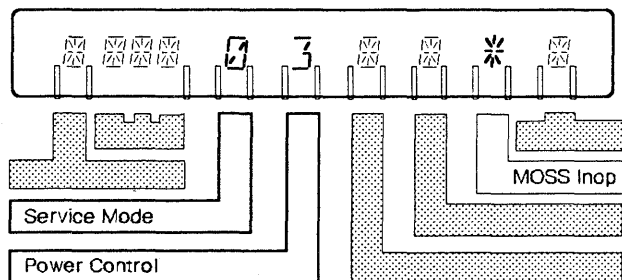
This drawing represents the control panel display. The control panel is fully illustrated and explained in the *3745 Basic Operations Guide* and on the *3745 Control Panel Reference Card*. (See Appendix A, "Control Panel.")

The highlighted name (for example: Service Mode) identifies the display position or the indicator to look at.

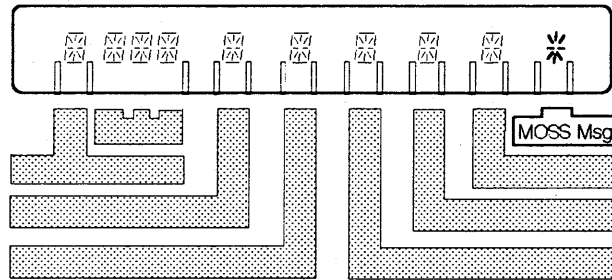
When an alarm is generated, the MOSS Msg indicator is lit on the control panel.

- If the console operator is logged on, the alarm is displayed and an audible signal is emitted.
- If the console operator is not logged on, log it on (refer to the *3745 Advanced Operations Guide*, SA33-0097).

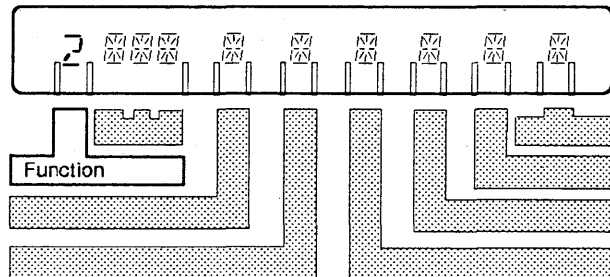
- Dump MOSS from the control panel: Press **Function** repeatedly until **2** is displayed; then press **Validate**:

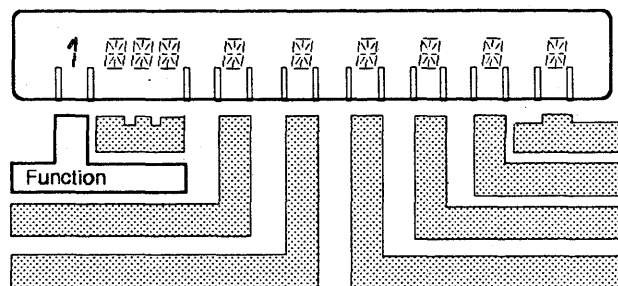
- Re-IML MOSS from the control panel. Press **Function** repeatedly until 1 is displayed; then press **Validate**:

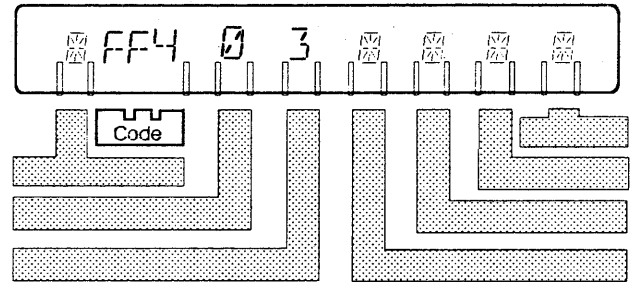
- The progression of a function (for example, IPL).
- The status of the components.
- An error. In this case, the code blinks.

Code	Explanation and Action
0 0 0	3745 IPL has been successfully completed. The control program is loaded and MOSS is online.
0 0 1 or 0 0 2

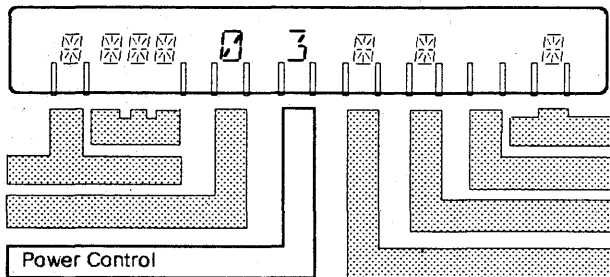
Power control on the control panel display is: 1, 2, or 3

- If 1 Go to page 4-2
- If 2 Go to page 4-3
- If 3
 - Power off
 - Wait 10 seconds
 - Select the function 1 (MOSS IML)
 - Power on
 - If the problem persists:

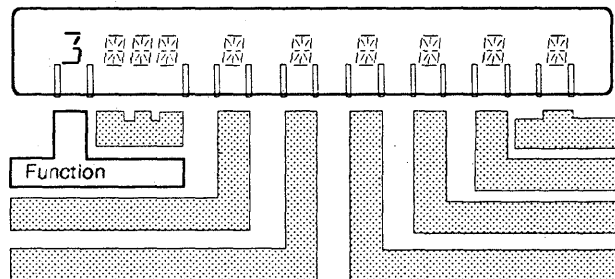
- 1 Press **Function** repeatedly until 3 is displayed, then press **Validate**. This informs the remote or RSF operator that you want to log on.

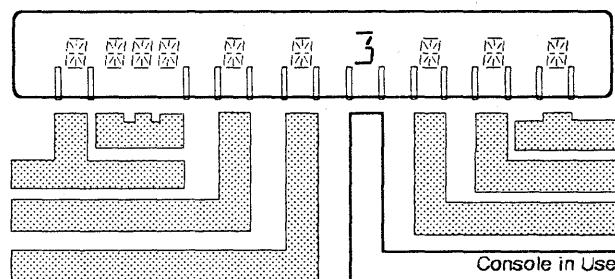
- 2 When **Console in Use** displays 3, the remote or RSF console is disconnected. You may log on at the local console. If 3 does not appear, go to next step.

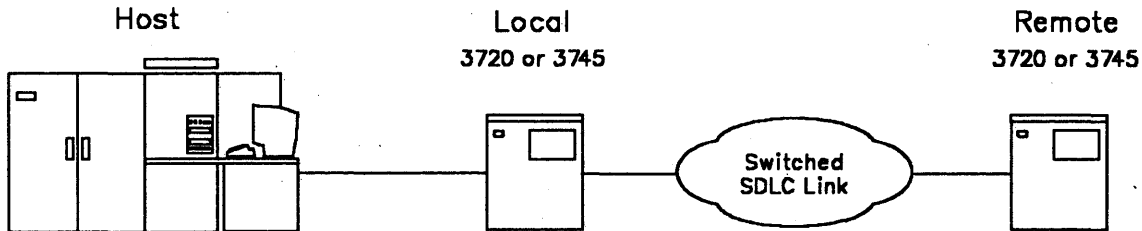
Figure 8-1. Initial Loading on Switched/Nonswitched SDLC and Nonswitched X.21 Links

- The remote initial loading can be performed by using VTAM* commands from the host.
- A link IPL port (LKP) must be defined in the remote controller.

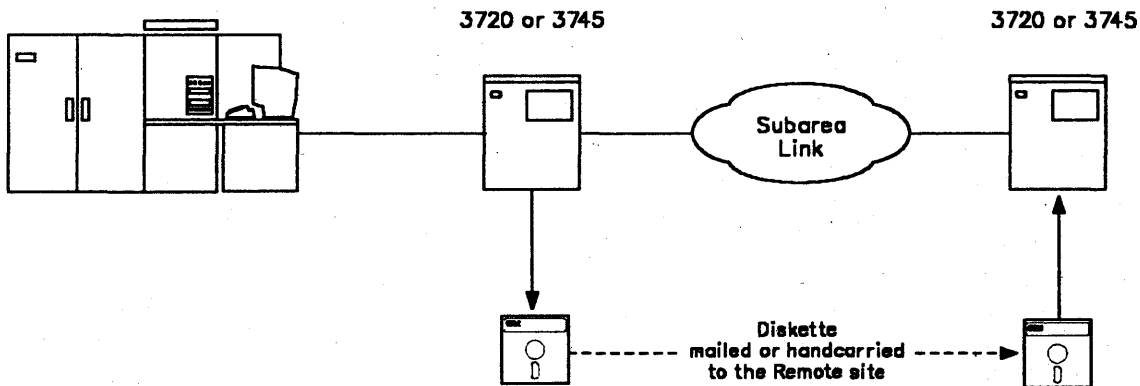
Figure 8-2. Initial Loading on Switched X.21, X.25 (SVC/PVC), and Token-Ring Links

- The remote initial loading can be performed only by using the diskette management procedure. Refer to the *3720/3745 Remote Loading/Activation Guide* or to the MOSS DII function described in the *3745 Advanced Operations Guide*.
- Those links do not require a link IPL port (LKP) definition in the remote controller.

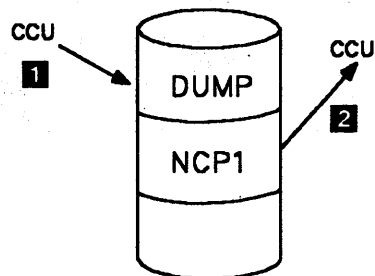
If the NCP1 fails or a hardcheck occurs:

- **1** The controller dumps NCP1 (which failed) onto the hard disk.
- **2** The controller reloads NCP1 from the hard disk, and you do not have to reload NCP using a diskette or an SDLC link.

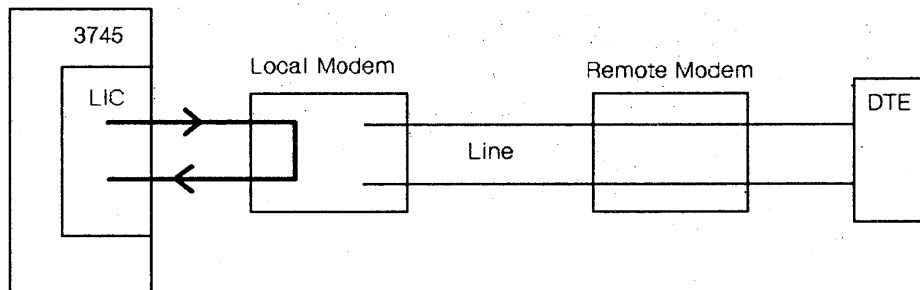
3. Local modem loopback test (loop 3)

Refer to the MOSS WTT function in the *3745 Advanced Operations Guide*.

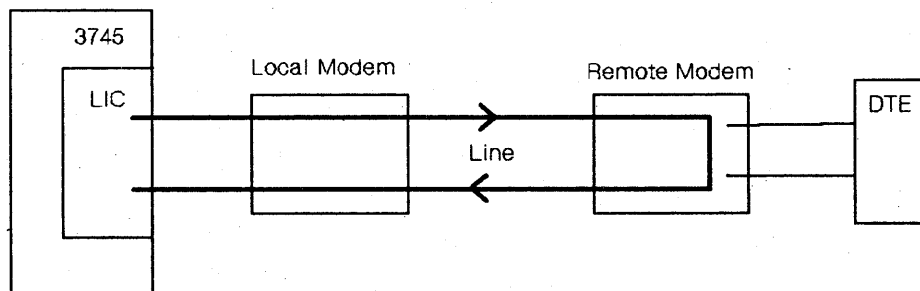
4. Remote modem loopback test (loop 2):

Refer to the MOSS WTT function in the *3745 Advanced Operations Guide*.

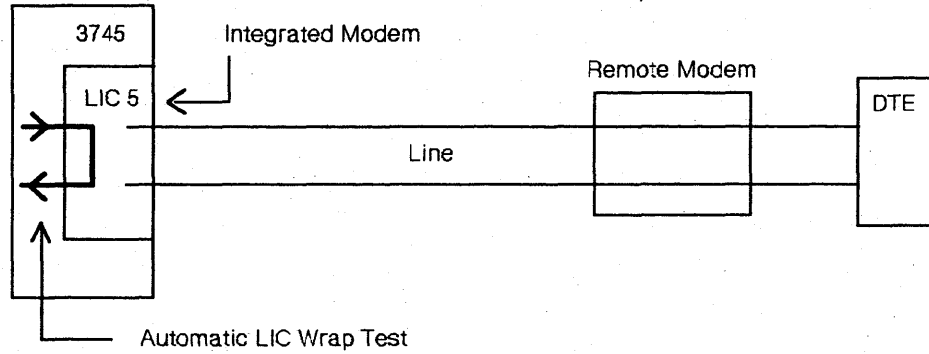
Figure 9-2. Automatic LIC Wrap Test on LIC5

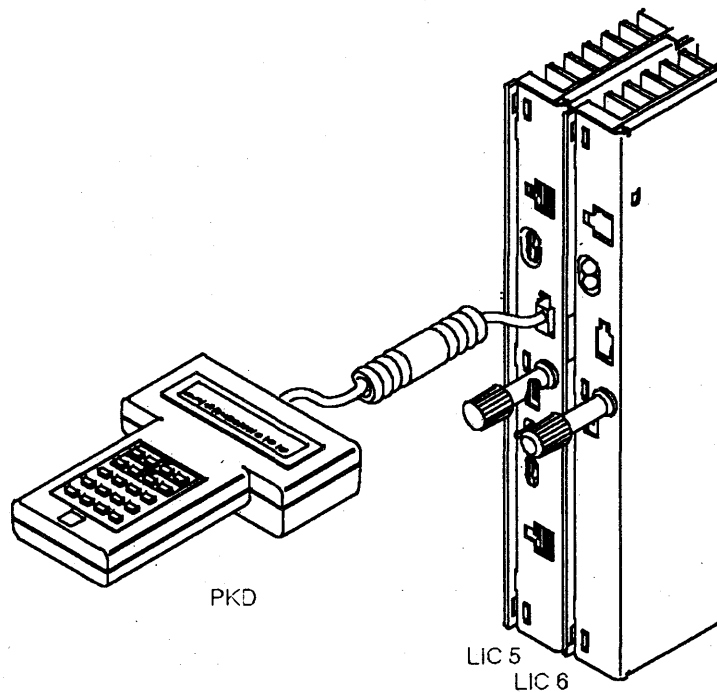
Figure 9-3. IBM 5869 Portable Keypad Display (PKD) plugged to a LIC5 or a LIC6.

- 8** Locate the LIC to be tested and plug in the IBM 5869 Portable Keypad Display (PKD) as described in the *3745 Connection and Integration Guide*.
- Various messages can be displayed on the PKD before performing the LIC line analysis procedure (LLAP). These are described under "LIC Messages (LIC5)" on page 9-41.
- If the mode is CCITT (and you checked the configuration in step 3), and the problem persists, suspect your common carrier or the other modem.

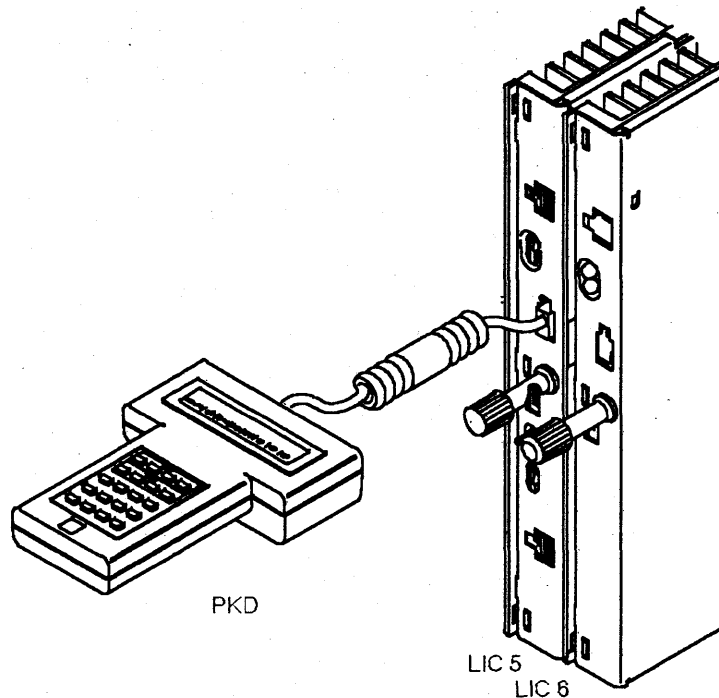
Figure 9-4. IBM 5869 Portable Keypad Display (PKD) plugged to a LIC5 or a LIC6.

- To check the lights, plug the PKD in (refer to Figure 9-4 on page 9-47 for connection); press the **Go** or **Stop** key; then the green and yellow lights should be on.

8 Locate the LIC to be tested and plug in the IBM 5869 Portable Keypad Display (PKD) as described in the *3745 Connection and Integration Guide*.

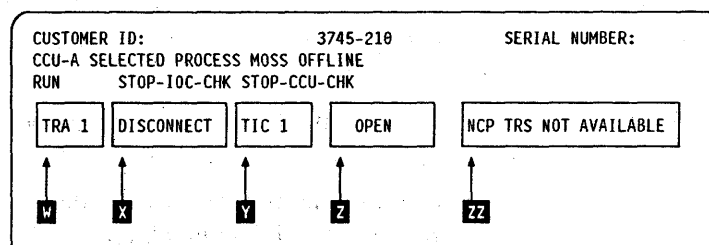
MSA Fields Definition (Token-Ring/TIC Information)

Figure 12-1. MSA Fields definition (Token-ring Information)

Token-Ring information is displayed on line 4 for CCU-A, and on line 7 for CCU-B.

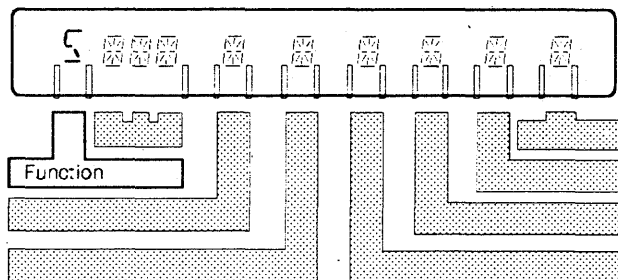
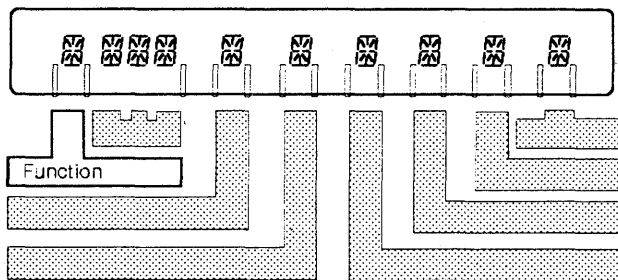
All segments of all the displays and indicators of the control panel should be lit, as illustrated.

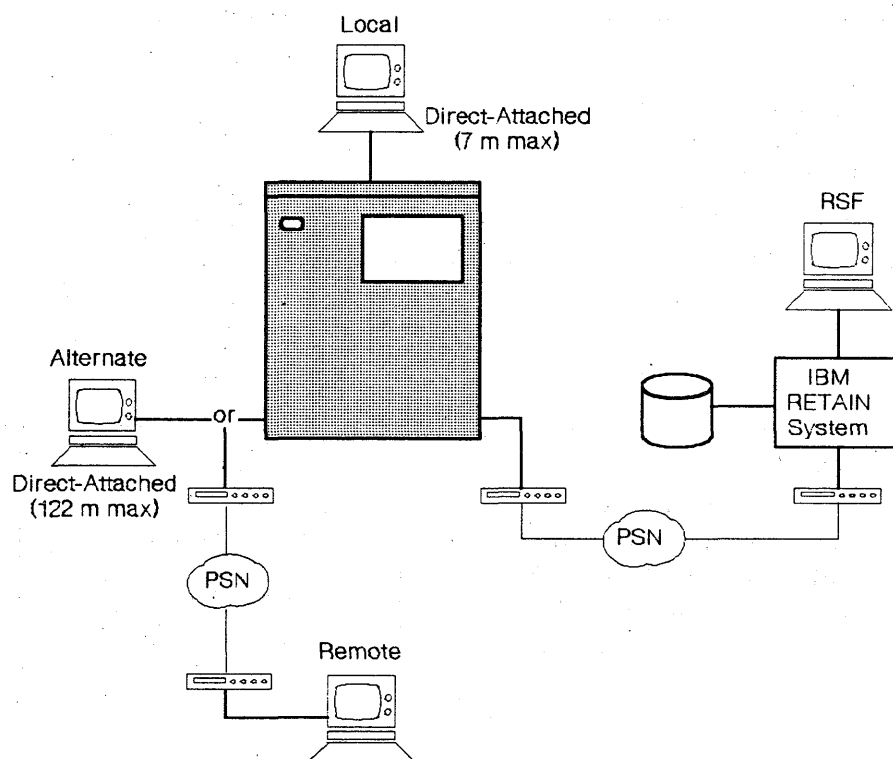
Figure 17-1. IBM 3745 with its Four Different Types of Consoles

- Local console
- Alternate console
- Local modem (at the 3745 end) for a remote console
- Local modem (at the 3745 end) for an RSF connection.

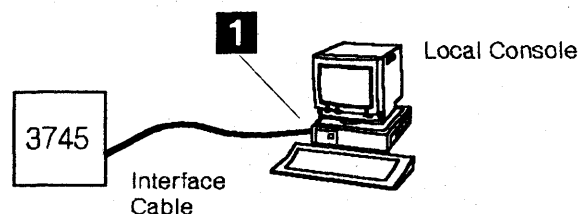
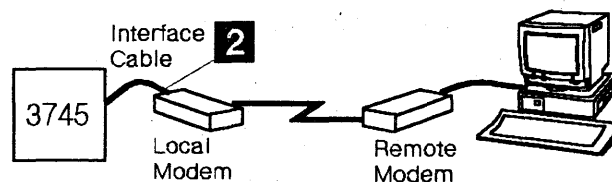
4 For the local or alternate console: Disconnect the cable **1** from the local or alternate console.

For the remote console or the RSF connection: Disconnect the cable **2** or **3** from the local modem at the 3745 end.

Figure 17-2. Local, Remote, and RSF Console Links

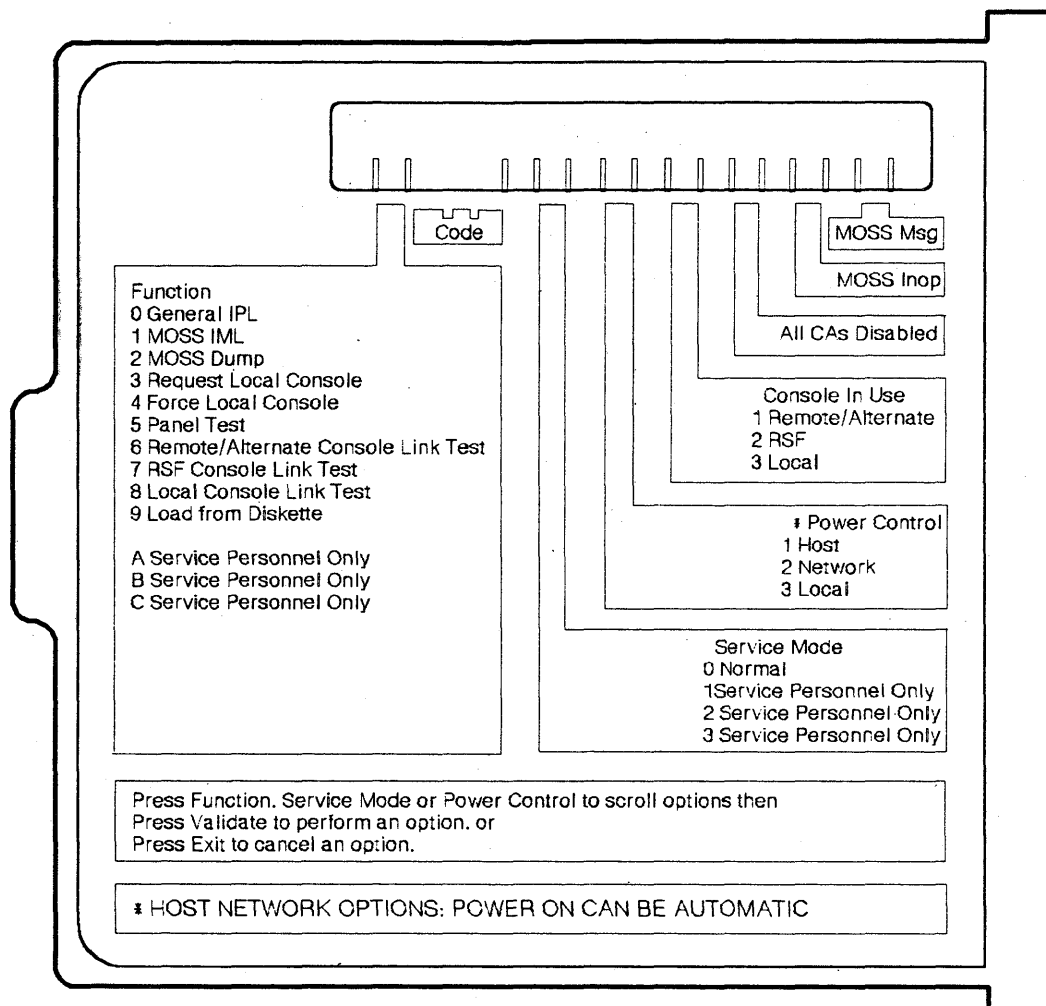
Figure B-1. IBM 3745 Control Panel Reference Card

The following control panel reference card (PN 65X8930) is attached to the diskette housing of the 3745 front panel and can be slid out for reading.

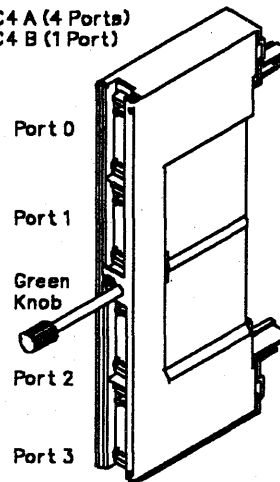
LIC4 A (4 Ports)
LIC4 B (1 Port)

- Use upper port for DCE attachment.
- Use lower port for direct attachment.

- LICs 4A and 4B are physically identical, the choice being made at configuration time.
- LIC 4B uses port 0 only.

Figure C-1. LIC Types

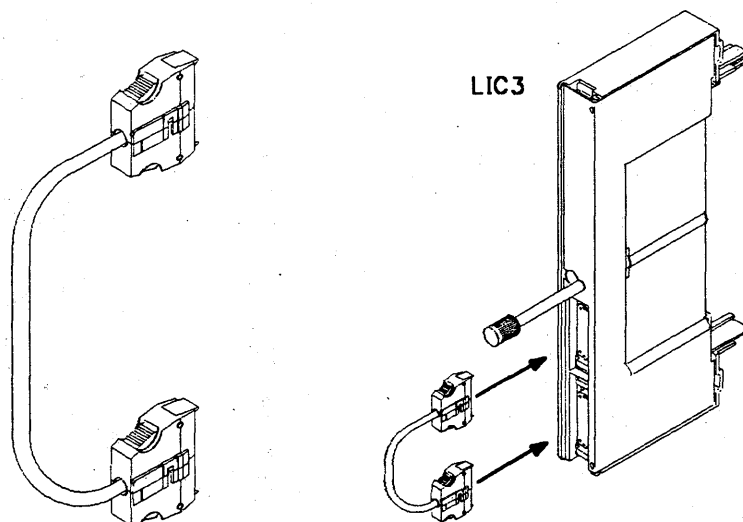
Figure C-3. LIC Type 3 Wrap Cable (P/N 65X8928)

Note: In order to test a LIC3 card, it is necessary to reverse the LIC3 wrap cable after the first test pass, then run the test again.

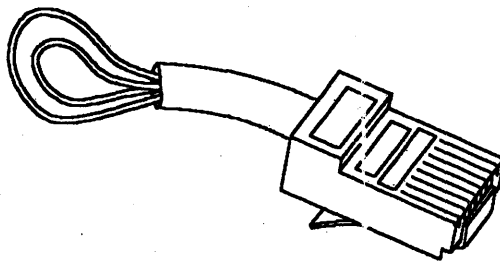
Figure C-4. LIC Type 5 and 6 Tail Gate Wrap Plug (P/N 11F4815)

Note: In addition to the tail gate wrap plug, a wrap block is also shipped with the machine. This wrap block may be plugged at the end of the cable (at the customer wall frame side) to test the line up to the customer wall frame.

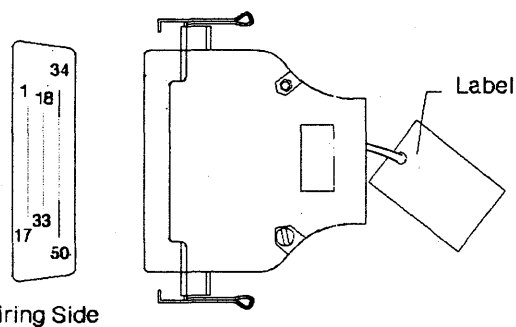
Figure C-5. HSS Lines Wrap Test Plug

HSS wrap plug for V.35 lines, P/N 58X9349

HSS wrap plug for X.21 lines, P/N 58X9354

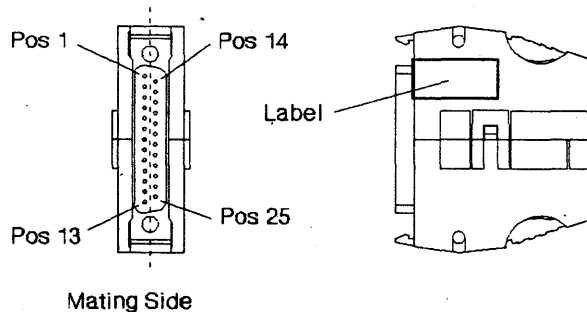
Figure C-6. Console Wrap Plug

Wrap plug for the 31xx console, P/N 6398697
